# MYSTERIES WITH THE 2.0L BEV ENGINE WITH AUTOMATIC TRANSMISSION IN 2007 VW CITY GOLF

What happens when the aftermarket parts source has difficulty finding the matching parts and the suppliers can not match the required parts? A disaster is a possibility and solvable.

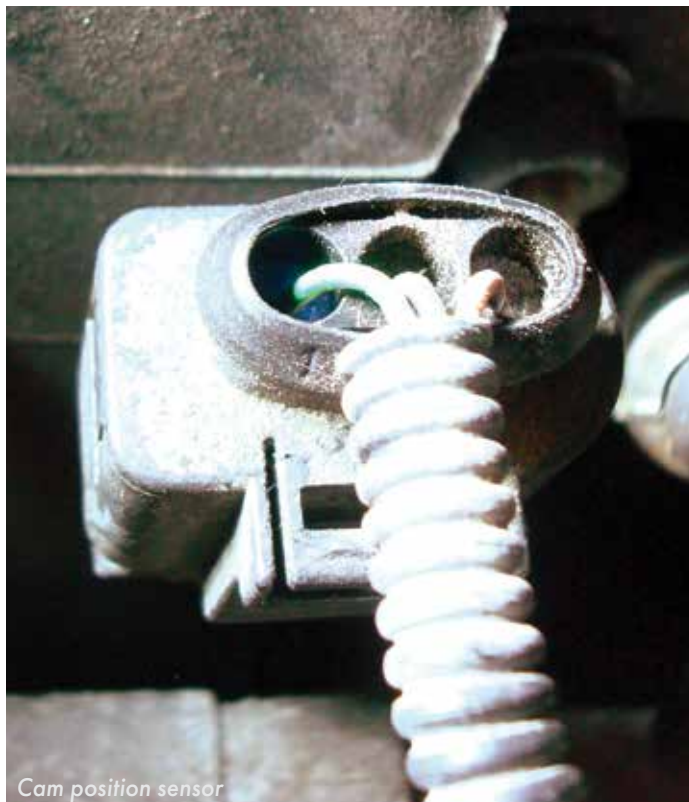
This ECM fault returned:

- 17746 - Camshaft Position Sensor (G40)
- P1338 - 35-00 - Open or Short to Plus

Cam position sensor

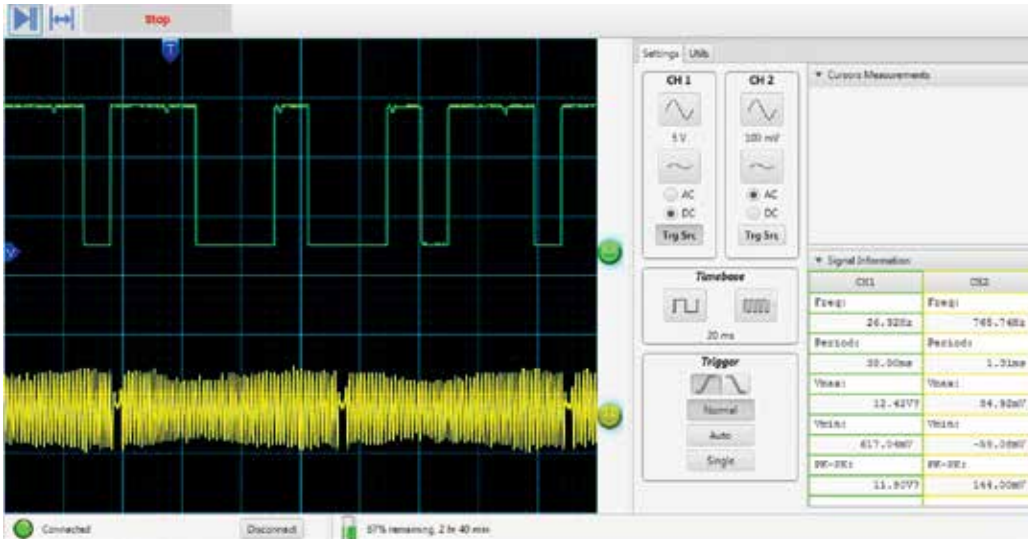
Scope Cam and Crank

While monitoring with VCDS, start the oscilloscope and take your time to capture multiple images. This one is interesting because there is a repeat in the downward spikes at the cam position high side and the voltage did NOT hit the "0" mark as expected on the low side.

Note C: On the full captured oscilloscope screen, each spike measures 3 centimeters and repeated itself across the screen.

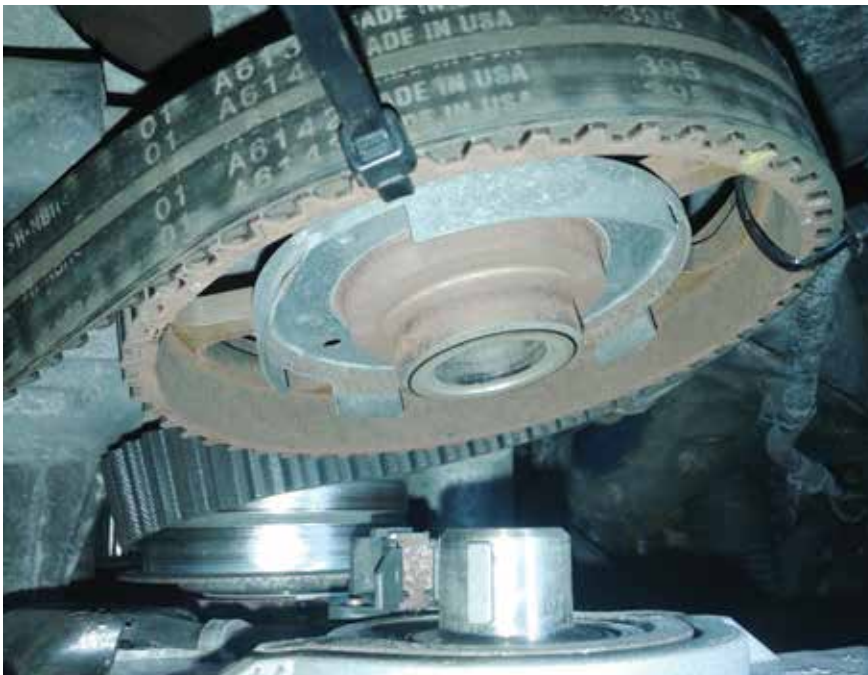
Cam sensor rust

Using a metric plastic ruler, look at the repeating image in green. The measurement is relative to the screen or photo that you are viewing. Markers measuring the frequency could have been used on this scope but the proof is in the image. Removing the gear and an inspection offers more proof that rust played a major part in the fault with the sensor and cam gear timing windows and the sensor was not behaving as intended. There was quite a bit of rust removed with compressed air before the image was saved.

Mark everything and remove the cam gear for inspection. There was a very large amount of rust flakes on the cam sensor. Opened the box for the cam position sensor – incorrect sensor arrived!

Having heard/read many comments about this engine and replacement parts, this is the advice. A complete timing belt and hardware replacement is not required if the timing belt was not due. Cleaning the rust was the best option on both engines that

were discussed. Scotchbrite or 3M pads work very well with compressed air and a dust mask.

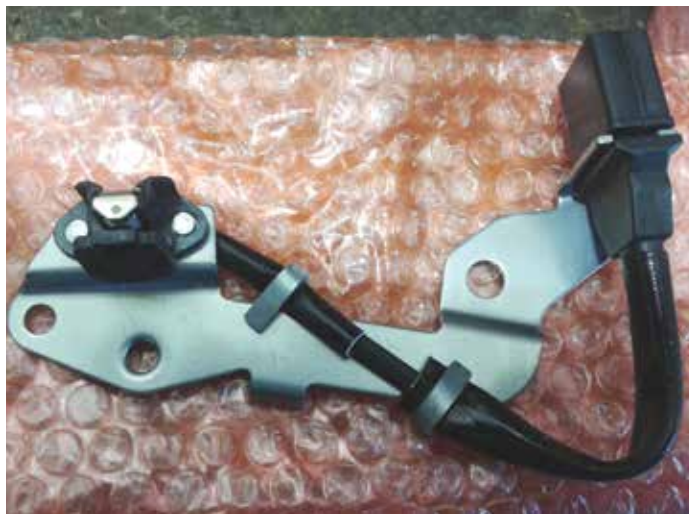
Aftermarket sensor

It will happen on occasion that the parts listings are incorrect. This engine is NOT a TFSI engine and this engine requires a completely different sensor.

The image is of the correct style of sensor and the problem is where the rivets were placed for the sensor mounting. The aftermarket sensor is incorrectly aligned to accept the cam gear timing windows. Since the timing windows of the cam gear were hitting the sensor magnet, the gear would not mount completely onto the camshaft, binding the sensor and gear windows.

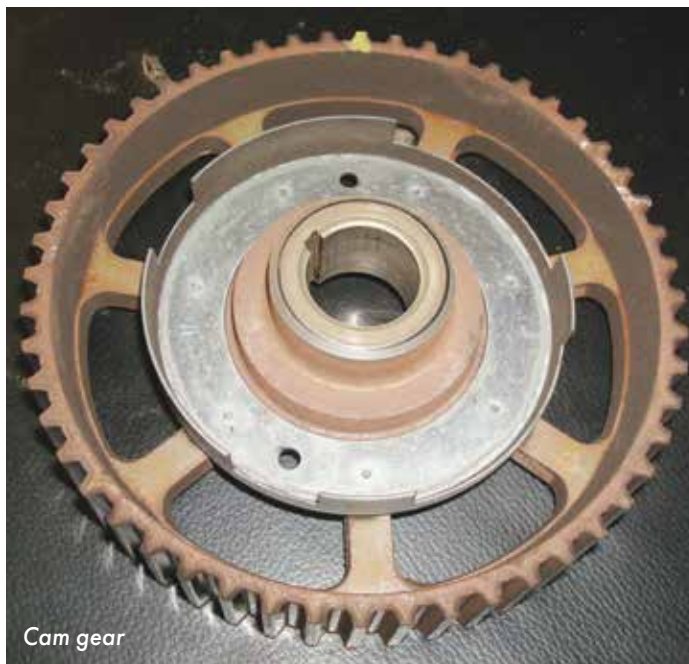
Cam gear

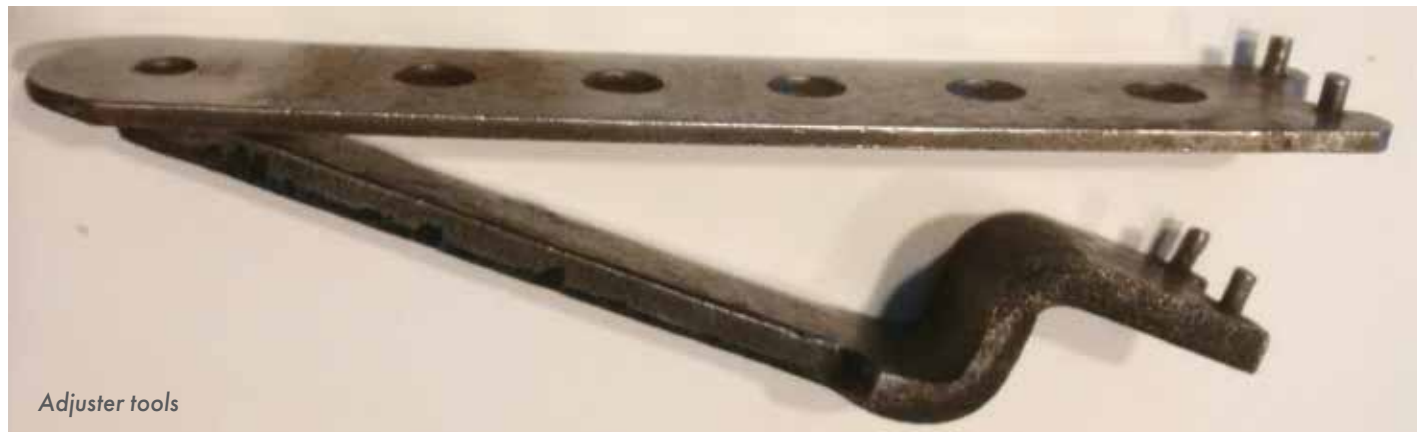
Adjuster tools

The timing belt adjuster was in perfect condition and there may be a problem if this procedure was accomplished with the mounting bracket to the engine block is in place. The tool required is the one on the left. Both are hand made tools and purpose made.

To adjust the timing belt, follow the service procedure, but some procedures are incorrect because of this unusual engine configuration. The procedure is to rotate the adjuster clockwise and view the alignment of the adjuster with a mirror.
