# TOYOTA SERVICE NEWS

Bulletin No. 2

November, 1981

**IASA/TOYOTA -  
"a Joint Effort  
to offer  
Quality Service"**

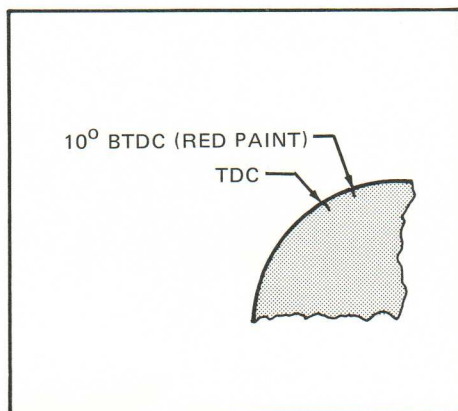
13471-33010 Pulley (Discontinued)

To permit a common crankshaft pulley to be used on the 8R, 8R-C, and 18R-C engines, the ignition timing marks have been changed as shown below. A notch has been added to the 18R-C engine crankshaft pulley to indicate 10 degrees BTDC. The new notch is identified with yellow paint and

is comparable to the 10 degree BTDC notch (red paint) on the 8R, 8R-C engine crankshaft pulley. When resetting ignition timing, be sure to use the correct timing mark.

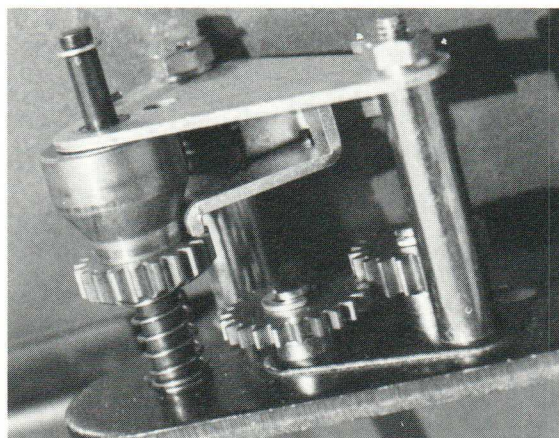
When the battery is disconnected, or the clock fuse is burned or removed, the clock will cease to operate and will not restart when the battery is reconnected or the fuse is replaced. To start the clock, the reset knob must be pulled out and then released. When the knob is released, the clock will continue to operate. This method of restart should

be followed whenever a power failure occurs. Photo 1 below is a partial view of the clock mechanism, and shows the shaft (to which the reset knob is attached) in the disengaged position. In Photo 2, the reset knob has been pulled out and the cam has engaged the lever which activates the clock start mechanism.

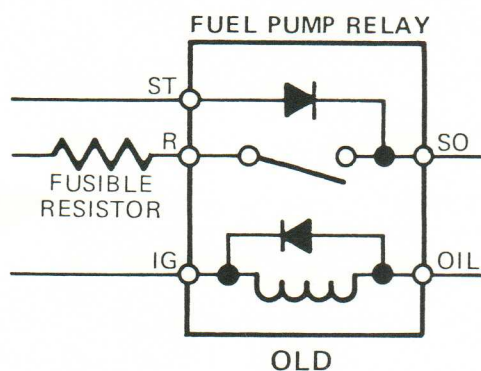
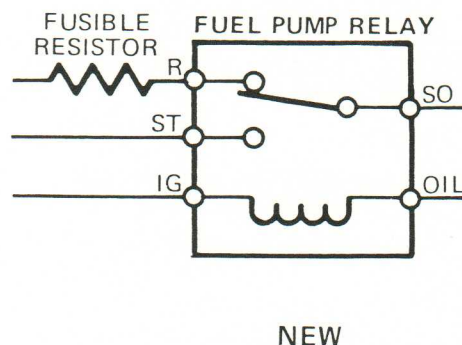
In February and March of 1975 (depending on the model of car) the fuel pump relay was changed. The exact serial numbers of the change are not available and since the relays are interchangeable,

the only way to be sure which relay you are working with is by part number. The part number is printed on the cover for easy identification.

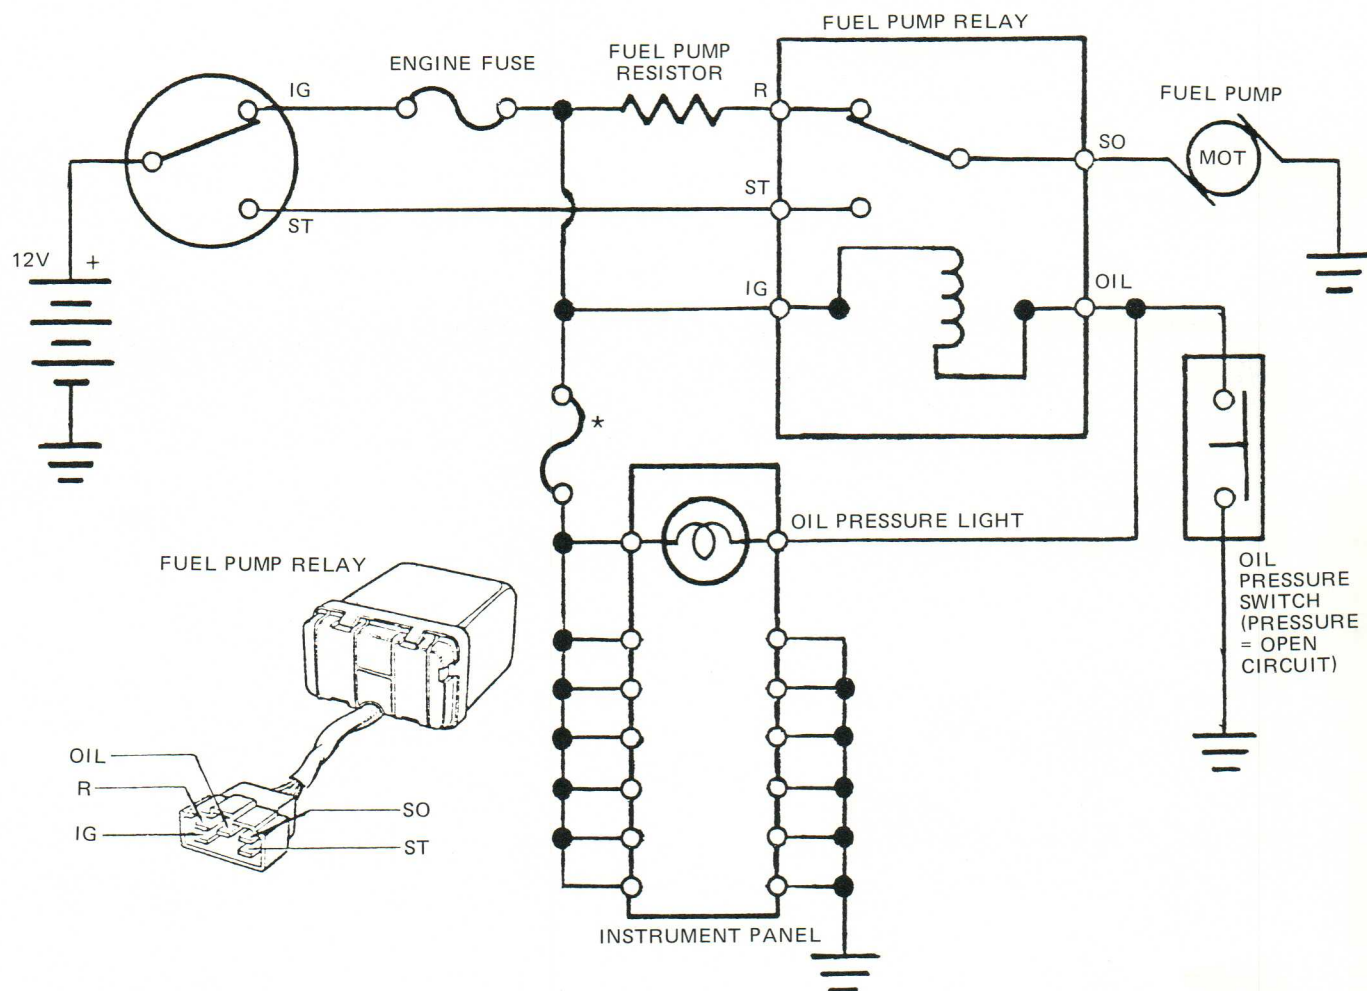
## ELECTRICAL FUEL PUMP WIRING DIAGRAM

Circuit is shown with engine and fuel pump operating. Relay is not energized due to open circuit of oil pressure. Switch relay points are spring loaded in the position shown.

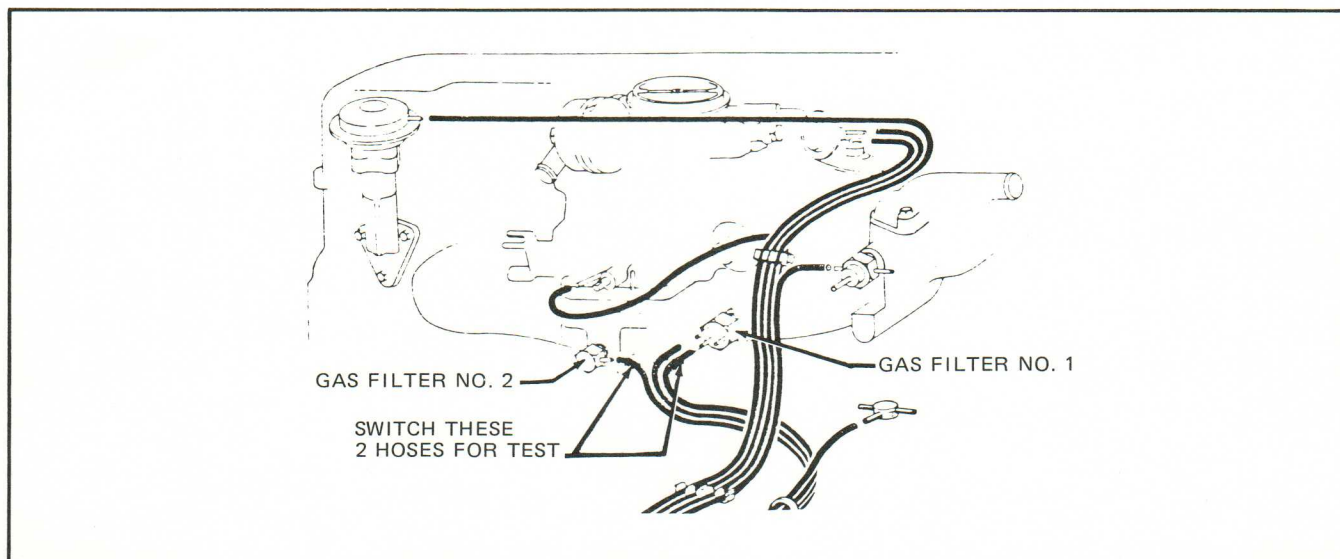
Customer complaints of afterburn (popping noise from the tail pipe after normal combustion process) during sudden deceleration can occasionally be

traced to partial clogging of the #1 gas filter (for vacuum system) located on the side of the intake manifold.

The afterburn condition can be readily duplicated in the shop as follows: 1) idle engine until coolant temperature exceeds 60 degree F; 2) rev engine to 2500 rpm, then quickly release throttle.

To test for a partially clogged gas filter, reverse the indicated vacuum hoses and repeat steps (1) and

(2). If the afterburn disappears, replacement of gas filter #1 is recommended.
