# TOYOTA

# SERVICE NEWS

Bulletin No. 4

May 1982

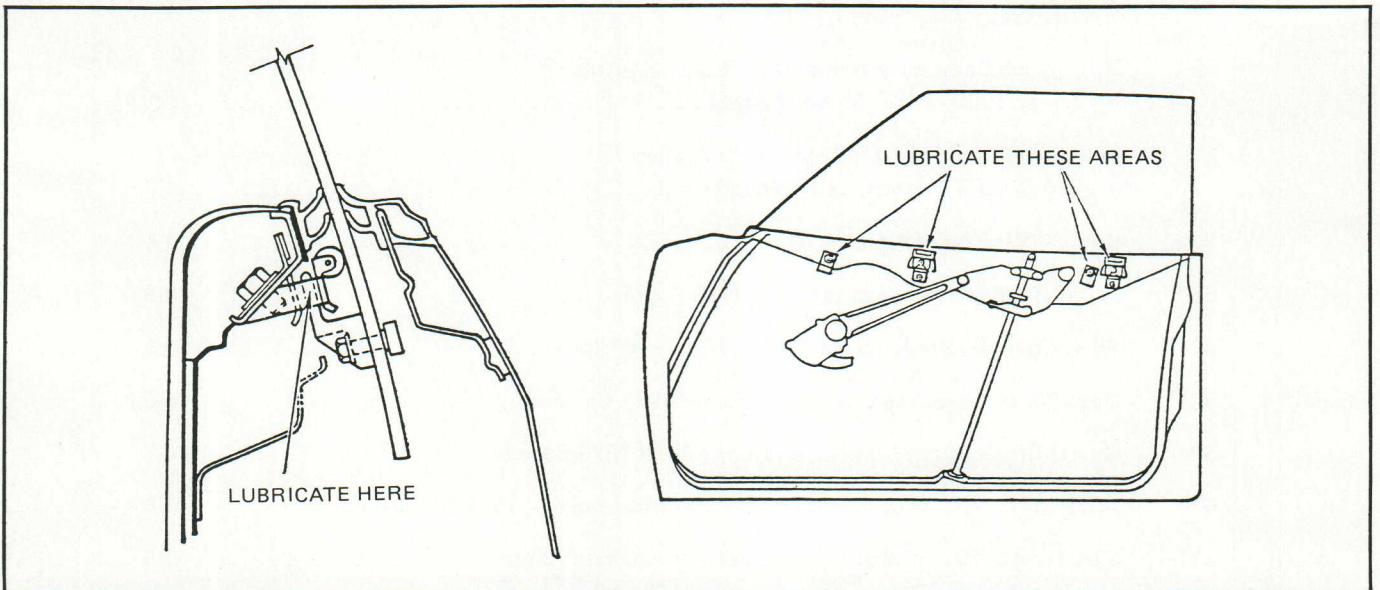
The following information is applicable if a 1979 Celica or Supra has a "creaking" sound in the upper door area when the window is fully closed. This noise will occur when pressing the top of the door trim as well as when hitting bumps in the road.

1. Remove door trim panel per the Celica Body Manual.
2. Loosen the top and rear of the service hole cover.
3. Lubricate the front door glass stopper and front stabilizer with Kent "K-44 Silicone Lubricating Compound" or equivalent through lower access hole.
4. Raise the door glass to within 50 to

75mm (2 to 3 inches) of the top and lubricate the rear door glass stopper and rear stabilizer with K-44 or equivalent.

5. Fully raise and lower the glass several times to be sure that no K-44 is on the rollers or glass.
6. Reinstall the door trim panel.

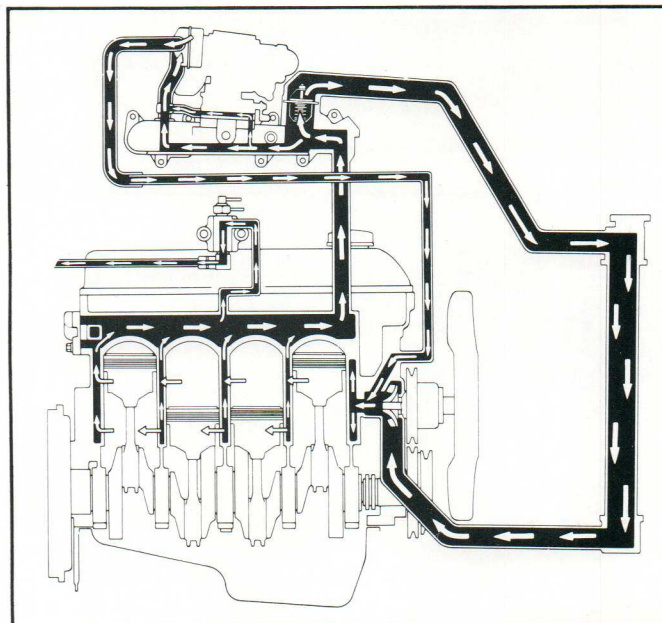
To improve cold weather operation, the 20R engines have been equipped with a carburetor which allows coolant to be circulated through

the carburetor base and through the choke coil outer housing as shown in Figure 1 below:

Due to this design, it is important to drain approximately one (1) gallon of coolant from the cooling system **BEFORE** removing the carburetor assembly to prevent coolant spills and contamination of internal engine parts.

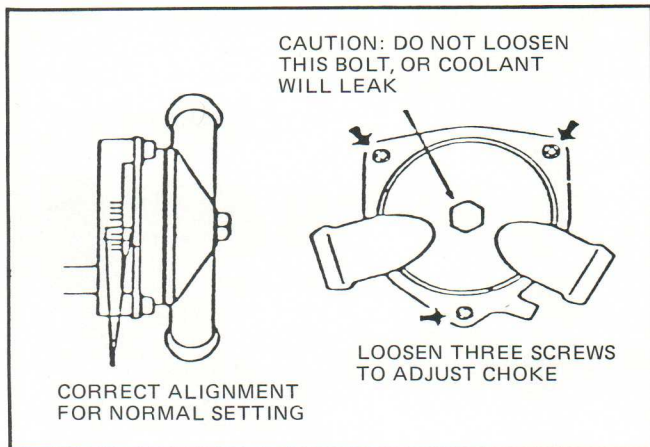
Adjustment of Choke Thermostat Setting

Should adjustment of the choke thermostats become necessary, loosen the three housing set screws **only** (**DO NOT** remove the center bolt as coolant will leak) and adjust as shown in Figure 2 below:

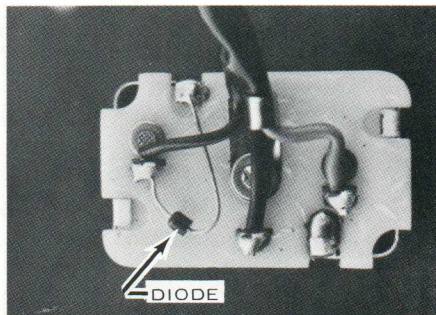
The seat belt interlock system on the 1974 model Toyota requires the use of a starter relay which incorporates a diode to protect the system computer. In the event a starter relay not equipped with a diode is used as a replacement, damage to the computer will result. This would then be considered an improper repair.

1974 model seat belt system. A correct starter relay (underside view, cover removed), with protective diode, is shown below.

Therefore, to avoid a situation of this kind, you are urged to ensure that the relay which is used as a replacement is the one that was specifically designed for use with the

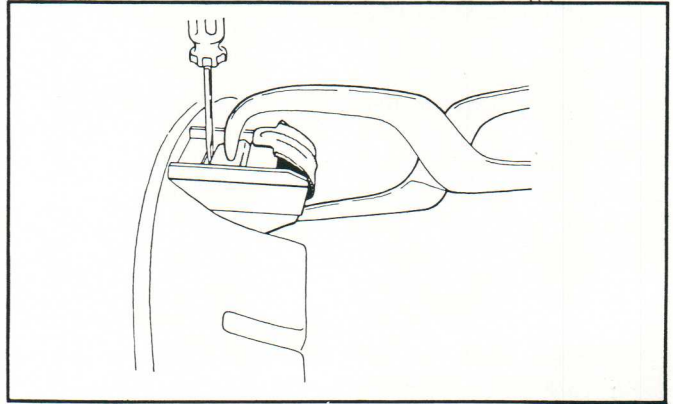
To repair Supra polycast wheel covers for the complaint of looseness, the eight retaining clips should be replaced. All retaining clips currently available have reduced tolerances for better fit. See your Toyota dealer for these clips.

1. Remove the wheel cover from the vehicle.
2. With a pair of brake spring pliers, depress the clips' retaining spring 1 to 2 mm (approx. 1/16 in.).
3. Insert a small screwdriver behind the clip as shown. Use the screwdriver as a lever to pry the clip out of its mounting. If more than slight resistance occurs, depress the clips' retaining spring a little more. The clip should slide out easily.

4. Repeat steps 2 & 3 for the remaining clips.
5. Push the replacement clip into its mount until the clips' retaining spring snaps into place. Repeat this procedure for remaining clips.
6. Reinstall wheel covers.

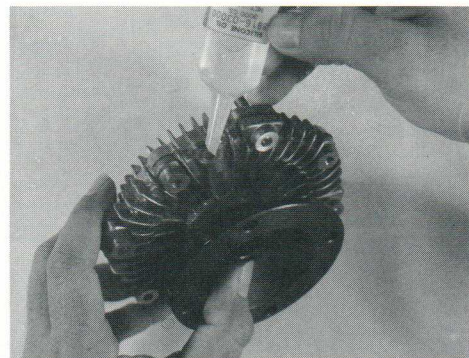
**CAUTION:** Usage of the wrong viscosity silicone

oil may result in the failure of the fluid coupling. See your Toyota dealer for the part numbers of the silicone oil.

The fluid coupling must be removed (as shown below). Clean thoroughly with a damp cloth and dry coupling unit completely. Avoid using gasoline or solvent as these fluids will linger and break down the silicone oil viscosity. Refill the unit and install.

The fluid coupling is not ready for installation as received. The unit must be filled with proper amount and viscosity of silicone oil before installation.

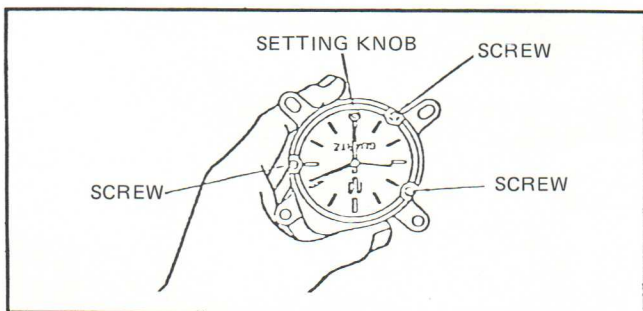
The Celica Quartz clock stopping or exhibiting intermittent operation symptoms has been traced to excessive spring plate pressure on the second hand drive gear. Installation of a "lifting clip" to remove this excessive spring plate pressure results in nearly a 100% successful repair.

- Keep your hands clean.
- Remove the clock assembly from the vehicle.
- Hold the clock in the upside down position (shown below).
- Using a #1 Phillips screwdriver remove the three screws from the face plate cover.

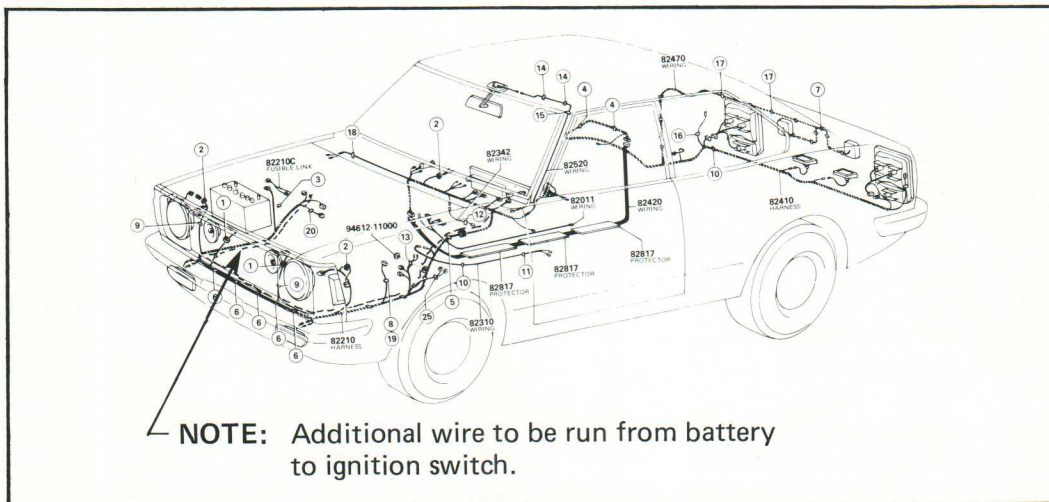
The above described condition is caused by an excessive voltage drop in the battery to ignition switch circuit (see page 3). This circuit is part of the charge warning system.

Take a 10-foot long 14 gauge wire and connect one end to the black/red wire found near the positive battery post (fusible link connector). Run and tape the wire along the wire loom under the radiator and along the left fender and through the fire wall. Connect the other end to the same wire (black/red) which terminates at the connector on the right side of the steering column going to the ignition switch.

Solder both connections to ensure good contacts.

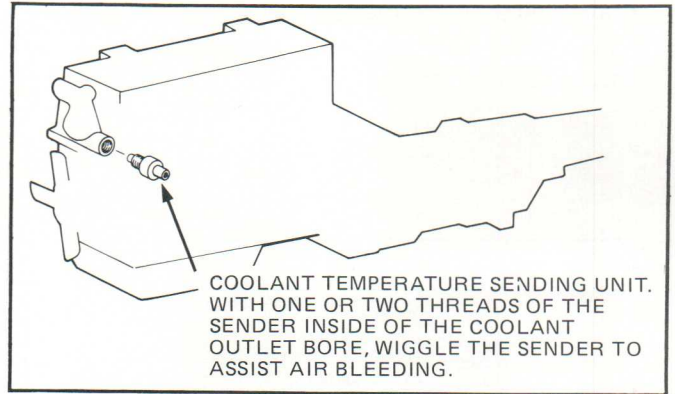
The reason for this procedure is due to the configuration and location of the coolant thermostat

and outlet on the 2T-C Engine. Air can be trapped in the cylinder head during normal radiator filling and can cause momentary overheating of the cylinder head. This overheating or hot spots could cause stress in the cylinder head, resulting in a cracked head.

1. Fill the radiator to the top.
2. Loosen the coolant temperature sending unit and back it out enough to bleed trapped air from the cylinder head. When all the air has been vented, the coolant level in the radiator will drop.
3. Top off the radiator with additional coolant.

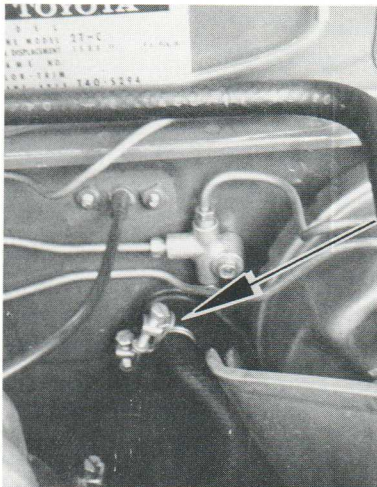
REMOVE HEATER HOSE AT FIREWALL

Customer complaints of noise from the heater area (popping or whistling noise) can be traced to the heater main valve opening or closing and coolant passing through the pressure relief valve.

- A. Drain two to three quarts of coolant from radiator.
- B. Disconnect heater hose from heater inlet tube at the fire wall.
- C. Install the nylon orifice in the inlet tube and reconnect the hose.
- D. Refill the radiator, start the engine

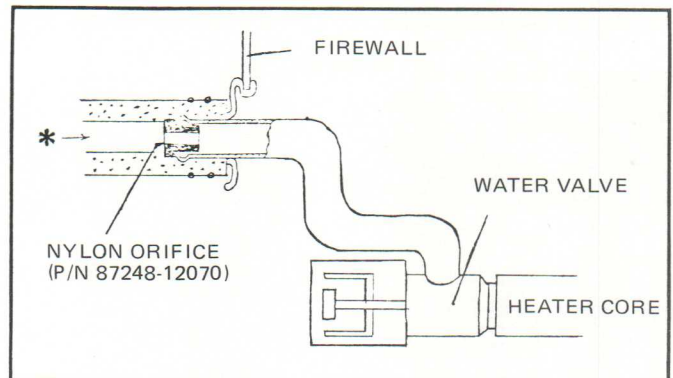
1. Popping noise can be experienced when heater temperature control lever is in 3/4 to 7/8 open position and on acceleration. This can be corrected by installing nylon restriction orifice (Part Number 87248-12070) in the heater inlet tube as illustrated below:

and check for leaks, radiator coolant level, and noise.
