Electrical Service

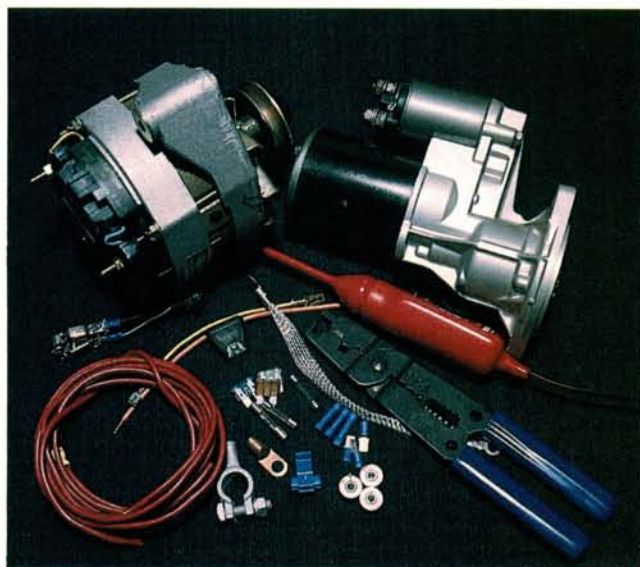
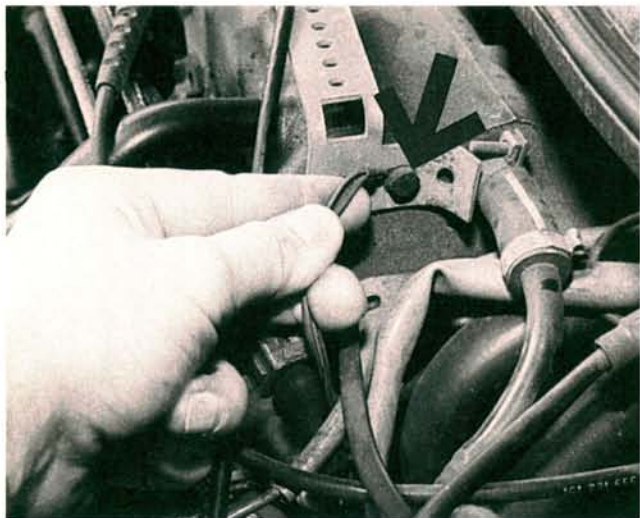
Volkswagen Fuel Injection Ground Wires

Broken ground wires at the intake manifold (arrow) on Volkswagen Golfs and Jettas equipped with CIS-E fuel injection will prevent proper operation of the differential pressure regulator. Symptoms are poor acceleration and black exhaust at wide open throttle. Remove the broken ground wire ends, then add extra wire to allow for engine movement. An alternative ground location is one of the valve cover hold down studs. The wires are then inspected with each valve cover removal.

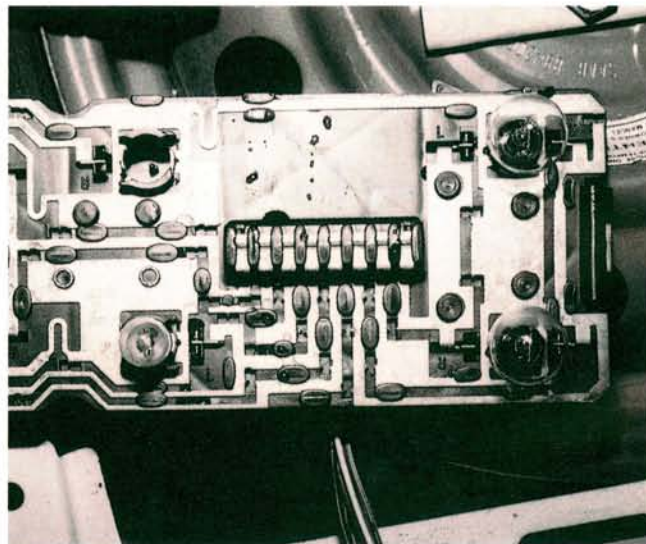
Saab 900 Tail Lamp Circuit

Corrosion (there's that word again) on the tail lamp printed circuit strips of Saab 900 four door models can cause some interesting feedback situations. The corrosion can either cause an open circuit or may bridge two strips. If the two strips happen to be power supplies for different circuits, the dashboard turn signal indicators may glow dimly when the brakes are applied, or tail lamp and brake light fuses will blow for no apparent reason.

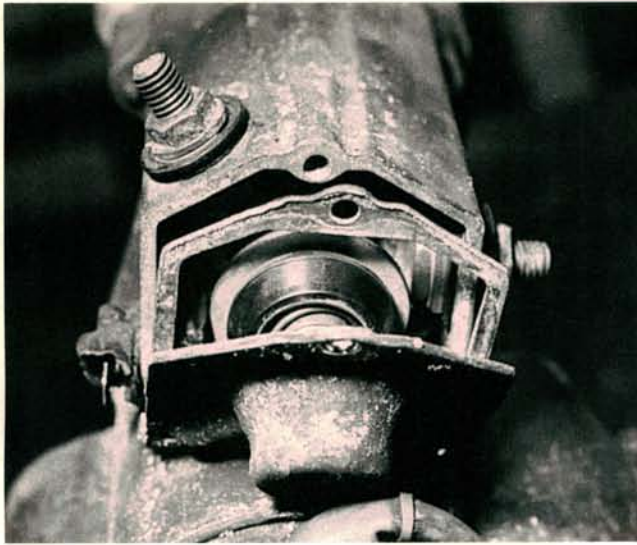
Nippondenso Starter Repair

Burned starter solenoid contact posts on gear reduction ND starters used on many Hondas, Subarus, and Toyotas, can cause an intermittent no-crank condition. Remove the three solenoid cover screws, then remove the cover and solenoid plunger. Inspect the solenoid contact posts. The post connected to the positive battery cable will usually be more heavily pitted than the contact post leading to the starter windings.

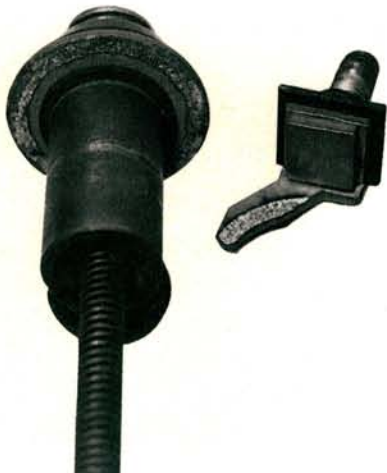
Polishing the Solenoid Plunger—ND Starter

The solenoid plunger has a much larger contact area than the contact posts. The plunger rotates in the housing each time the starter is engaged, so arcing isn't confined to just one spot on the plunger. Clean the plunger's contact surface with light sandpaper. If sanding won't do the trick, new plungers (P/N H/C 123245) are available from Honda. Even if you have to replace both the terminal post and the plunger, you'll still save your customer some money.

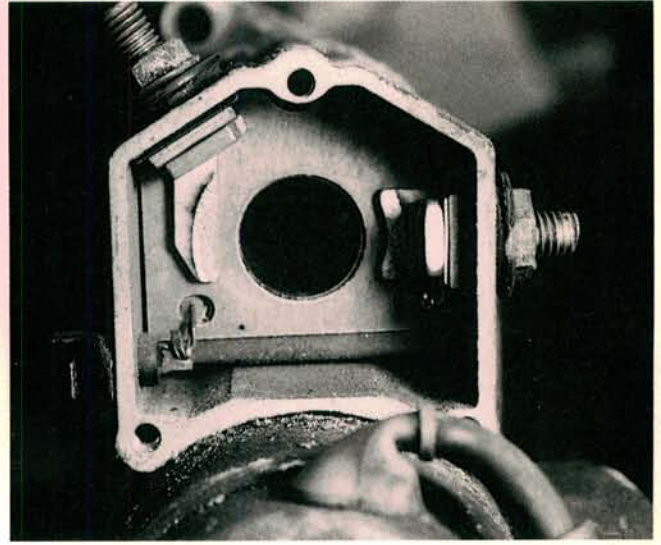
Nippondenso Starter Identification

Solenoid contact posts are available from Honda to repair their version of the ND starter. It can be identified by the location of the contact posts in the 11 and 3 o'clock positions when facing the solenoid cover. The battery contact post is mounted in the 9 o'clock position on other versions of the starter. Some technicians claim the starter's problems begin when engine oil leaks into the solenoid. Repairing oil leaks near the starter is good insurance against repeat performances.

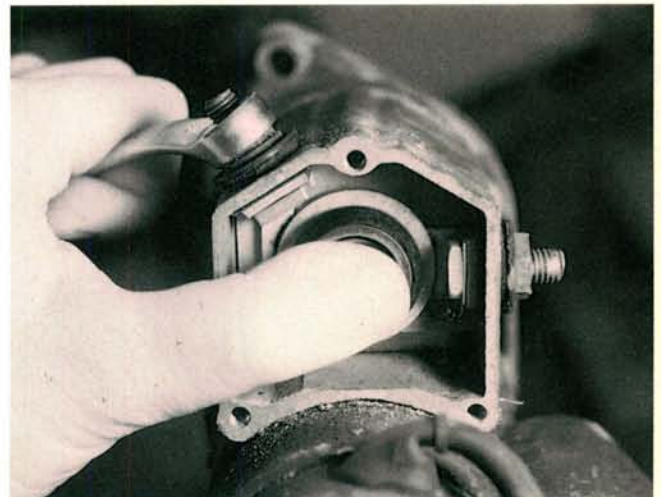
Installing Contact Post—ND Starter

Install the new contact post (P/N H/C 123244), insulating washers, lock washer, and nut. For proper alignment of the contact post, push in and hold the solenoid plunger against the contact post. While holding the plunger, tighten the post nut. Don't over-tighten it or you'll crack the insulating washer. Reinstall the solenoid cover, gasket, and screws. Check your repair by running a voltage drop test across the solenoid terminals.

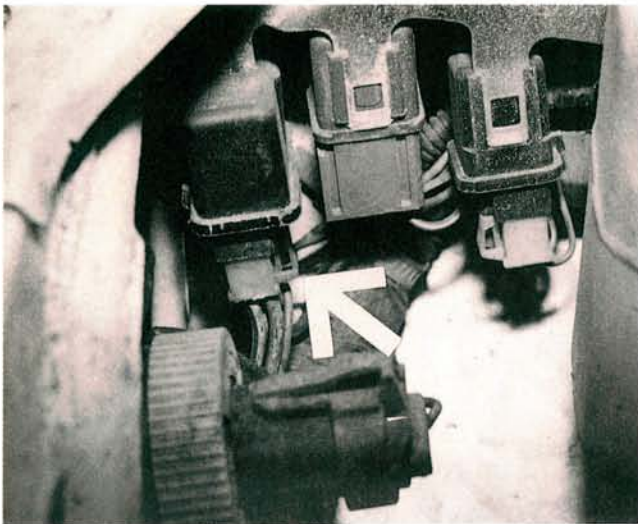
Nissan Sentra Hesitation or No Start

Corroded terminals at the ECC main relay can cause an intermittent or complete loss of power to the engine control unit on 1984-86 Nissan Sentras. The relay is mounted on a bracket inside the right front fender. The plastic inner fender doesn't always protect the relay from salt and road splash. Remove the radiator overflow bottle and relay cover, then check terminals inside the relay connector for corrosion. Clean or replace corroded terminals and the relay as necessary.

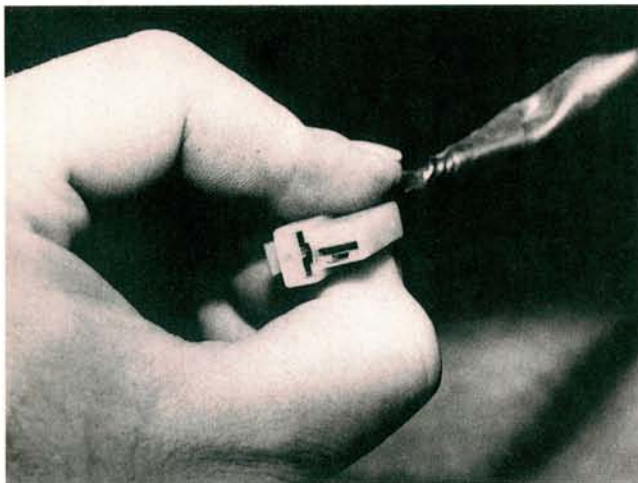
Nissan Sentra Blown Blower Fuses

High current flow through the blower motor wiring harness on 1982-86 Nissan Sentras can produce enough heat to melt this jumper harness's plastic connector. If the blower motor is blowing fuses instead of air, give the jumper harness connector at the blower motor a close inspection. Heat melts the plastic between the two wire terminals, allowing them to short against one another. An improved, melt-proof jumper harness is available through Nissan parts departments.

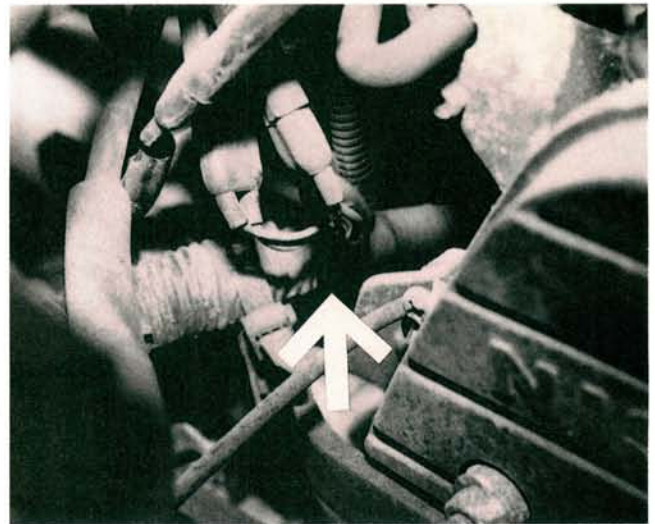
Nissan Sentra Blown Engine Control Fuse

A misrouted engine wiring harness near the alternator bracket on 1982-86 Nissan Sentras can allow the wire to chafe against this cylinder head reinforcement plate (arrow). The wires may only ground against the plate when the engine is under load. Turn the harness over near the reinforcement plate, then peel open the plastic harness cover and check for insulation breaks. Repair the damaged wiring, then reroute the harness away from the plate and secure it with tiewraps.

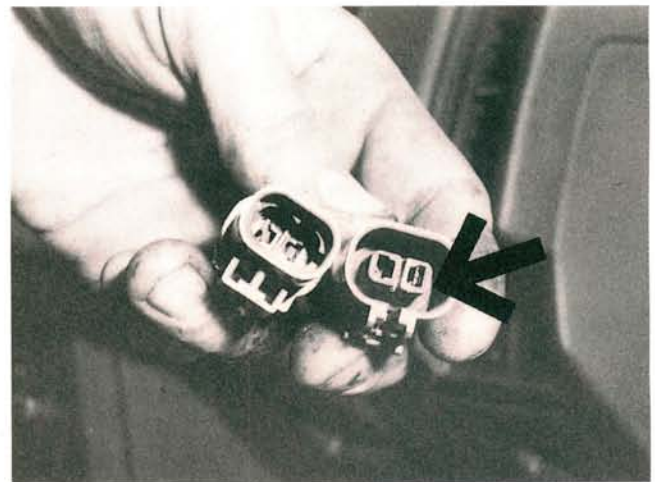
Nissan Corroded Wiring Harness Connectors

These grommeted wiring harness connectors are used extensively on Nissans and other imports in areas exposed to moisture. When the power windows and door locks on this 1987 Nissan Stanza began acting strangely at only 5000 miles, the Weatherpack connectors in the door were about the last thing anybody suspected. Both male terminals and one female terminal had completely disappeared. Make sure that the sealing grommet (arrow) is in place before reconnecting the connectors.

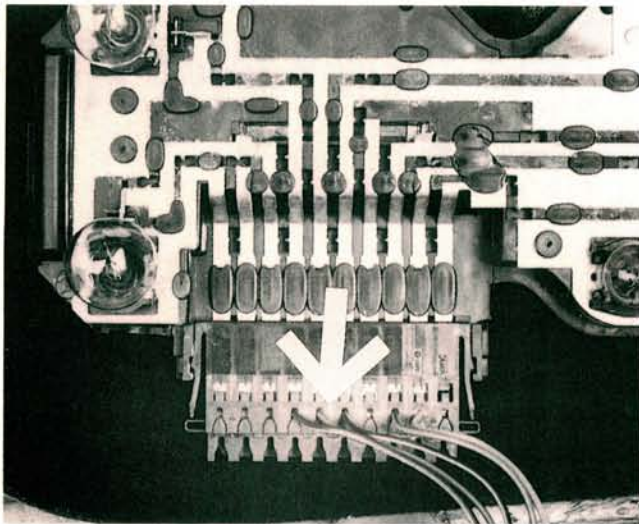
Audi 5000 Tail Lamps

Corrosion at the tail lamp wiring connections on 1978-83 Audi 5000s can cause dim or inoperative brake lights and an inoperative cruise control system. Like the Volkswagen system, the Audi cruise control will not engage unless all brake lights are working properly. Corrosion usually hits the brown ground wire (arrow). For a long lasting repair, solder a ground wire to the tail lamp printed circuit, then solder it directly to the body harness.

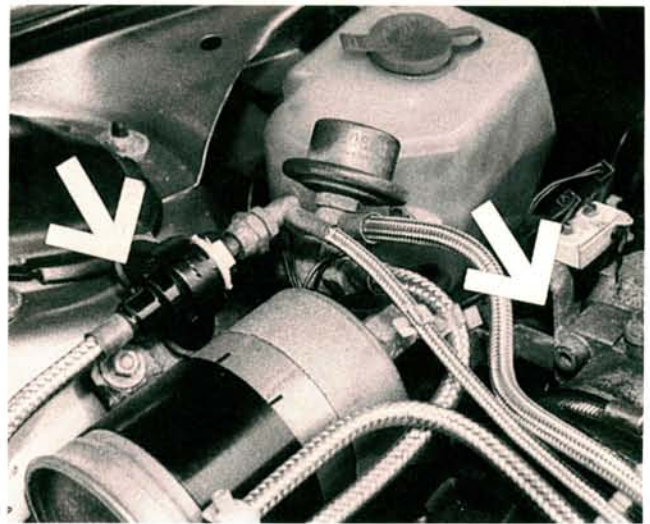
Audi 5000 Engine Ground

An inoperative frequency valve (left arrow) on Audi 5000s with CIS fuel injection may be caused by broken fuel system ground wires. Engine vibration and movement may cause these fuel system ground wires (right arrow) to break. The wires are secured under a bolt below the throttle switch. Replace the damaged ground wires, allowing enough extra length to take the strain off the wires caused by normal engine movement.

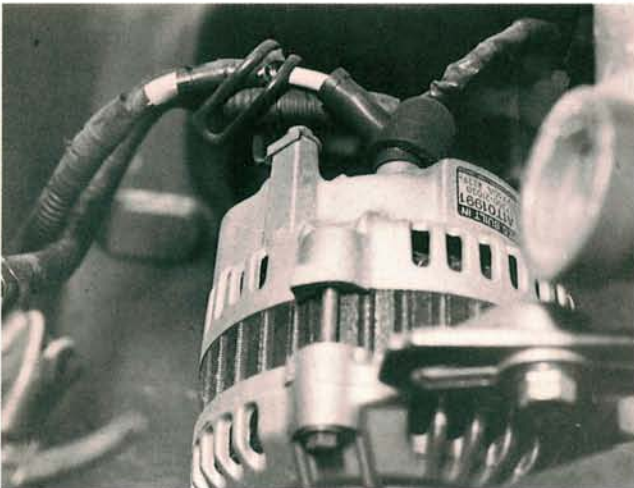
Broken Hyundai Alternator Terminal

High current flow through the B+ terminal on Hyundai Excels with Mitsubishi and Mando alternators may cause the terminal to melt and break off. A terminal repair kit, P/N 37366-21200, and B+ alternator wire, P/N 00214-S7700 are available from Hyundai dealers to correct the problem. Use the original B+ wire to fish the new wire through the cross-member. After installing the new wire, cut off and tape both ends of the original wire where it enters and exits the main harness.

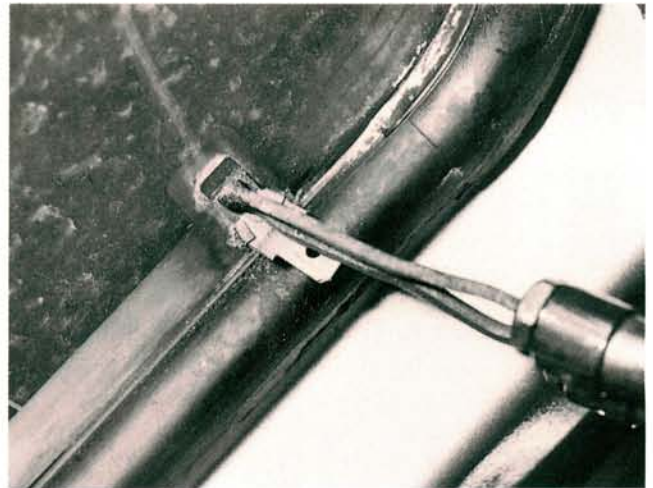
Rear Window Defogger Terminals

Broken rear window defogger terminals can often be repaired without replacing the glass. Clean the broken terminal and the contact area on the glass with an abrasive pad. If the terminal is missing, a replacement terminal kit, P/N H/C 0252437 available from Honda, should work well on other makes too. Apply paste flux, then hold the terminal in place with a 300 watt soldering iron. Add solder when the terminal is sufficiently heated. Turn the iron off, then hold the terminal in place until the solder dries.

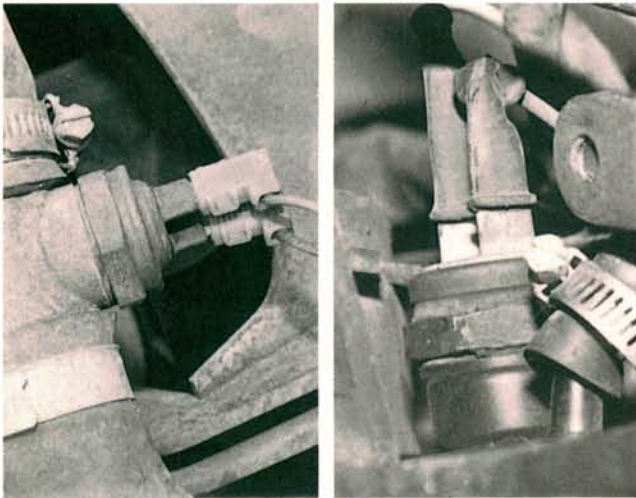
Saab Coolant Sensor Mixup

Two similar coolant temperature sensors used on Saab 900s can be mistakenly interchanged. The left sensor is a normally-closed type, attached to the upper radiator hose. The sensor disables the A/C compressor clutch circuit if coolant temperature exceeds a set value. The right sensor is a normally-open type, mounted in the radiator to control cooling fan operation. Reverse the sensors, and you'll have a cooling fan that runs constantly and a compressor that only engages when the engine is on the verge of overheating.

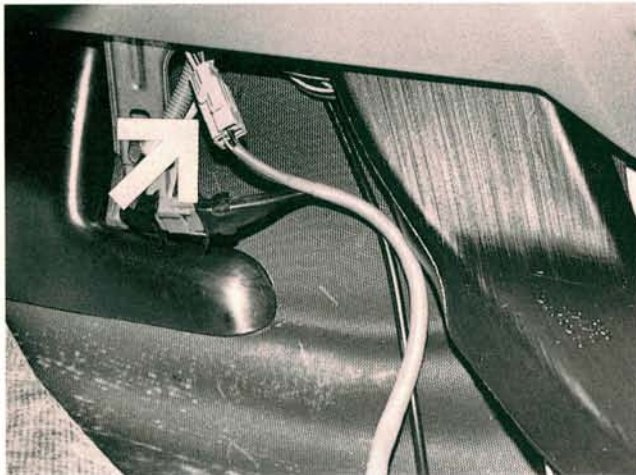
Volvo SRS Harness

Several high line imports are now equipped with Supplemental Restraint Systems (SRS). The SRS wiring harness on this Volvo runs along the driver's side of the transmission tunnel, right where a cellular phone installer might drill his mounting holes. Always familiarize yourself with SRS layout and operation. On pre-1989 700 series Volvos, the yellow connector (arrow) should always be disconnected with the ignition off before doing any electrical fault tracing or repairs.

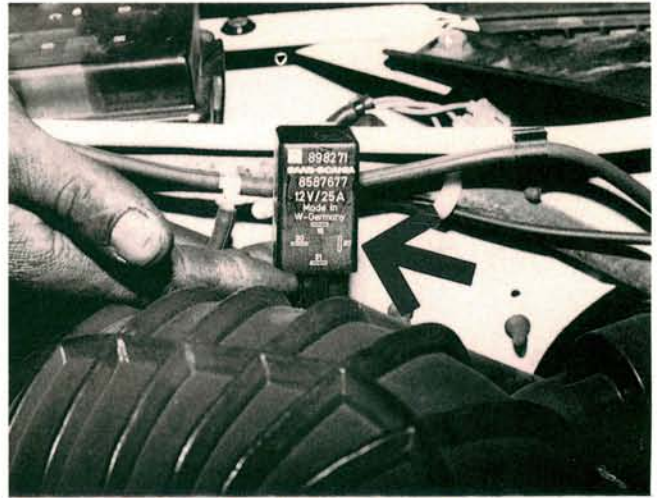
Saab 900 Cooling Fan Operation

Here's one for the winter corrosion file. The cooling fan relay (arrow) was moved out of the fuse panel to this location on the left inner fender on 1985 and later Saab 900s. Corrosion at the relay terminals will cause intermittent or inoperative radiator cooling fan operation. This might go unnoticed when the weather is cold enough, but will cause some serious problems in a traffic jam in August. Replace any damaged terminals, then coat the connector with dielectric grease.

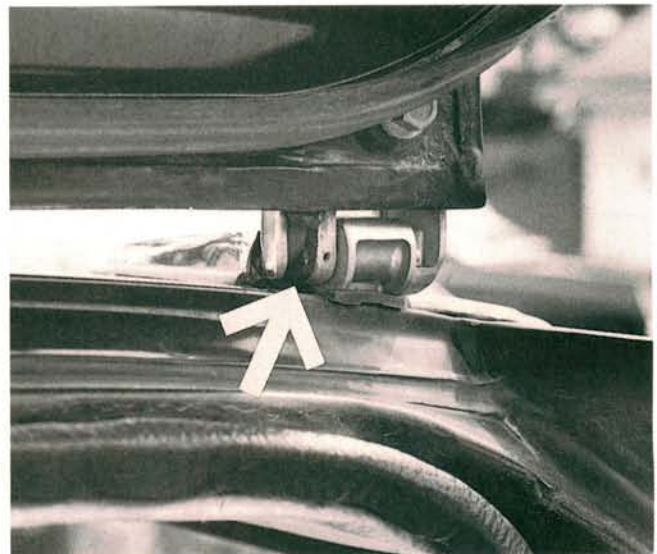
Volvo Wagon Tailgate Wiring Harness

Here's one to watch for on 240 Volvo station wagon models. Individual wires in the tailgate wiring harness become frayed or broken after years of opening and closing the tailgate. This can cause some strange electrical problems when the frayed wires start making and breaking contact with themselves or adjacent wires in the harness. Harness breaks in this area aren't unique to Volvos. Check this spot (arrow) on hatchbacks and wagons from other manufacturers too.

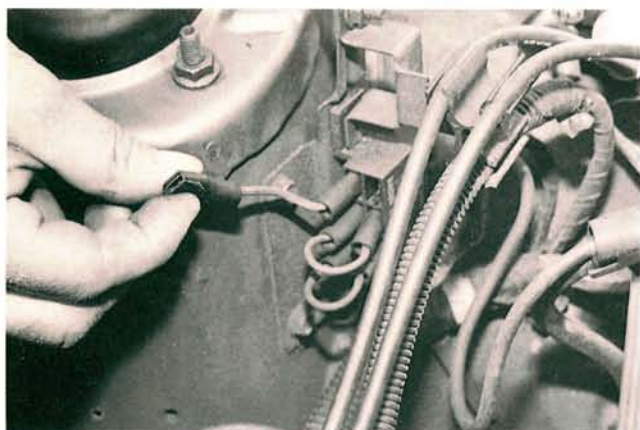
Mazda RX-7 Fusible Links

Heavy current flow through fusible links can weaken them over time. They continue to pass current, but build up additional resistance and heat due to their partially melted condition. Testing the link with an ohmmeter can be misleading. A high impedance DVOM could show an acceptable resistance reading when testing a link with only one wire strand left. Test for voltage drop across each fusible link and replace any link that drops more than 0.2 of a volt.

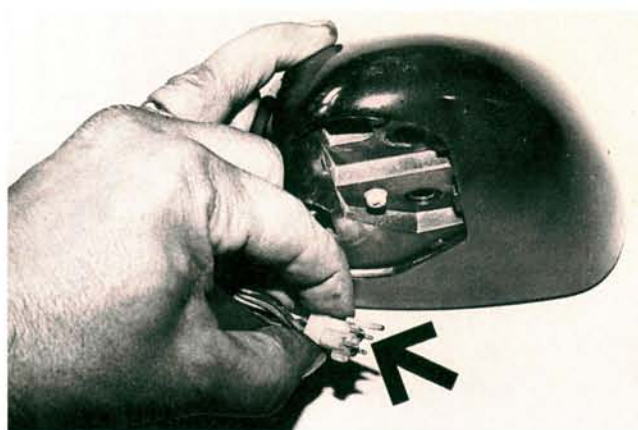
Mazda RX-7 Power Side View Mirrors

These tiny pin terminals (arrow) supply power to the side view mirror motors on Mazda RX-7s. Moisture inside the doors can cause the terminals in the unprotected connectors to corrode. For a long lasting repair, first remove any damaged terminals from the connector. Cut off the damaged terminals, then solder the power mirror motor wires directly to the door wiring harness. Finish the repair by covering the solder joints with heat shrink tubing, then reinstall the mirror.
