Electrical Service

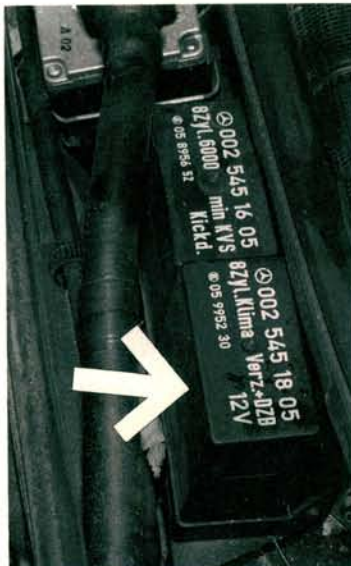
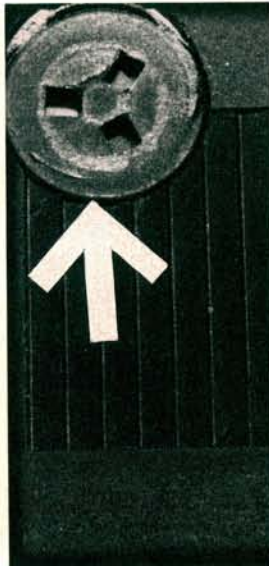
Mercedes-Benz Fuel Pump Relays

A defective fuel pump relay may cause an intermittent stalling problem on 300 and 400 series Mercedes-Benz models. The 420 SEL fuel pump relay's governor circuit cuts fuel to the engine at a set RPM (left photo). Over twenty different relays cover several years, models, and engine sizes. The relays look similar, but don't interchange them. Using the wrong relay can keep the engine from starting or may cut power to the fuel pump at the wrong RPM. Keep the relay's vent (right photo) open and free of rustproofing.

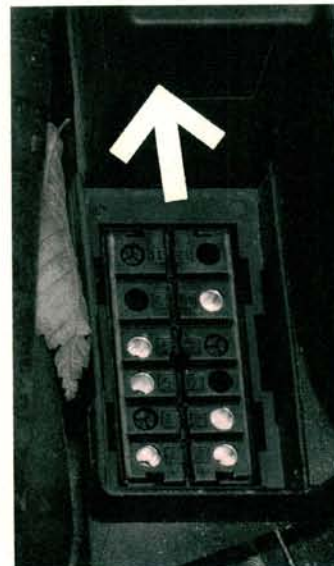
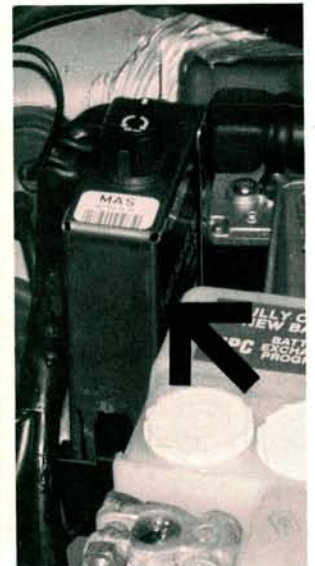
More M-B Fuel Pump Relays

The fuel pump relay can also vibrate loose in the relay socket, causing intermittent stalling or no start problems. The Climate Control relay next door (left photo) also uses a tach signal and can develop many of the same intermittent problems as the fuel pump relay. This 300 relay is mounted near the battery (right photo) and combines the fuel pump and climate control relays in one package. A locking cam at the top of the relay pushes down, then firmly locks the relay's contacts in place on the relay block.

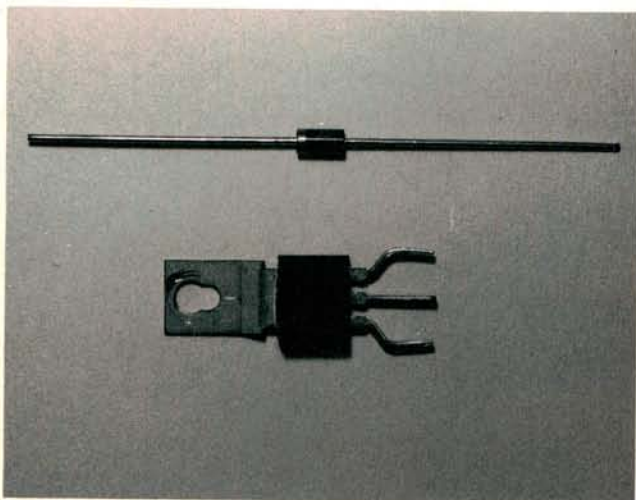
Volkswagen Voltage Stabilizer

Installing an in-line diode will protect the dash gauge voltage stabilizer on all 1980-84 Volkswagen models. Before replacing a burned out voltage stabilizer, solder a 1 N 4006 diode to the new stabilizer's center ground lead with the diode's identification ring facing toward the stabilizer. Solder a three inch ground wire to the diode's other lead. Crimp a 4 mm ring terminal to the ground lead, insulate all connections, then reinstall the stabilizer. Attach the new ground wire to the coolant gauge ground post.

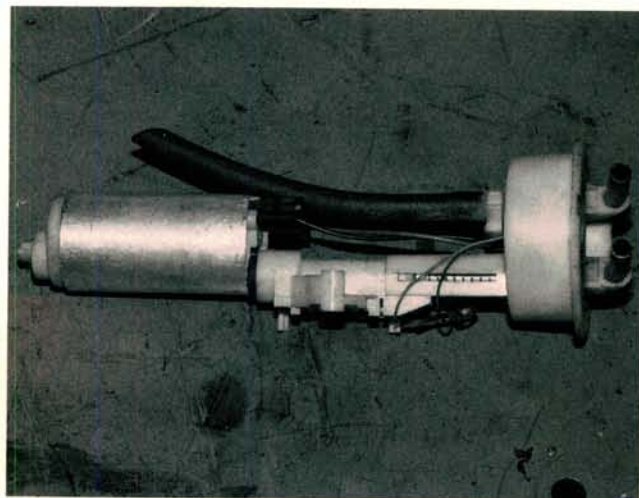
Volkswagen Transfer Pumps

Fuel starvation problems on Volkswagens equipped with CIS-E or Digifant fuel systems may be caused by a bad in-tank fuel transfer pump. The low pressure, high volume transfer pump's job is to supply fuel to the inlet side of the high pressure, low volume main pump. Gravity can't keep the main pump inlet supplied with fuel if the transfer pump fails. Run a hose between the transfer pump's outlet fitting and a safe container. Check delivery volume by jumpering the fuel pump relay harness terminals.

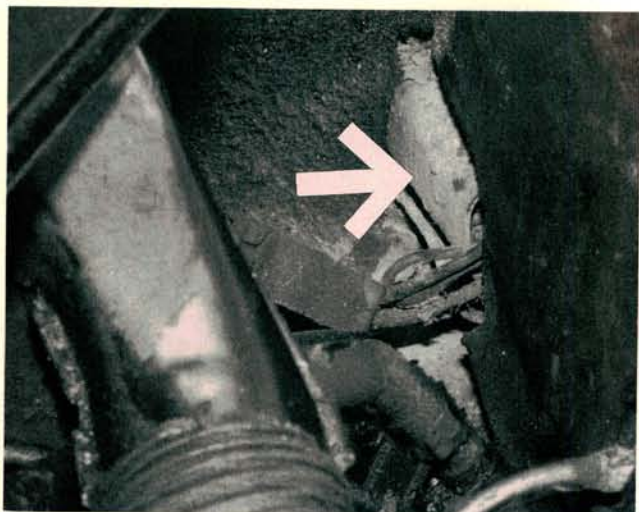
Volkswagen Beetle Engine Miss

There's got to be at least three of these still running around out there. Corroded dropping resistors mounted inside the right rear inner fender on fuel injected Volkswagen Beetles may cause a dead miss. The inner fender rusts away, which gives water and road debris a clear shot at the dropping resistors. Add a pinch of salt and the dropping resistors are soon just a memory. The resistor block on this poor Beetle was about ready to drop out of the car.

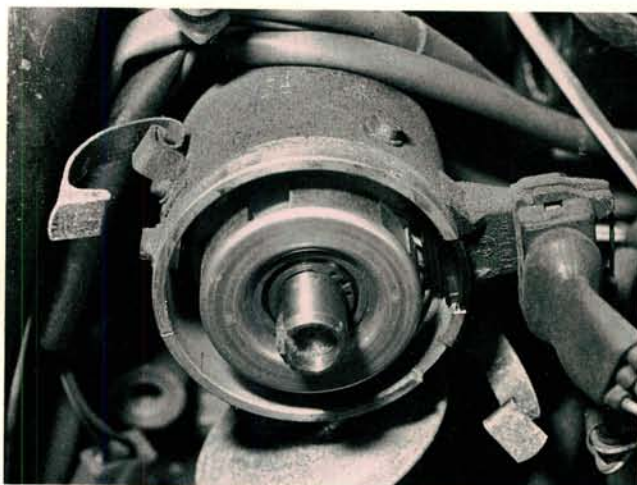
Volkswagen Hall Sender Replacement

Volkswagen has superseded some part numbers and now lists just one replacement part number for both four and five-cylinder distributor Hall senders. Make sure to count the number of ears on the replacement trigger wheel before installing it. Just one trigger wheel is included with each kit, and it's the five-cylinder version. Reuse the original trigger wheel on four-cylinder engines. Putting a four-cylinder distributor together with a five-cylinder trigger wheel won't make for a smooth running engine.

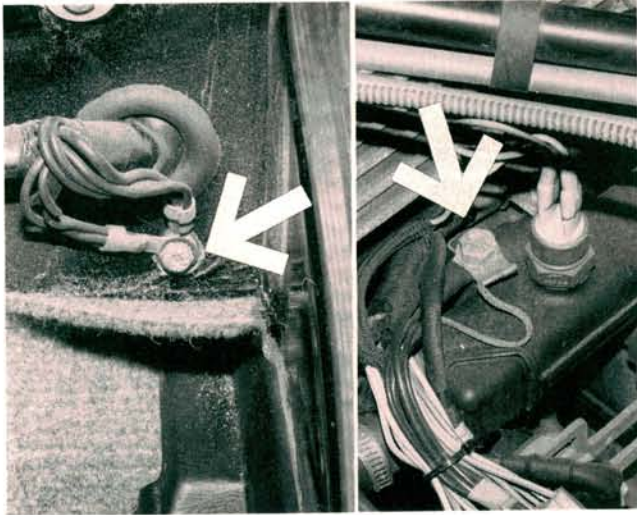
Jaguar XJ-6 Ground Wires

Loose or corroded ground wires on 1978-87 Jaguar XJ-6s can cause some puzzling fuel injection problems. Peel back the carpeting inside of the trunk and check the ECU ground wiring behind the right tail light (left photo). Corrosion here will cause the engine to run rich and blow clouds of black smoke. Also, make sure the EFI ground at the top of the intake manifold (right photo) is clean and tight. A poor connection here will cause hard restart problems on hot engines.

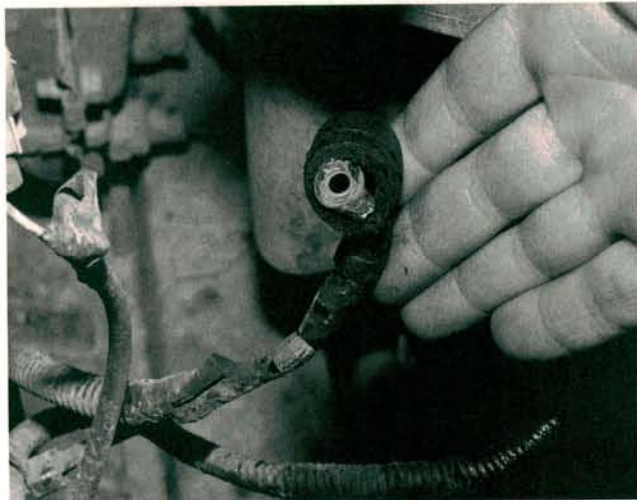
Hyundai Arc Welding

Use extra care when changing the oil filter from above on Hyundai Excels. If the alternator's rubber battery terminal insulator is missing, it's very easy to touch the terminal with the oil filter and do a little arc welding. At the very least, you risk blowing the fuse for the starter or alternator when this happens. Check the alternator first, then disconnect the battery cable before changing the filter if the insulator is missing.

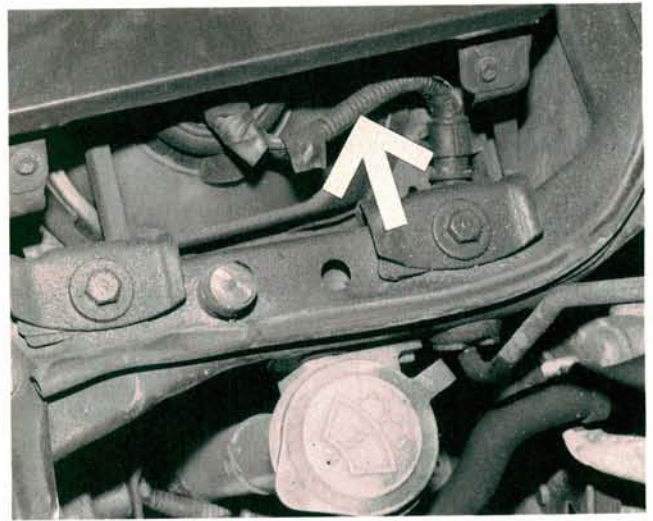
Honda Accord Retractable Headlights

The retractable headlight supply wiring on 1986 Honda Accords may break inside the harness about six inches away from the harness connector. The steady diet of bending and straightening that the wires endure finally causes them to break. If the broken wires touch one another in the harness, you might have a dead headlight and a blown headlight fuse too. Honda hatchback wiring also shows this type of wiring fatigue failure.

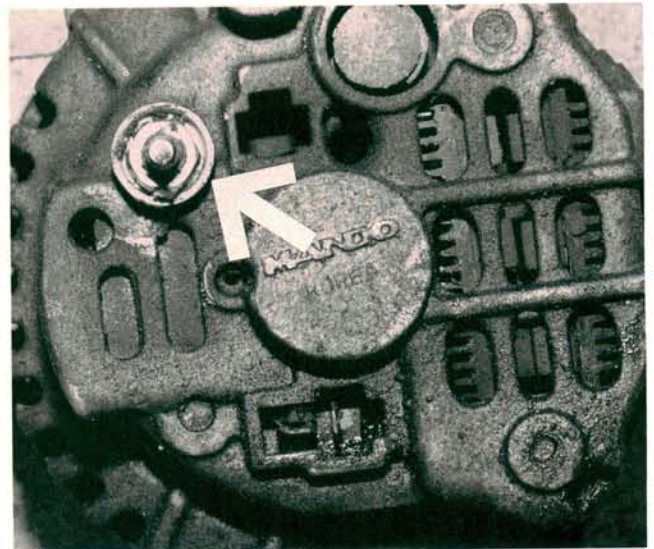
Mitsubishi Precis Alternator Terminal

The alternator B+ terminals on Mitsubishi Precis models built before February 1989 may be damaged by high alternator current flow. A 6 mm terminal kit is available from Mitsubishi to replace the original 5 mm terminal. Always install Mitsubishi's replacement B+ wire along with the larger terminal kit. Don't modify the original harness by reaming out the 5 mm terminal eye or attaching a new terminal.

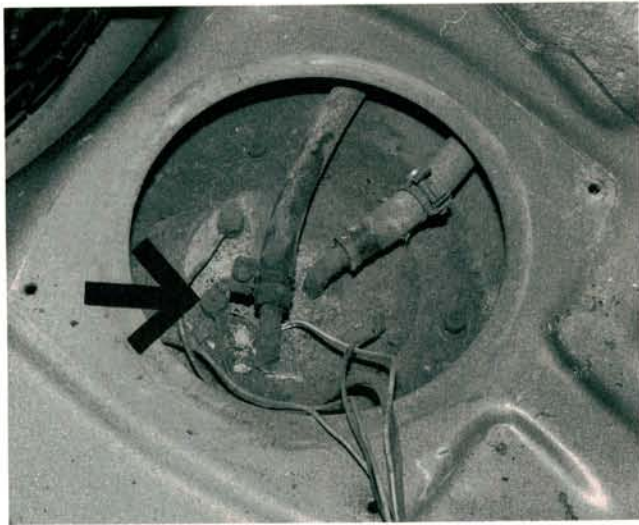
Nissan Fuel Pump Follies

In the May 1989 edition of *Electrical Service*, we pointed out a fuel pump terminal corrosion problem on 1984-88 Nissan 200 SXs. 1987 and later Nissan Pulsars and Pickups are joining in with the same problem. The in-tank fuel pump's soldered wiring terminals corrode on the outside of the combination sending unit/fuel pump unit. The corrosion can either kill power to the fuel pump or may cause the pump to run when the ignition is off. You'll have to drop the tank to reach the sending unit on Pickups.

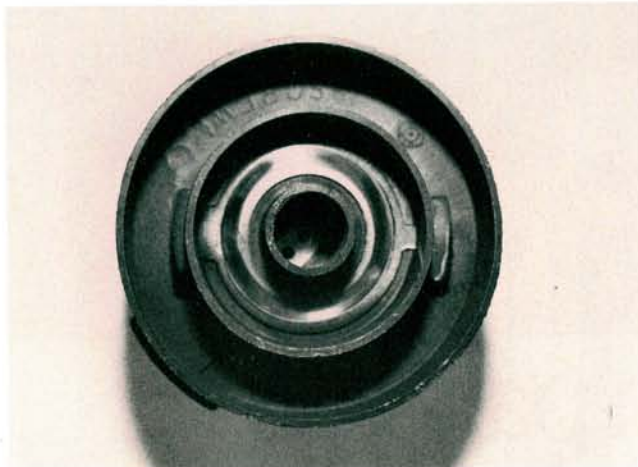
Nissan NAPS-Z Rotor Rooter

The NAPS-Z dual spark plug ignition system used on 200 SX, Stanza, and Pickup models through 1989 uses this double conductor distributor rotor. Carbon tracks can develop between the intake and exhaust sides of the rotor and also to ground. Also watch for poorly insulated Hitachi distributor caps on these models that leak spark to ground when wet. An improved cap, marked with the letter "S" should cure the insulation problem.

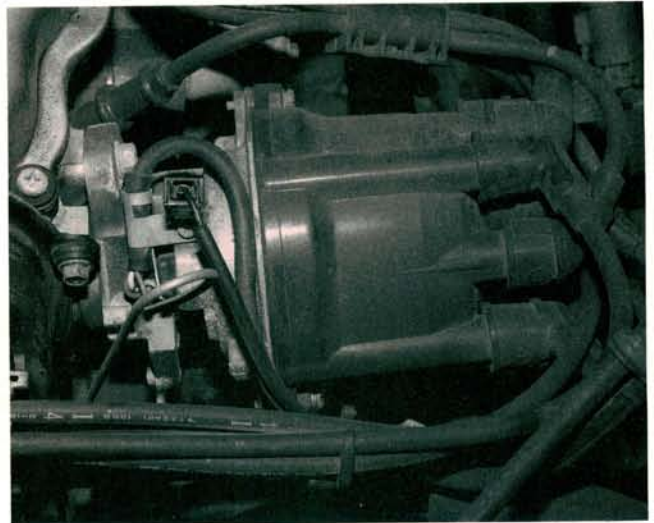
Intermittent Nissan Distributors

The Mitsubishi distributor used on some 1986.5 200 SXs, 1987 Stanzas, and 1987 Sentra Coupes may cause the ignition to cut out during light acceleration with a warm engine between 2000 and 4000 RPM. The tachometer may also drop 300 RPM when this happens. Once the engine RPM drops out of this range, the ignition comes back and the car will continue running. Check the distributor cap for the Mitsubishi trademark to identify the distributor. Complete distributor replacement is the recommended fix.

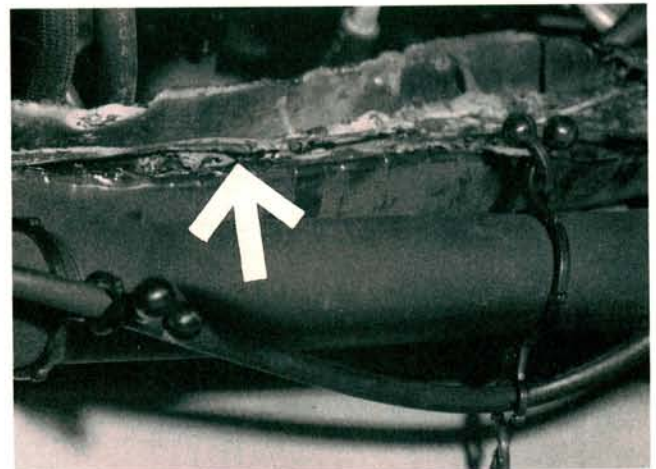
Nissan Stanza Wiring Meltdown

A pinched wiring harness on the left end of the radiator caused serious wiring damage on this 1988 Nissan Stanza. Rather than burning a fusible link or blowing a fuse, a big portion of the main engine wiring harness (shown) burned instead. The engine still started and ran okay, but the starter engaged each time the transmission was shifted through neutral. The front body harness passes under the core support and may be improperly positioned during assembly or during air conditioning installation.

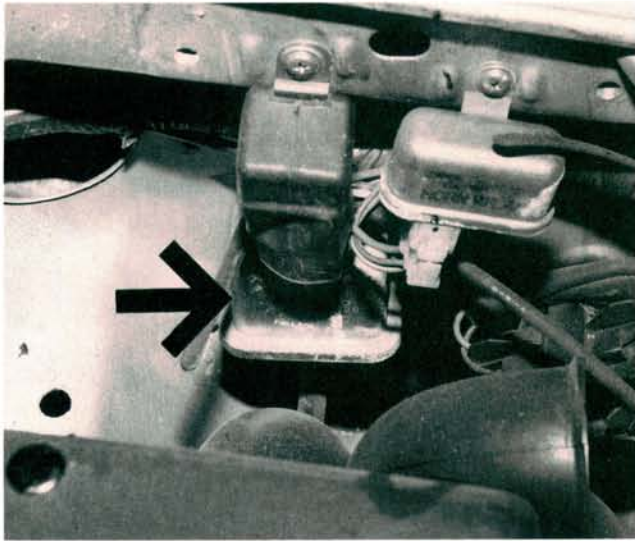
Mazda Cold Starting Problems

Frosted main relay contacts on 1986 Mazda 323s and 626s can cause hard starting problems in very cold weather (0 degrees F or less). The frost forms after the car has been driven, then stopped for 30 to 60 minutes. A one piece moisture-proof replacement relay (arrow) will correct the starting problem. Unclip the relay harness from the relay on 626 models. Attach the relay harness to the engine harness, then use a tie wrap to position the harness connector facing downward. This keeps water out of the harness connector.

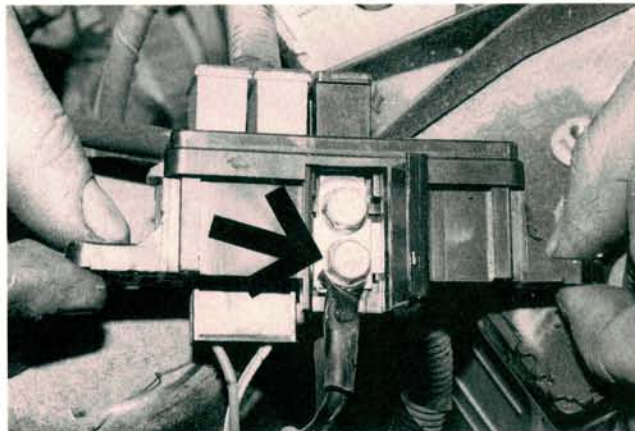
Mazda B2000 80 Amp Fuse

A loose or dirty connection at the 80 amp main fuse connections may cause a no-start condition on 1986 Mazda B2000 trucks. Look for signs of distortion or discoloration at the fuse's wiring connections (arrow). Test for a voltage drop across the bolts on either side of the main fuse. Disconnect the battery, then clean and reinstall the fuse connections. Tighten the bolts to 7.3 Nm (5.4 ft-lb). This is the electrical system's main fuse, so a poor connection here could affect the operation of the rest of the electrical system too.

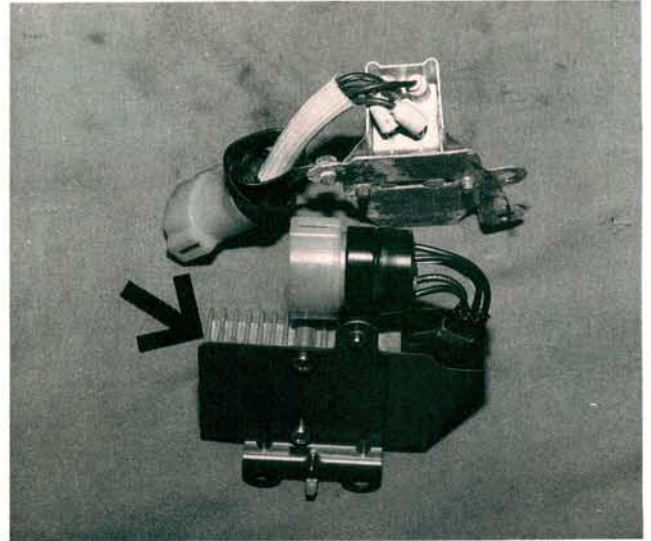
Mazda 323 Injector Resistor

A rough idle or no-start condition on a 1986-7 Mazda 323 may be caused by an open circuit in the injector resistor. Salt spray corrodes the resistor terminals, causing an open circuit to one or more of the injectors. Remove the resistor assembly from the left inner fender. Resistance measured with an ohmmeter between the resistor B terminal and terminals 1-4 should be 5-7 ohms. A die cast, weather protected injector resistor (arrow) is available as a service replacement.

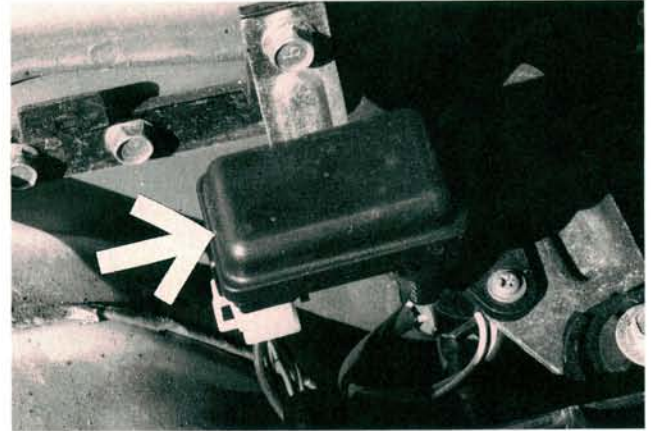
Mazda RX-7 Acceleration Surge

A 1986-87 RX-7 that surges or stumbles while accelerating above 2500 RPM may be caused by a poor ground between the ECU and the air flow meter. Remove the Boost Sensor (non-turbo) or Pressure Sensor (turbo) harness connector (arrow). Resistance between the Brown/Black wire at the sensor harness connector and terminal 2C at the ECU should be 0 ohms. If it's not, splice a new ground wire into the Black/Brown sensor harness wire. The ground wire's other end must be attached to the water filler neck, not the body.

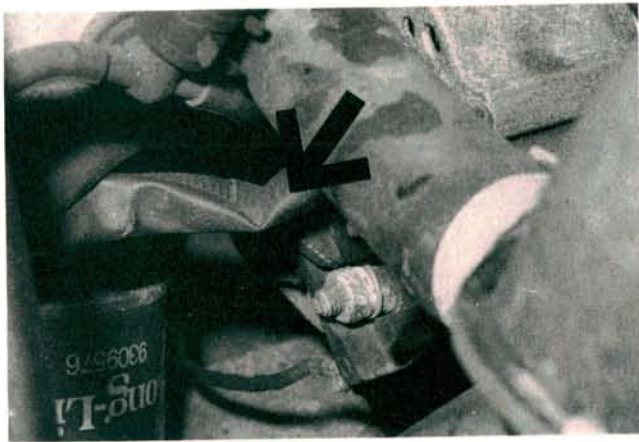
Saab 900 Intermittent Charging

A positive battery cable that's broken internally between the starter motor and the alternator can cause an intermittent charging condition on 1985 and later Saab 900s. The cable has been known to break at any point along its length, but usually breaks near the eyelets at either end. Check for a voltage drop by attaching DVOM leads to the alternator and starter terminals, then wiggling the wire. The wire's insulation often covers the break.

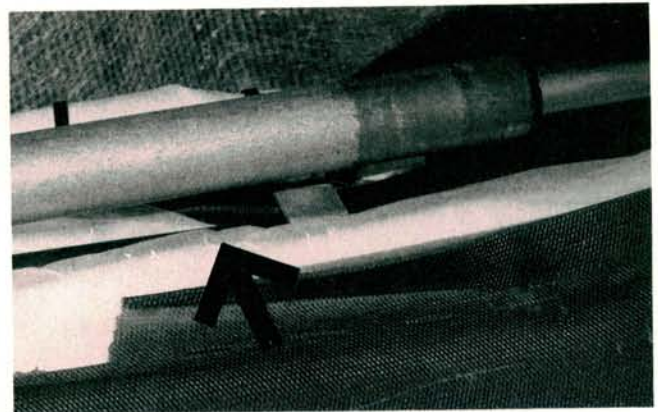
Saab Ignition Switch Wiring Harness

Wiring to the floor-mounted ignition switch on 1981 and later Saab 900s can become damaged by high floor temperatures. The damaging heat may be caused by a rusted or missing catalytic converter shield directly below the ignition switch and wiring. Also, if the engine is running rich, the extra converter heat can send the wiring into a meltdown. The extra floor insulation (shown) used on later models can be retrofitted to early 900s. Repositioning the harness off the floor with tie wraps also helps.

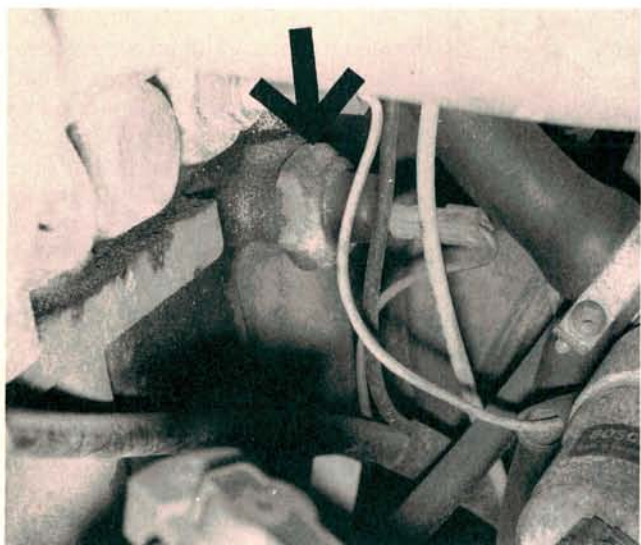
Volvo 240 Temperature Gauge

If the temperature gauge on a 240 series Volvo heads straight for hot as soon as the ignition is turned on, the cause may be a pinched or frayed wire between the temperature sending unit and the gauge. Locate the sending unit below the intake manifold (arrow), then disconnect its lead wire. If the gauge still reads hot, it's a safe bet the wire is grounding on the engine. The harness continues under the intake manifold before reaching a multi-pin connector at the center of the firewall.

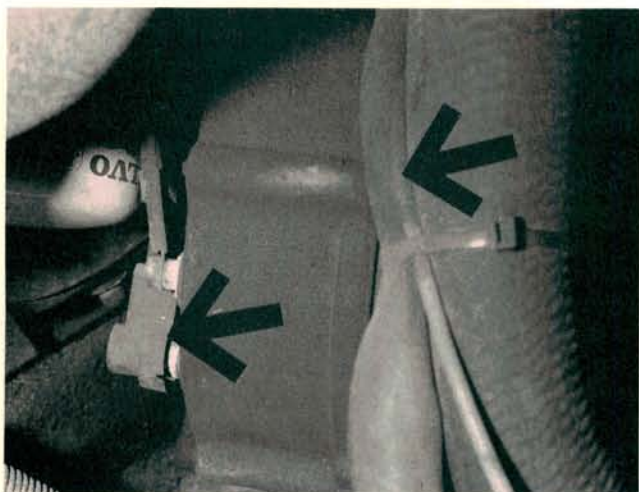
Volvo 240 Alternator Wiring

A combination of engine heat and vibration can spell trouble for the alternator wiring harness on Volvo 240s. Tie wraps hold the harness to the lower radiator hose, which causes engine heat to dry out the harness insulation used on early models. Later models (shown) run the wiring through an insulating tube. Engine vibration and exhaust manifold heat may also cause the alternator wiring to break at the rear of the alternator, then short against the alternator or oil filter.
