Electrical Service

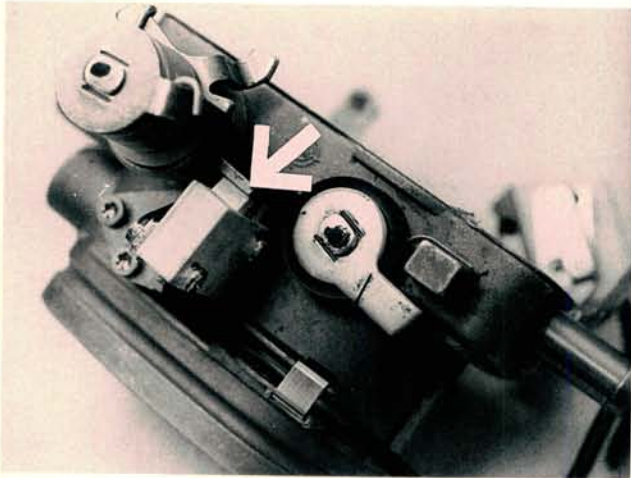
Volkswagen Idle Surge

A defective throttle switch may cause a rough idle or low speed surge on 1988 and later Digifant-equipped Volkswagens. We removed the throttle housing so you could see the switch. The switch contacts should close only when the throttle is closed. If the switch contacts stay closed when the throttle is opened, the Digifant control unit will send incorrect control signals to the ignition and injectors. Test the switch and replace it if the contacts stay closed when the throttle is opened.

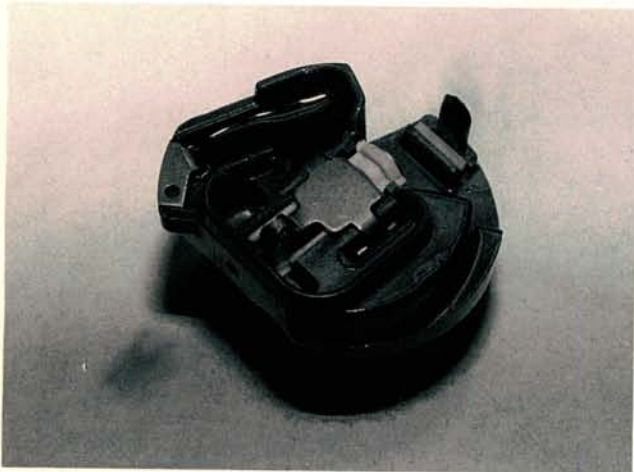
Volkswagen Rotor Governor

A faulty distributor rotor may cause the engine to cut out on some 1969 to 1971 Volkswagen Type 1, 2, and 4 vehicles. The rotor has a built in centrifugal governor cutout that prevents the engine from over revving. Low speed cut out may be caused by a weak governor spring. The rotor can be replaced with a conventional non-governor rotor, but the engine may be damaged by over revving. Some late 60's and early 70's Mercedes, Porsche, and BMW models also used similar rotor designs.

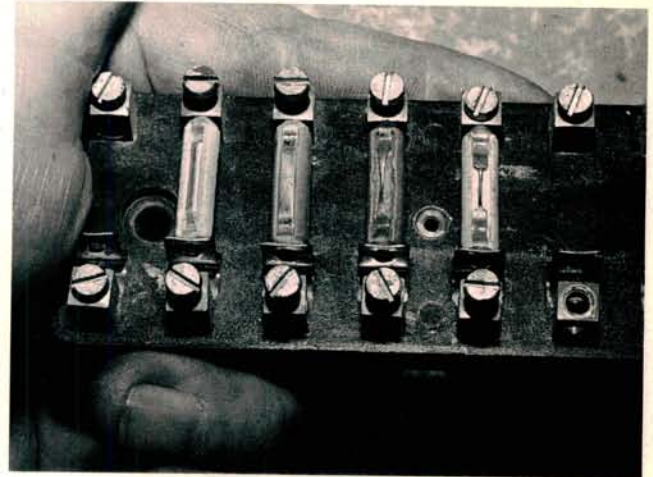
Porsche 911 Fuse Panel

Loose or corroded fuse panel terminals on older Porsche 911s may cause problems, especially on high current draw circuits such as the air conditioning or headlights. Poor contact between the tips of the ceramic fuses and the fuse panel terminals causes extra resistance and heat. If the fuse and terminals get hot enough, they can melt the fuse panel plastic, loosening the fuse panel terminals as well as the buss bar connections at the back of the panel.

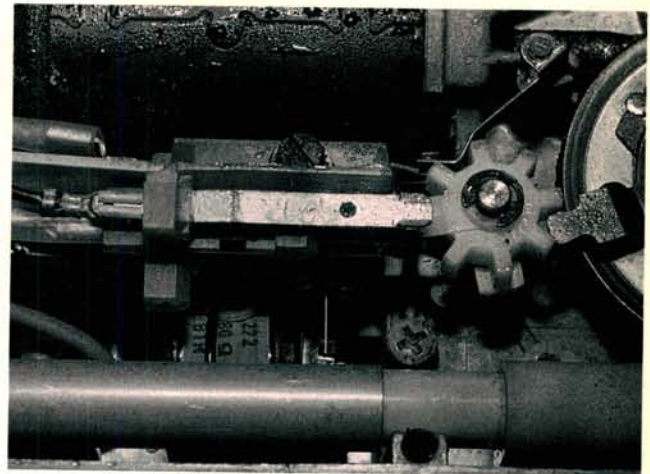
Porsche Power Antenna Failure

Moisture accumulation can cause battery problems on all Porsche models equipped with power antennas. Water can leak past the antenna mast and collect inside the antenna motor. The moisture may cause these relay contacts (arrow) to stick closed when the antenna is raised or lowered. This problem may go unnoticed if the car is driven regularly. But the small current drain will run the battery dead if the car sits for a few days at a time. Replace the antenna to correct the water leakage and battery drain.

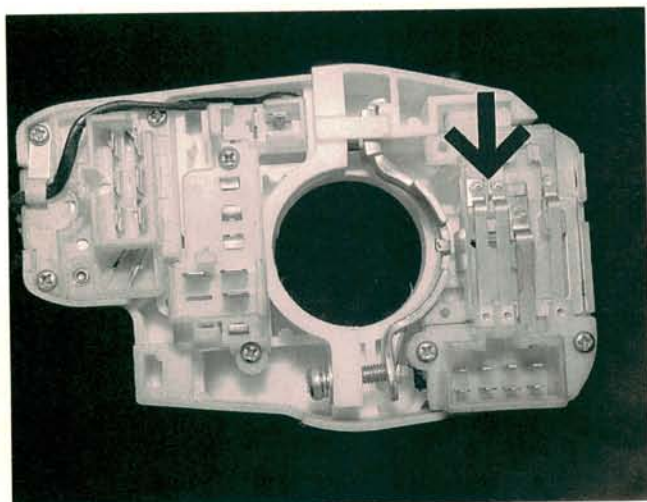
Nissan Headlight Switch

A defective headlight switch may cause intermittent headlight operation on some 1986 Nissan Pulsars. The headlights will switch off and on, even though the headlight switch is in the on position. Replacing the defective switch isn't always necessary. Remove the steering column covers to expose the switch. These contacts on the back of the switch are the culprits (arrow). Clean the switch contacts, test the switch operation, then reinstall the column covers.

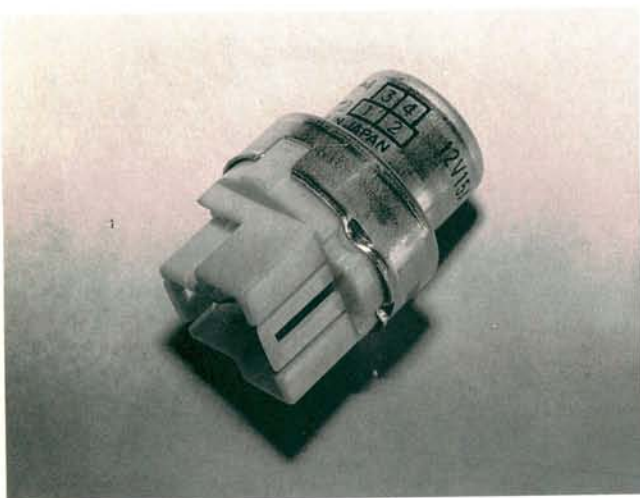
Toyota Main Relays

A defective EFI Main Relay or Main Power Relay may cause intermittent stalling, flickering dash lights, or a no start condition on 1982-84 Toyota Cressidas. The relays are identical and are located in the main fuse panel behind the battery. Temporarily swapping the relays will get the car started if only the EFI Main Relay has failed. Heat caused by normal relay operation may damage the plastic internal relay parts over time, causing an open circuit. Replace both relays to correct the problem.

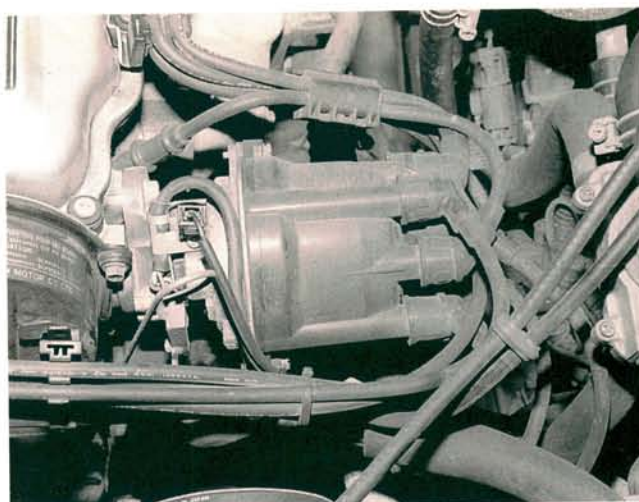
Nissan Distributor Caps

Installing the wrong distributor cap can cause hesitation problems on 1987 Nissan Stanzas and 200SXs. These models were equipped with either a Hitachi or Mitsubishi distributor. The distributors caps used on these distributors look the same at a glance and can be easily installed on the wrong distributor. Find out which distributor you've got by checking the distributor body. Don't rely on the cap markings because someone may have already installed the wrong cap.

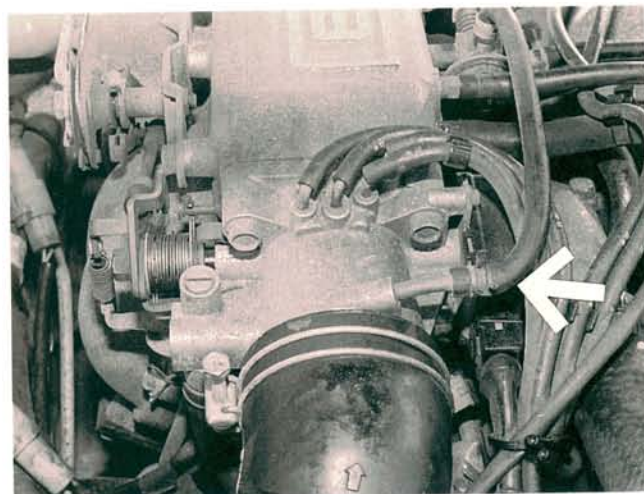
Toyota Throttle Switch

A misadjusted throttle switch (arrow) or defective throttle switch circuit may cause a rough idle or other driveability problems on Toyota models equipped with 22 R engines. To test the throttle switch and circuit, check the ignition timing with the engine idling at operating temperature. Now ground the test connector. If the timing is at its base setting, the throttle switch is operating normally. If the throttle switch circuit is open, timing won't return to the base setting when the test connector is grounded.

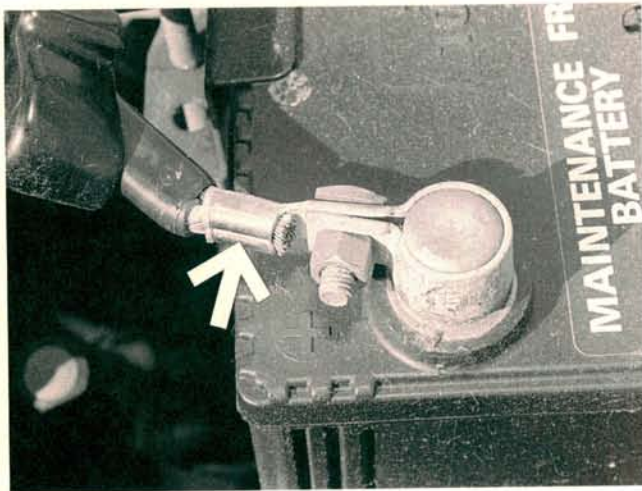
Stalling Mazda

Some 1986 Mazda 323s may stall intermittently due to a poor connection between the positive battery cable and the inside of the positive battery terminal clamp. The stalling usually occurs when a voltage surge is combined with an already heavy electrical load. This causes a momentary open circuit at the battery cable. The engine will usually restart immediately. Engine and vehicle speed have no effect on the stalling problem. Replace the positive battery cable harness to correct the problem.

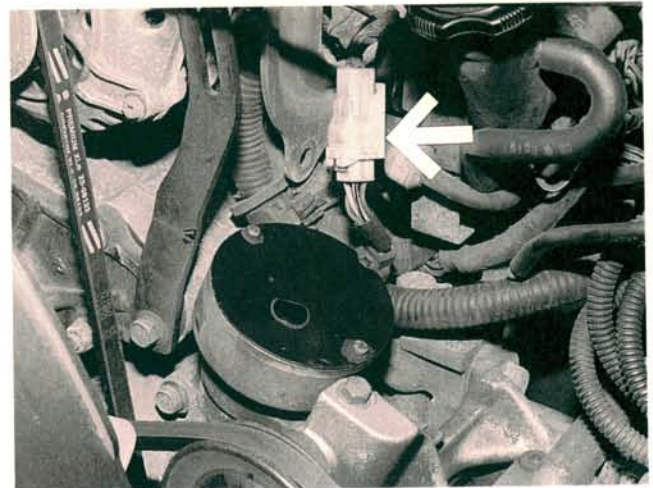
Mazda RX-7 Crank Angle Sensor

A faulty wiring harness connector at the crank angle sensor may cause some 1986 Mazda RX-7s to buck and/or stall. Check the blue/white crank angle sensor wire for continuity at both sides of the connector (arrow). Engine heat affects the connector. A connector that checks good when the engine is cold may break contact when underhood temperatures increase. The wiring terminals inside the connector can also break contact even though the harness connector fits together tightly.

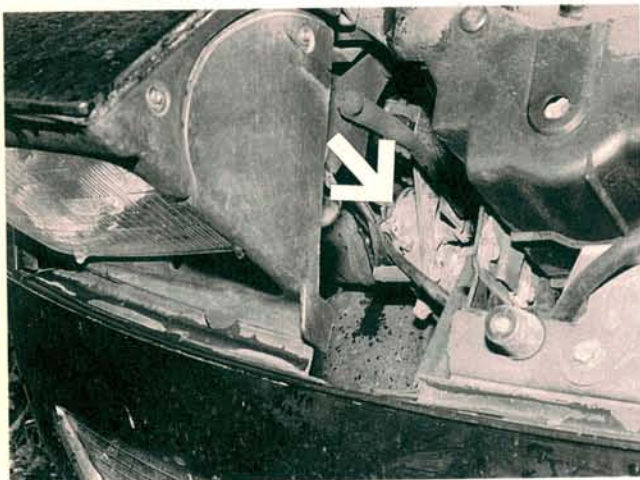
Mazda RX-7 Headlight Operation

The right headlight assembly on 1986 Mazda RX-7s may operate erratically and park improperly. Two switches inside the headlight motor cut power to the motor when the headlight door has reached the full up or down position. If either switch fails, the motor does not shut off when it reaches the park position, and the headlight assembly continues to cycle. The internal switches are not serviceable. Replace the headlight motor to correct the problem.

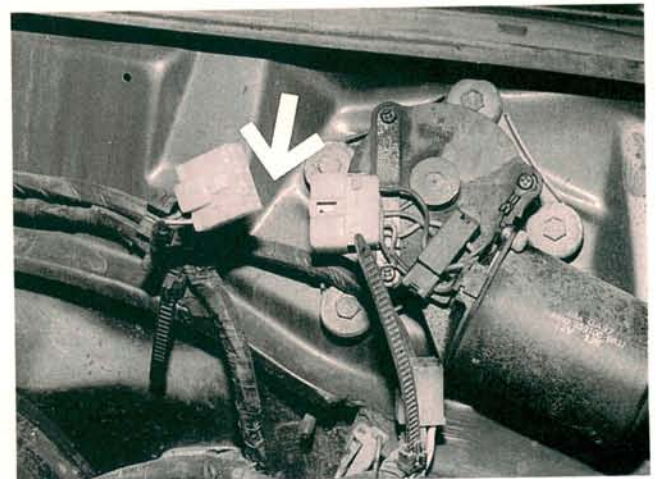
Mazda Wiper Motor Operation

A corroded wiring harness connector may wear out the windshield washer pump and make the wiper motor run continuously on some 1986 Mazda 626s. Corroded terminals in the connector can short together, making the wiper and washer motors run all of the time. The washer motor usually locks up after it runs out of washer solvent. To correct the problem, clean the corrosion from the connector, seal it with dielectric grease, and replace the washer motor.

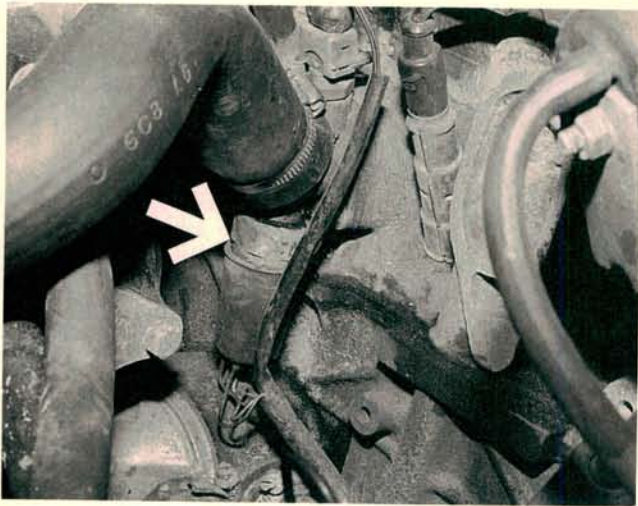
Audi Starting Problems

A defective combination sensor may cause intermittent temperature gauge operation and hard cold starting problems on 1985 and later Audi 5000s. The combination sensor is mounted below the engine end of the upper radiator hose (arrow), and includes a temperature gauge sensor and a cold start injector thermo time switch. If the upper radiator hose develops a small leak, antifreeze may corrode the combination sensor wiring harness connector. Repair or replace the corroded harness connector.

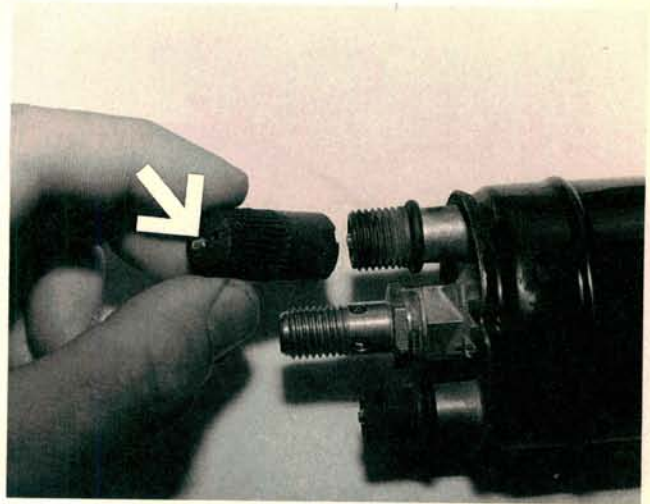
Audi Fuel Pumps

Fuel pump wiring harness connectors can cause problems on fuel injected Audi models. The wires inside these screw-on, waterproof harness connectors can become damaged when removing or reinstalling the fuel pump connectors. Broken wire strands can cause an open circuit. If replacement connectors aren't available, install a fuel pump with stud-type terminals instead. Make sure the new pump's pressure and delivery specifications match the original pump. Waterproof all wiring connections.

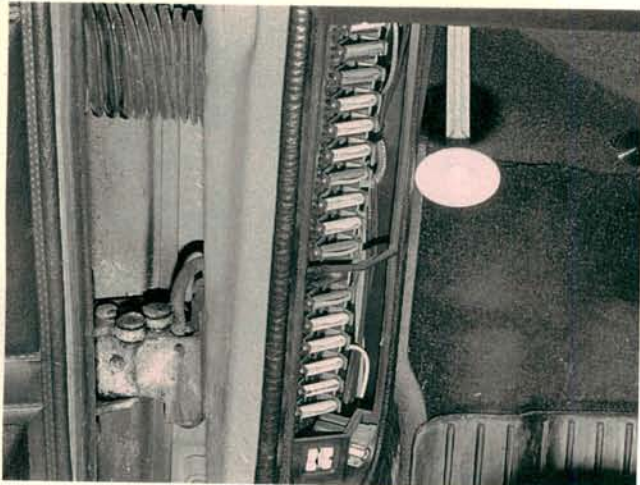
Volvo Ceramic Fuses

Corrosion at fuses 5, 7, or 13 may cause stalling or no start problems on 1980 and later Volvo 240s. The ceramic fuses often corrode where their tips meet the fuse box terminals. A corroded fuse terminal may stop passing current, even though it isn't blown and is still touching the terminals. Voltage drop and heat at the corroded terminals can also melt the fuses. Fuse problems like these are the cause of 50 percent of the Volvo tow ins at the shop that gave us this tip.

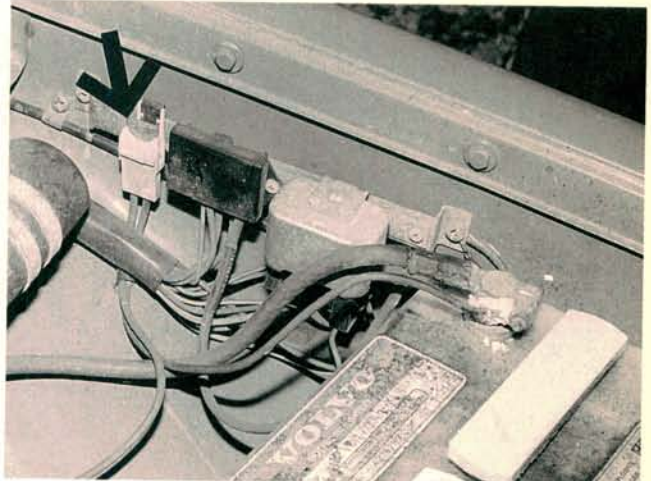
Volvo 240 Fuel Pumps

Positive battery voltage is routed to the fuel pump through this in-line fuse (arrow) on Volvo 240 models. No starts or intermittent fuel pump operation may be caused by terminal corrosion on the underside of the fuse holder. The fuse holder gets its power directly from the positive battery terminal clamp, so corrosion at the terminal clamp can cause the same symptoms. These heavily corroded battery terminals look like a problem that's getting ready to happen.

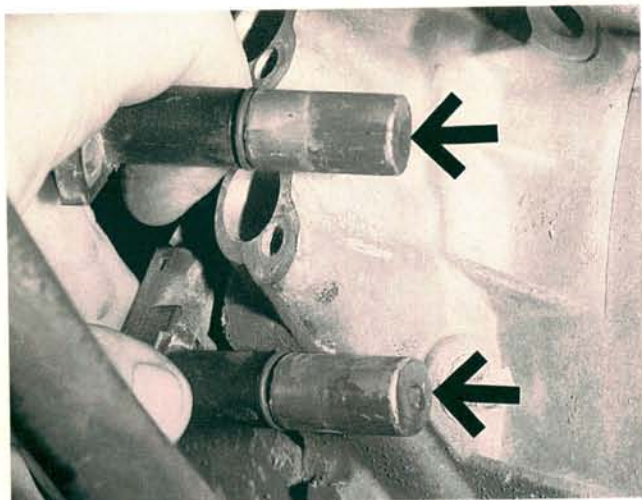
BMW Driveability Problems

Driveability problems on all BMW models equipped with Dual Sensor Motronic engine management systems may be caused by a poor signal from either the RPM or Mark Sensor. Corrosion or dirt on the sensor tips insulates the sensors from the trigger teeth on the flywheel, weakening the sensor signals. Removing and cleaning the sensors will usually correct the problem. If the problem persists, check for chipped or missing flywheel teeth. Damaged teeth may cause backfiring, surging, and poor throttle response.

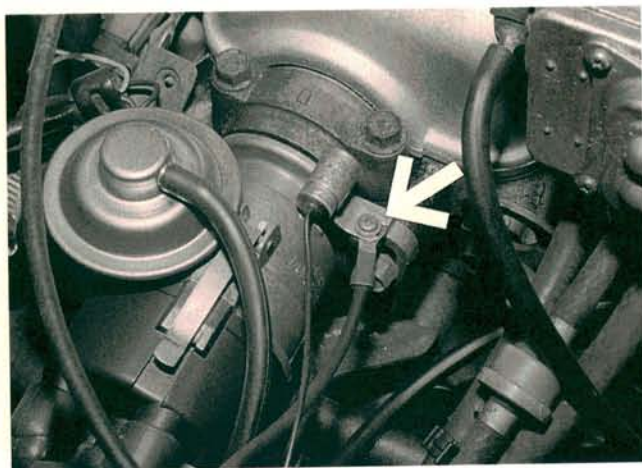
Grounds For Aggravation

Poor ground connections cause problems on many vehicles. Wiring harness eyelet terminals are usually made of steel. If a grounding eyelet is bolted to an aluminum component like this distributor housing, the electrical/chemical reaction between these dissimilar metals can cause corrosion. The physical connection between the parts may be good, but corrosion causes the electrical connection to be lost. Aluminum bolted to steel, or a steel bolt installed in aluminum can also cause these problems.

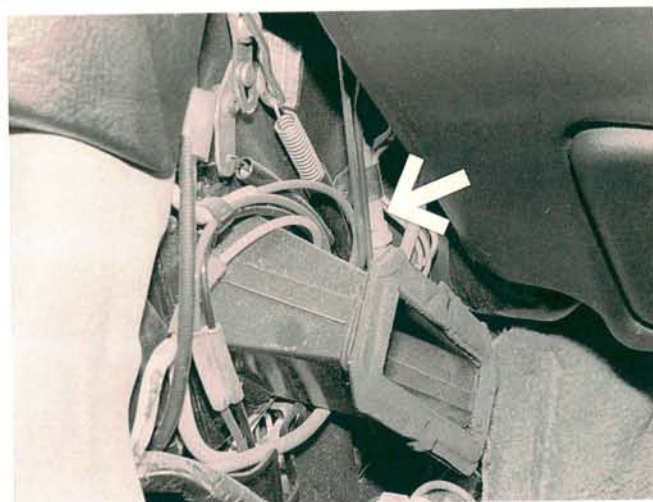
Jaguar XJ-6 Air Conditioning

The air conditioning on some Jaguar XJ-6 models may not operate, even though all of the fuses in the fuse box are good. The air conditioning control head has a separate in-line power supply fuse which may be blown. To reach the inline fuse, remove both screws from the vent cover on the right side of the center console. Remove the vent and the center console side panel. Reach through the opening to locate the in-line fuse. The A/C fuse in the fuse box protects the A/C compressor clutch circuit.

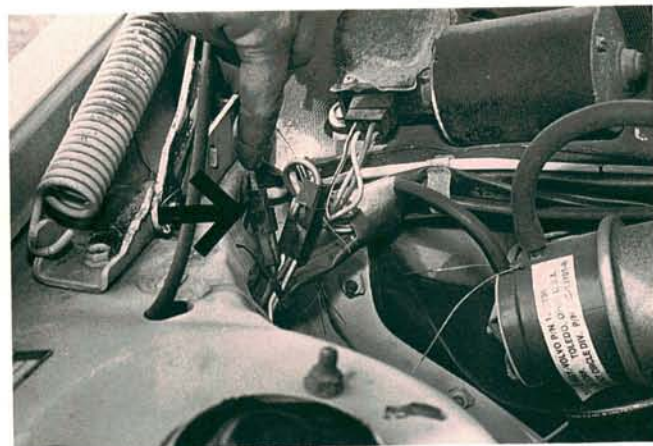
Volvo Stalling or No Start

Corroded terminals at these multi-pin connectors below the right hood hinge may cause an intermittent stalling or no start condition on 1982-84 Volvo 240s. The wiring harness carries the dwell signal from the ignition control unit to the LH Jetronic control unit. The fuel injection control unit will shut down the injectors if it loses the dwell signal. Damaged connectors can be removed and replaced with solder joints and shrink wrap. The connectors are only needed for factory assembly.
