TECH TIPS

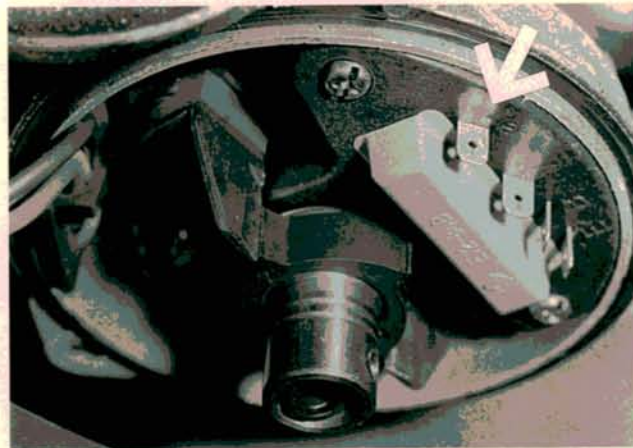
A distributor rotor that has burned a path to ground on the distributor shaft may cause poor acceleration on 1982-87 Nissan Stanzas. The burnt rotor can keep the spark from reaching some of the spark plugs on this eight spark plug engine, especially during heavy engine loads.

A failed distributor module may cause similar symptoms. There are two separate ignition control circuits in the module, one for the intake coil and one for the exhaust coil. If the intake side of the module

fails, the car will have a noticeable loss of power and may be hard to start.

You'll get a slightly different set of symptoms if the exhaust side of the module fails. The module normally shuts off the intake ignition coil under heavy acceleration. If the exhaust side of the module is already dead, the engine will have no ignition when the module shuts off the intake ignition coil. The engine dies, just like the ignition has been shut off (it has).

If you let your foot off the gas, the intake side of the module switches back on and the engine will usually start running again. Customers may describe this as a sudden loss of power during acceleration. Use an oscilloscope or ignition timing light to make sure both sets of spark plugs are firing when they should.
