# Little Star

## 190 Service

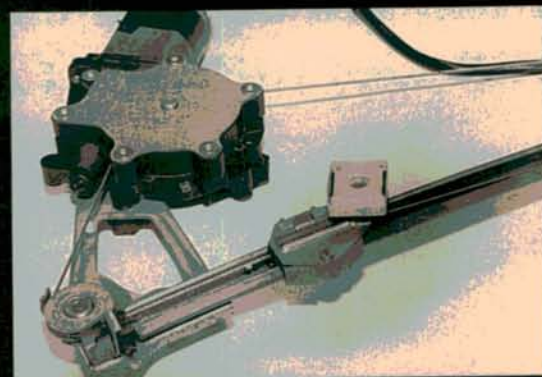
If the rear power windows won't move or move sluggishly, there are several possible causes. The window regulator is cable driven with an integral motor. If the window won't move, and you hear little or no motor noise, the cable drive is binding. The only sure fix is to replace the regulator assembly.

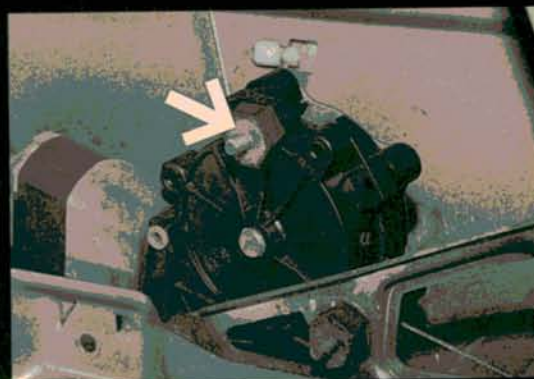
If the window motor is turning, but the window stays put until you move it by hand, check the regulator mounts. The regulator mounts can loosen, putting extra pressure on the neoprene window drive, breaking it off. An updated mount, with serrations on its mating surface (arrow) keeps the regulator tight.

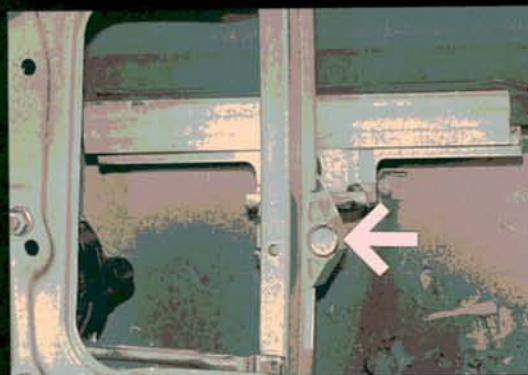
If the regulator mounts are okay, check the drive connection. The regulator assembly must be replaced if the drive is broken. Later regulators have a modified sliding jaw drive and metal reinforcement for those kids in the back seat who can't keep their fingers off the window switches.

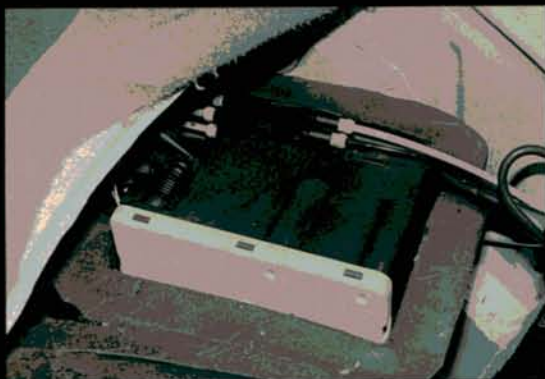
4

The 190 power door locks are actuated by an electric vacuum pump under the right rear seat cushion. Does the pump run when you cycle the driver's door lock up and down? If the other power door locks don't move, check for broken vacuum lines. If the pump doesn't run, suspect a switch, electrical supply, or a dead pump.

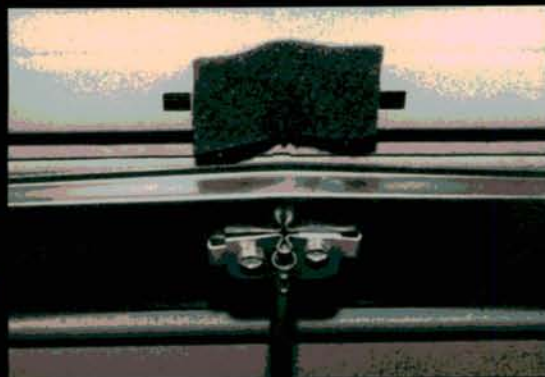
5

Check the drive attachment bolts if the motor and drive cable operate but the sunroof panel doesn't move. Early self-tapping bolts can back out of the roof panel, disconnecting the drive attachment. Replace the bolts with machine thread bolts and self-locking nuts. Repair or replace the drive attachment piece as necessary.

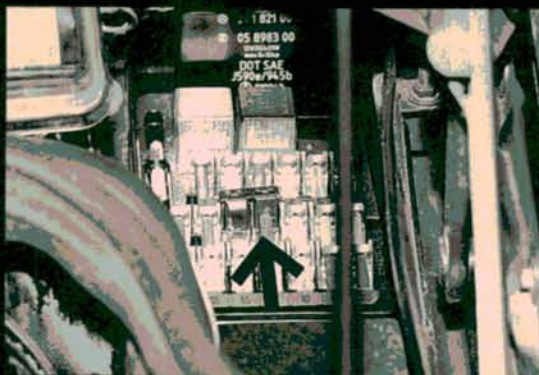
7

A blown number 9 fuse killed the brake lights on early 190s. This also made it impossible to disengage the cruise control by hitting the brake pedal. A modification including a 16 amp fuse and fuse bridge corrected the problem. A label is included in the kit to show the "fix" has been made.

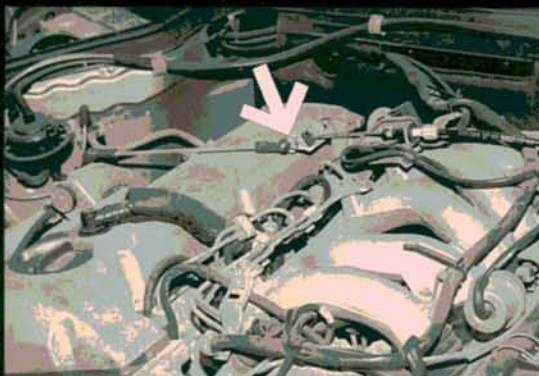
8

A loose or disconnected diesel cruise control linkage (arrow) can bind the throttle linkage. A modified cruise control amplifier with removable reference resistor was developed to correct cruise control surge during deceleration on downhill grades. Resistors must be matched to specific models.

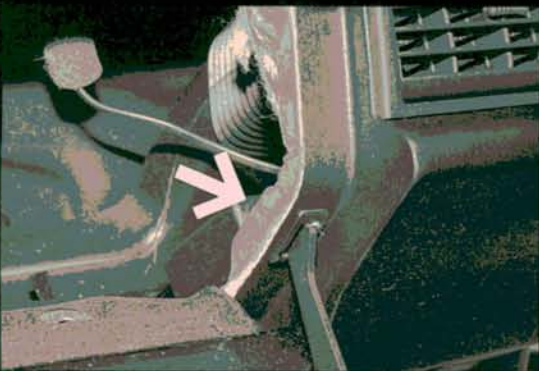
9

The automatic climate control (ACC) vacuum switchover valve located behind the glove box may produce a clicking noise when the ACC is in the automatic cooling mode on some 1984-85 190s. Rubber plugs are available to cap the fittings at the ends of the valve to stop the clicking noise.

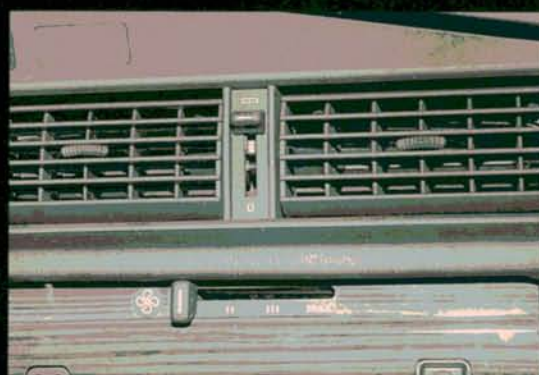
10

A faulty feedback potentiometer, located behind these center vents above the heater box, may keep the compressor from operating when the automatic climate control (ACC) is set to the normal cooling mode. A screw adjustment on the new potentiometer simplifies the voltage signal adjustment.

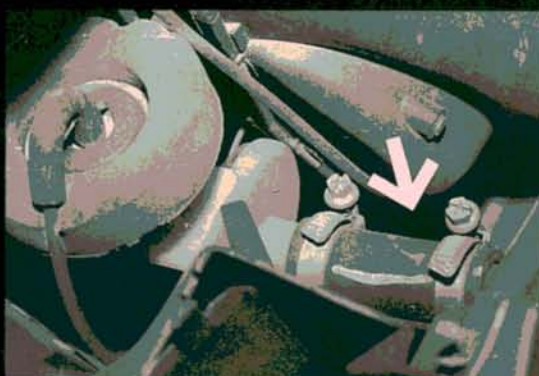
11

If the A/C compressor shuts off after operating for a short time, check for a failed evaporator temperature (ETR) switch. An updated ETR switch is available to correct this problem. Remove the cowl venting below the windshield to locate the switch at the bottom right corner of the heater box.

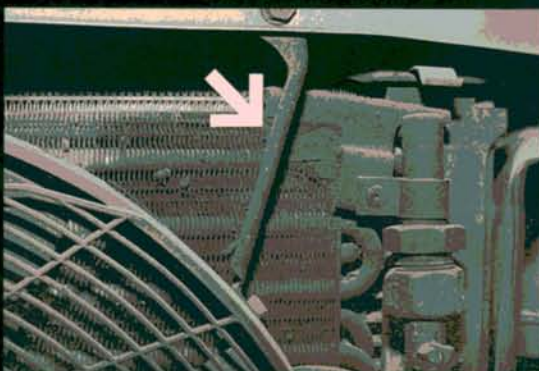
12

The A/C condenser is vulnerable to punctures caused by road debris. Like any vehicle, whatever is farthest forward is fair game. I've seen a number of leaks in the upper left corner of the condenser, but leaks in other spots are possible too. Manufacturing defects seldom cause A/C condenser leaks.

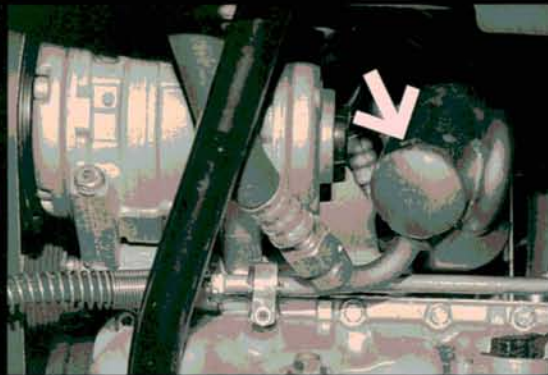
13

A revised A/C compressor hose assembly was introduced in June 1986 and may be installed on earlier models to keep compressor noise from entering the passenger compartment. The new hose assembly includes an integral muffler. Be prepared for a fair amount of disassembly to replace the hose assembly.

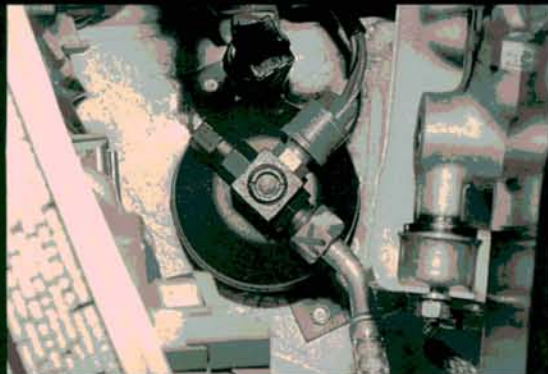
14

A complete modification kit was made available to cure other early A/C system problems, primarily overheated A/C components. The kit includes new pressure lines, condenser, a receiver/drier with pressure switches, and encapsulation panels for the lower sides of the engine compartment.

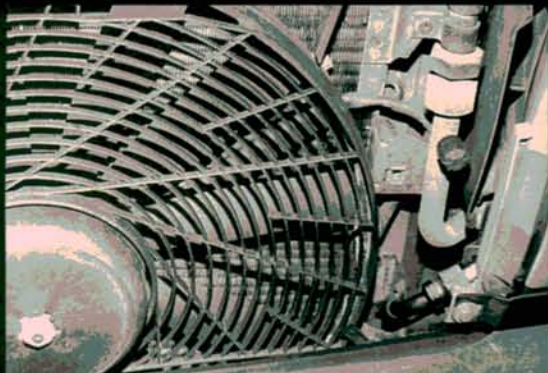
15

The engine and auxiliary cooling fan circuits can be modified to increase the engine cooling capacity on 1984-5 190 E models. This modification causes both fans to engage at high engine temperatures. The necessary relay, connectors, wiring, and instructions are available through M-B dealers.

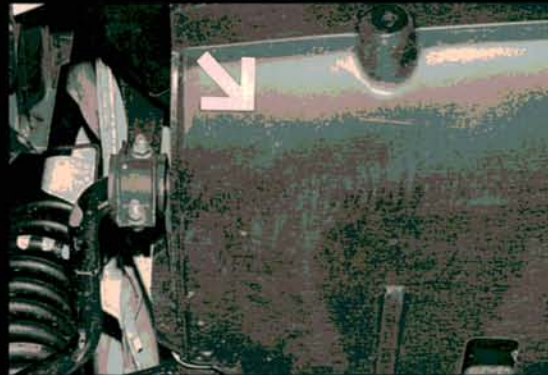
16

The six cylinder 190 2.6 engine is a tight fit in the engine bay, and high underhood temperatures aren't unusual. To cool things down several degrees, remove the lower encapsulation panel. Drill a dozen 1-1/2 inch holes in the right front side of the panel with a hole saw. Four rows of three holes works well.

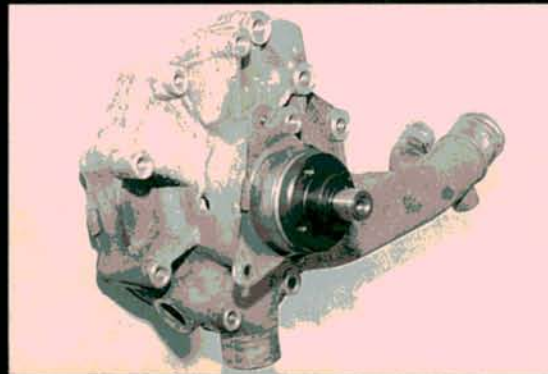
17

Water pump leaks were fairly common on early 190s. Look for seepage at the breather hole, usually during engine cool down. The engine cooling fan is controlled by an electro-mechanical clutch. If the clutch is in good condition, transfer the clutch from the old water pump to its replacement.

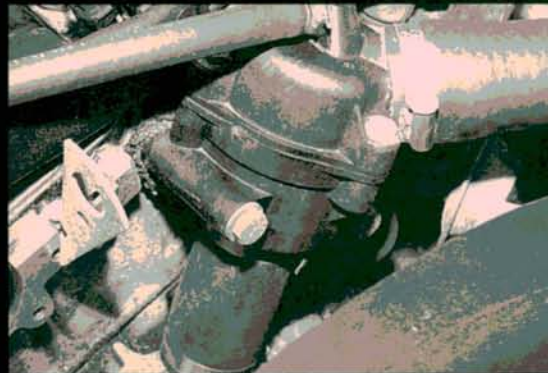
18

Early 190 gas engines used a plastic thermostat housing and housing cover. The plastic housing may warp, causing coolant leaks. Replace the warped housing with an updated alloy housing and paper gasket. Use a new o-ring and longer 6 x 1.00 x 25 mm bolts to mount the old plastic housing cover to the aluminum housing.

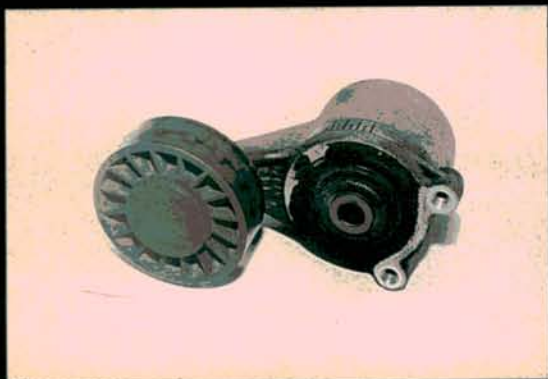
19

The serpentine drive belt tensioner may cause a fluttering noise during light acceleration on 2.3 liter gas engines, including the 16 valve version. The tensioner design was changed in 1985 and 1987. Updated parts may be installed on early 2.3 engines to correct this problem.

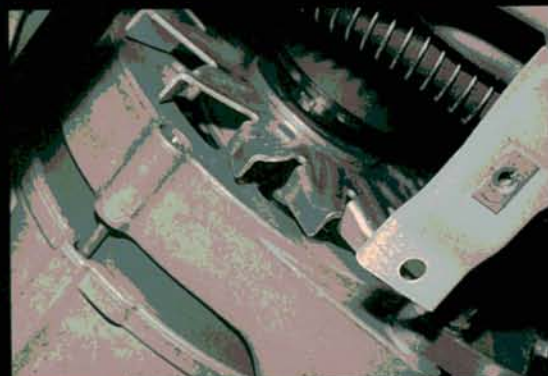
20

Don't be fooled when replacing the alternator on a poly vee belt-equipped 190 engine. The alternator does not use a Woodruff key. The shaft has a keyway, but it's not keyed to the pulley. Use a 22 mm box wrench and 8 mm Allen wrench to torque the pulley nut to 80 Nm. Air tools should not be used.

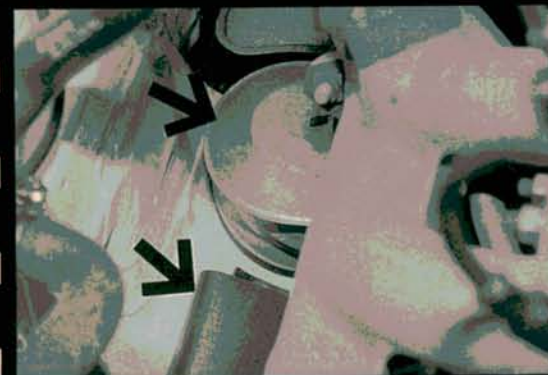
21

The hydraulic motor mounts on gasoline models can soften after vehicle mileage begins to add up. M-B introduced a modified mount which helped, but was only part of the solution. A cooling duct, heat shield, and tow hook door were also added to shield the right side mount from exhaust manifold heat.

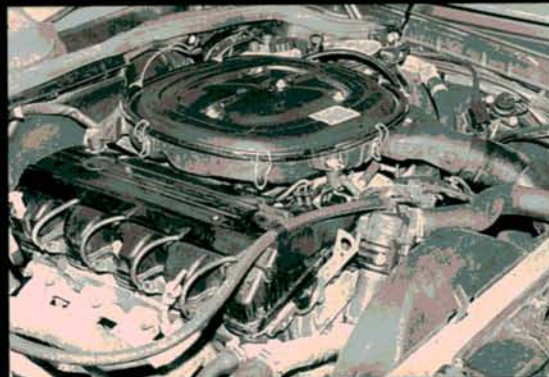
22

Worn valve guides may cause higher than normal oil consumption on 2.3 liter gas engines. Many guides were replaced at the dealership level. Dealership techs use a go - no go gauge to determine guide condition. Always check piston tightness if the head is removed for guide replacement or for any other reason.

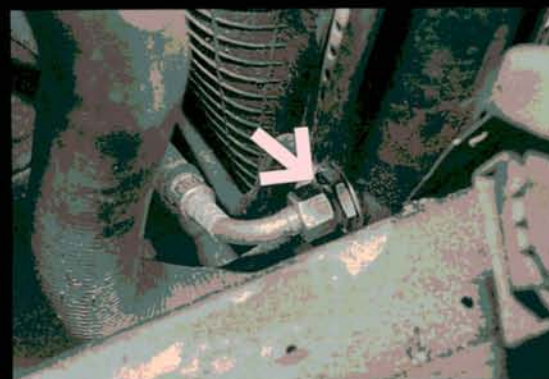
23

Watch for transmission fluid leaks at the radiator on 1985-86 models equipped with automatic transmissions. Leaks may occur at the aluminum collar nuts that secure the transmission oil cooler. Steel replacement collar nuts and washers are available to correct fluid leaks.

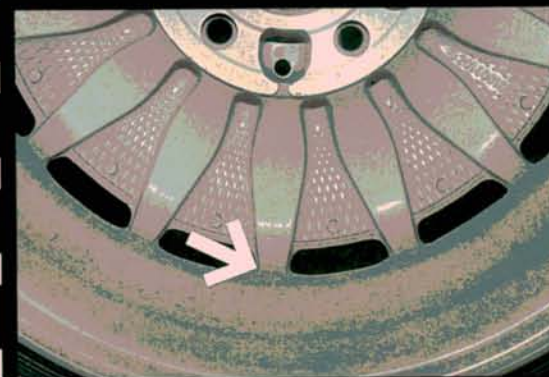
24

Inspect the inner spoke surface whenever the alloy wheels are removed. Early wheels were prone to cracking in this area. The wheel design was changed in 1987 to accommodate vented brake discs. Never install an early wheel on an '87 or later 190. Brake interference will damage the inside of the wheel.
