Electrical Service

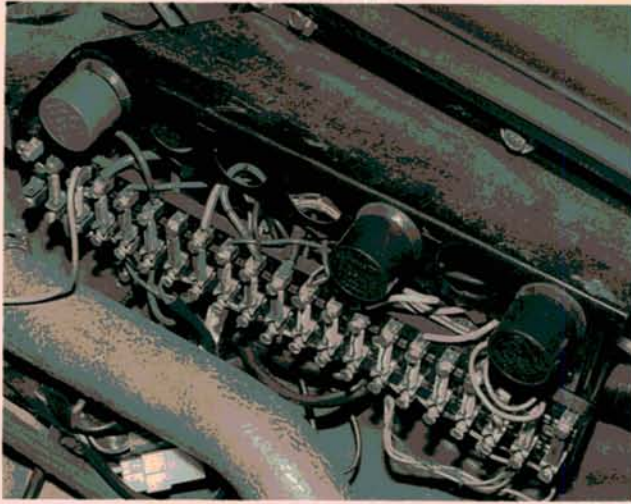
REVISED PORSCHE FUSE RATINGS

The recommended fuse ratings have been changed from 25 to 30 amps for three circuits on 1989-90 Porsche 911 models. Increased amperage fuses (30 amp) may be used for fuse 2 (oil cooler blower), fuse 13 (sunroof/cab top), and fuse 39 (A/C condenser blower). The circuits protected by these fuses may draw current greater than 25 amps without causing damage to the electrical system wiring. As a result, 30 amp fuses may be installed without additional modification.

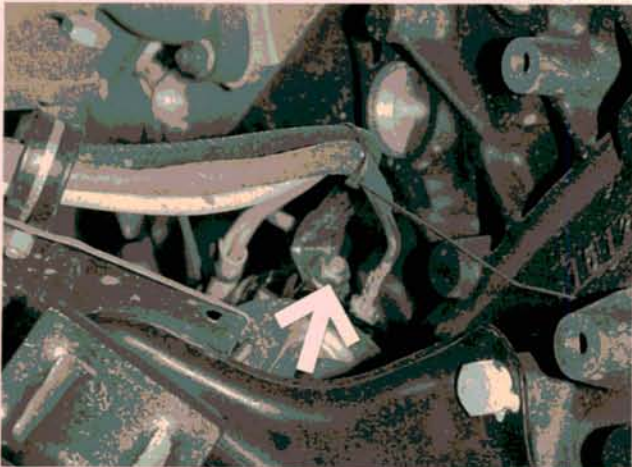
VOLKSWAGEN FOX CRANKING PROBLEMS

A loose nut at starter terminal 30 may cause a no start or discharged battery on some Volkswagen Fox models. Disconnect the battery ground terminal, then inspect and clean the starter connections as necessary. Torque the terminal 30 nut to 10 Nm (7.5 ft-lb) and reconnect the battery ground terminal. If the starter won't engage, check the fuse box for proper seating of the wire bridge between terminals 36 and 38. The bridge supplies power to the starter solenoid.

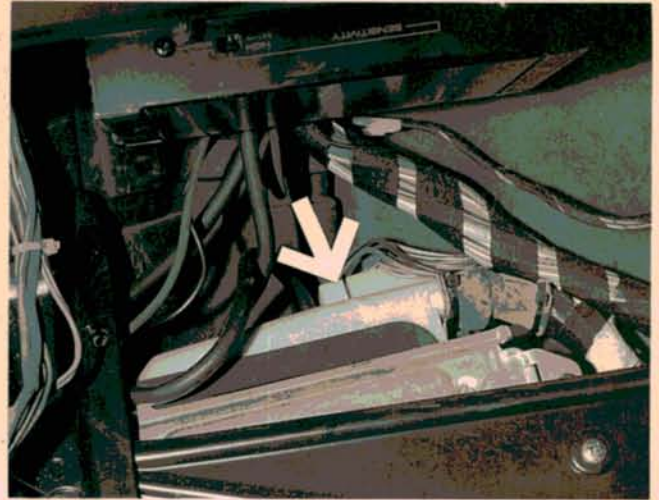
PORSCHE CONTROL UNIT MEMORY

Porsche 928 S4 and 944S models with DME or EZK/LH injection control units have a performance curve memory which is maintained by supplying battery voltage to ECU terminal 30. This memory is lost if the battery or ECU are disconnected. Run the engine for at least 10 minutes to restore the performance curve memory. Engine performance may be erratic during this period. Specifications such as idle speed, air/fuel ratio, and ignition timing should not be checked or adjusted until the memory has been restored.

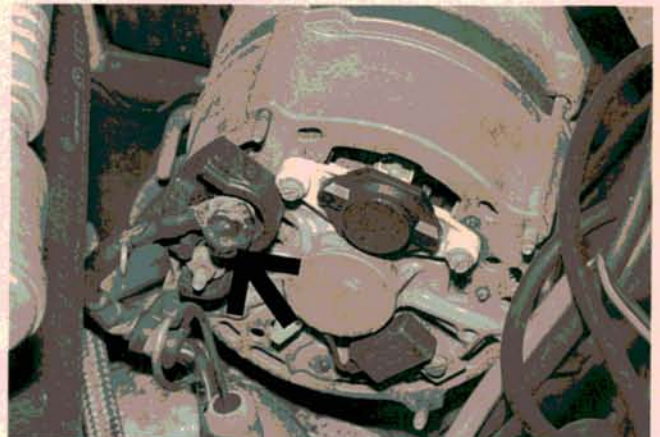
FLICKERING VOLKSWAGEN BATTERY INDICATOR LIGHT

The battery indicator light may flicker on some 1983-87 Volkswagen models, except Vanagons. The flickering light may be caused by loose wiring eyelet connectors at the alternator. Inspect the eyelet connectors for a brownish discoloration caused by high resistance. If discoloration is visible, replace the nut and eyelet connectors. To make sure the alternator nuts don't loosen, torque the small nut at alternator terminal D+ to 3 Nm (2.2 ft-lb). Torque the large nut at the alternator B+ terminal to 16 Nm (12 ft-lb).

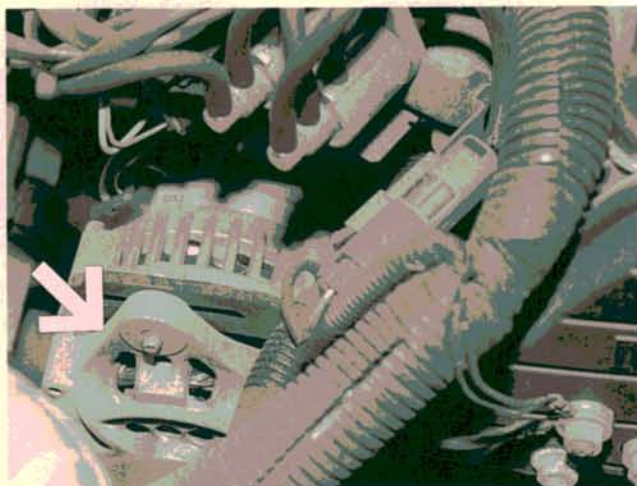
NISSAN PULSAR NX NO RESTART

A 70 amp alternator (P/N 23100-70A00R), adjusting bar (P/N 11715-01M03), and fan belt (P/N 11720-67A00) are available to correct low charging rates on some 1987-88 Pulsar XE and Sentra models. Low speed driving, heavy accessory loads, and low alternator output may cause a low or dead battery and no restart condition on these models. Before replacing the alternator, test the charging system to make sure that low alternator output is causing the discharged battery.

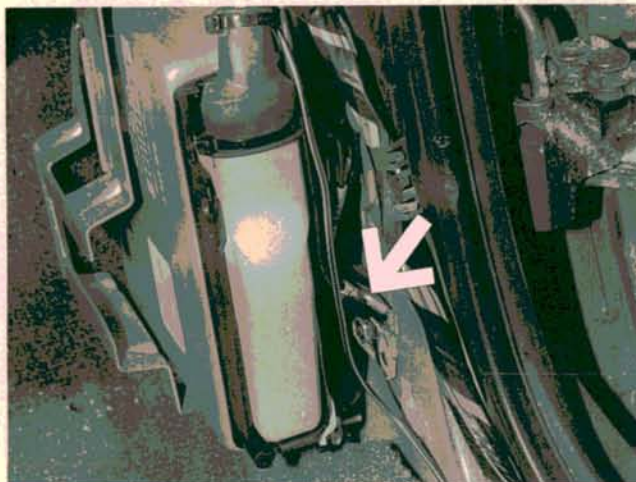
VOLVO 7 SERIES GROUND CONNECTIONS

Many of the electrical components on Volvo 7 series models are grounded at a central grounding terminal located at the right kick panel. If any of these components fail, check the harness connectors at the bottom of the kick panel for proper attachment to the ground terminal. A loose, corroded, or damaged ground connection at this point can cause any number of electrical problems. Begin any electrical diagnosis by removing the A pillar trim (for a quick inspection of the grounding terminal.)

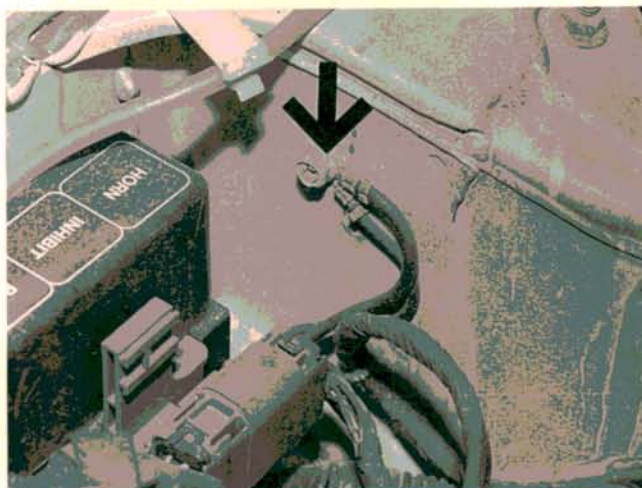
OVERHEATED NISSAN GROUND WIRE

A damaged throttle body fuel injection mixture heater may cause an overheated ground wire on some 1987 Nissan Pulsar NX and 4WD Sentra wagon models. The ground wire is located in the main harness and runs between the mixture heater and a grounding point at the right strut tower. If the mixture heater shorts, the harness may be destroyed by the overheated wiring. These models were recalled for mixture heater replacement under warranty, but there's a chance that some were not replaced.

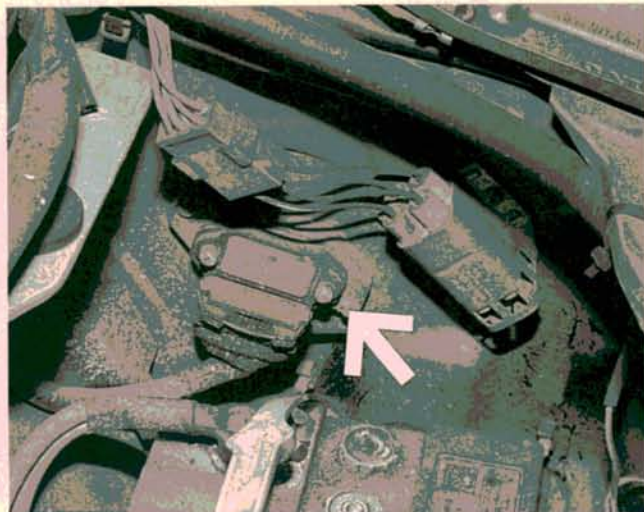
VOLVO BATTERY REPLACEMENT

There may be insufficient clearance for the ignition control unit when replacing the battery on Volvo 760 Turbo models. Relocate the control unit approximately two inches upward to ensure proper contact with the sheet metal. Drill new mounting holes, then install the control unit using the original screws. Do not alter the control unit's electrical connector direction. The connector must point downward and the aluminum cooling plate must be properly installed.

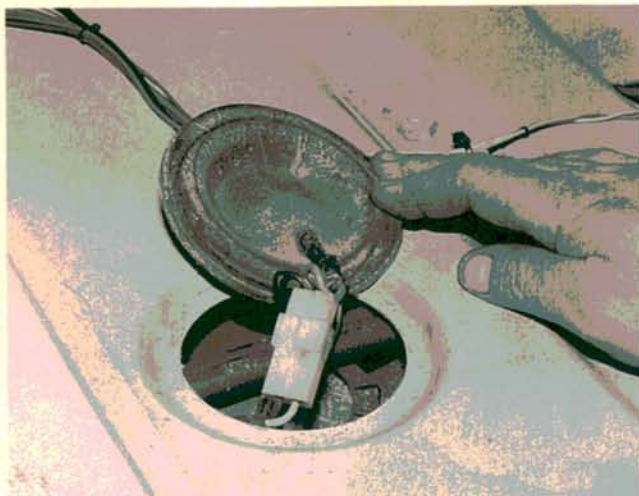
SAAB 900 FUEL PUMP AND GAUGE MALFUNCTION

Overheated electrical terminals at the sending unit may cause erratic fuel gauge and fuel pump operation on some Saab 900 models. Remove the trunk floor and sending unit rubber cover. Perform a continuity check while moving the sending unit wire leads. If a poor connection is found, replace the damaged terminal with a new terminal (P/N 85-82-090). Reconnect the sending unit and test the fuel gauge and fuel pump operation. Install the sending unit rubber cover and trunk floor.

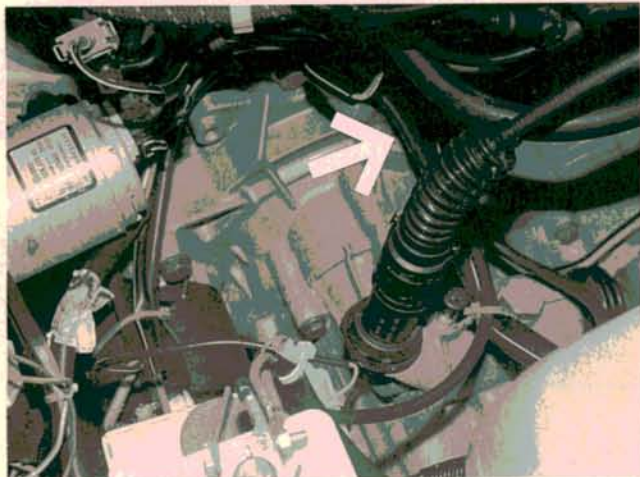
VOLKSWAGEN COLD START

Some 1986-88 Volkswagen Jetta GLI and Scirocco models equipped with 16-valve engines may be hard to start at below freezing temperatures. This condition may be caused by an inadequate ground circuit to the ignition system. The weak ground causes a voltage drop to the ignition system during cranking. To repair this condition, an additional ground wire (P/N 533 971 235) is available for installation between the battery ground post and the upper transaxle mounting bolt.

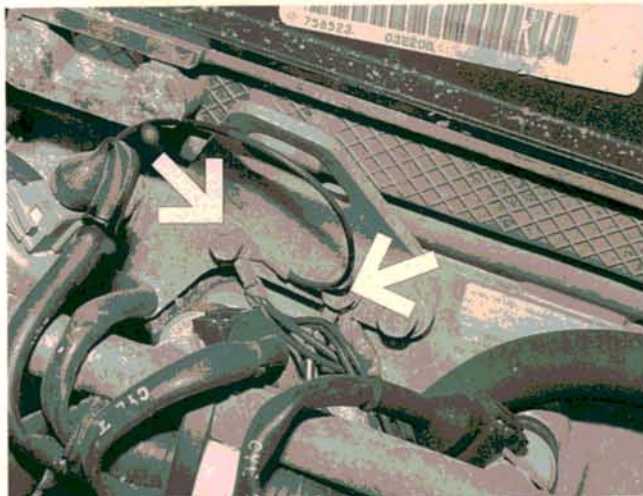
SAAB 900 ENGINE GROUND POINTS

Loose or dirty fuel injection system ground wires may cause poor driveability and starting difficulties on some Saab 900 Turbo models. The main fuel injection ground wires are bolted to the engine lifting lug at the front of the engine (arrow). Make sure that the bolts and wire terminals are clean and correctly tightened to 10 Nm (7.4 ft-lb). The ground wires should not be moved from these ground point locations.

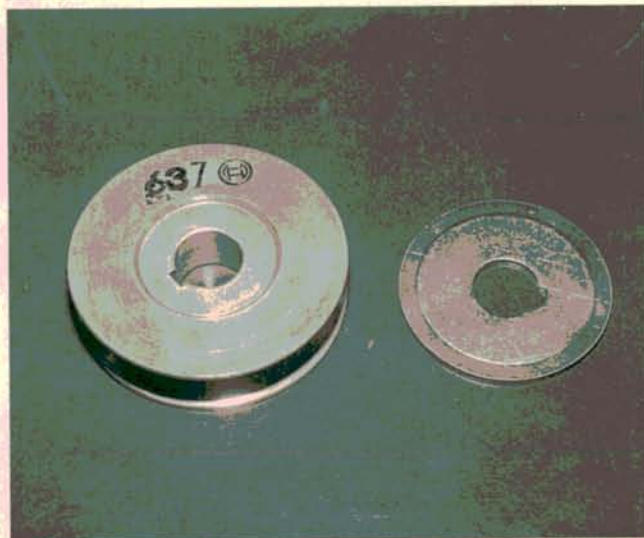
BMW 7 SERIES CHARGING RATES

Under certain driving conditions, particularly during winter, the battery in BMW 735 and 750 models produced between January 1987 and September 1988 may not receive a sufficient charge and the engine may not restart when turned off. Smaller diameter alternator pulleys are available to correct these low charging rates. On 735 series vehicles, install pulley P/N 12 31 1 722 983. On 750 series vehicles, replace the existing alternator pulley with P/N 12 31 1 720 368, and fan wheel P/N 12 31 1 725 734.
