FOUR VOLVO QUICK TIPS

SUBARU THROTTLE BODY GASKET

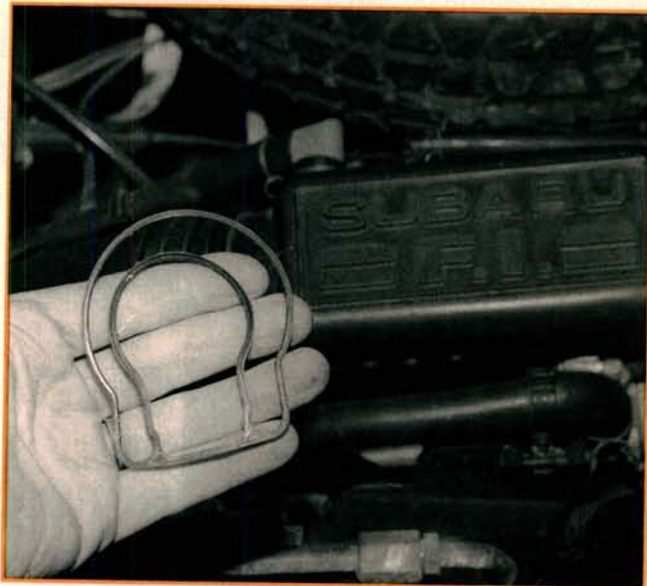
A leaking seal at the base of the throttle body may cause a rough idle and hesitation on "L" series Subarus equipped with single point fuel injection. If the formed rubber seal is leaking, engine coolant may be drawn into the intake manifold and burned, or the coolant may leak onto the hot engine and evaporate. Either way, there may be no obvious signs of coolant leakage.

If you are trying to locate the cause of a mysterious loss of coolant, check the condition of the throttle body seal before condemning the head gaskets. Drain the cooling system, then remove the hoses and wiring connectors that are attached to the throttle body. Remove the four throttle body mounting nuts, then lift the throttle body to replace the rubber seal. The seal fits into grooves that are machined into the underside of the throttle body.
