We caught up with a 1986 Jetta GLI while it was in space dock recently. The Jetta had just returned from a journey of over 77,000 Earth miles. We'll chronicle the maintenance and repair items that were performed to ready the Jetta for its next 77,000 miles of Earth duty. These repairs are typical for 1985 and later second generation Jettas.

Return Of The Jetta

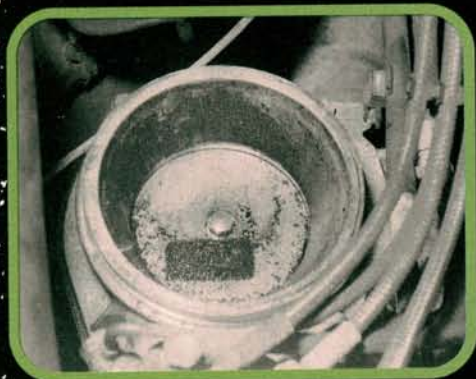
1

A sludged up valve cover and a clogged PCV system had loaded the top of the sensor plate with an oily residue. We cleaned the sensor plate, then checked for proper centering and height. Adjust plate height by bending the wire spring stop below the plate.

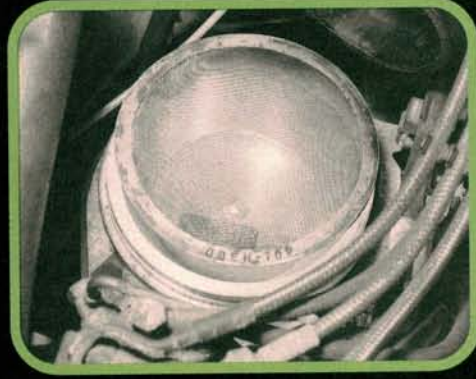
2

If a KE equipped engine accelerates poorly or lacks power, check for an improperly installed or bent sensor plate screen. A bent or upside down screen will limit the sensor plate's upward travel. Clean and straighten the screen, then install it with the words *oben* or *top* facing upward.

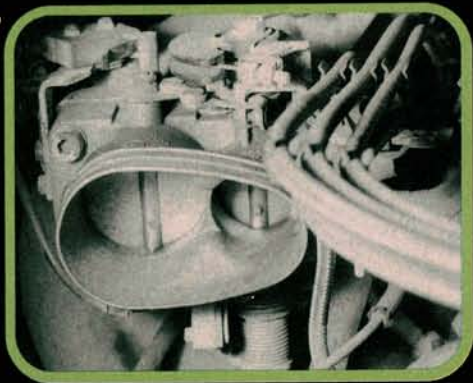
3

Throttle housing deposits can keep the throttle plates from opening and closing properly, causing an unstable idle or a binding throttle. Remove the rubber intake boot, then clean the throttle housing deposits with carburetor cleaner. Readjust the idle stop screw if it has been tampered with.

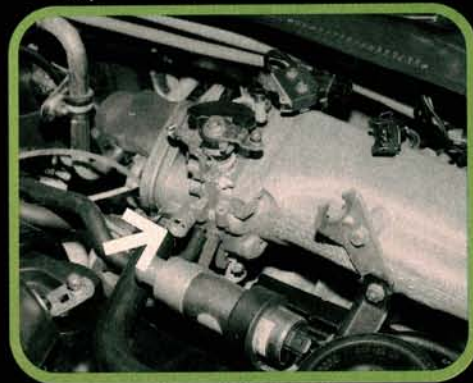
4

The ECU uses the idle stabilizer valve (arrow) to control the idle speed at all engine temperatures and loads on KE and Digifant systems. Turning the air bypass screw in the throttle housing adjusts the idle stabilizer valve's duty cycle. Don't attempt to adjust the idle speed "by ear" by turning the air bypass screw.

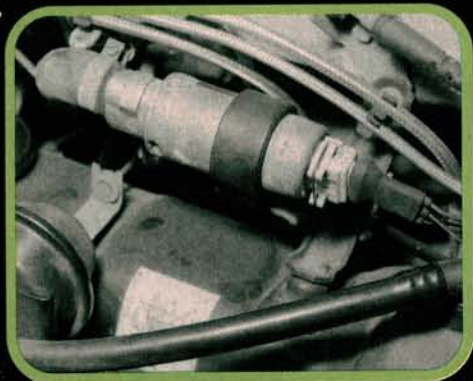
5

Idle stabilizer valve deposits may also keep the engine from idling properly. Also check for air leaks in the hoses leading to and from the valve. If the throttle must be fully depressed to start the engine on Digifant models, the idle stabilizer valve has stuck closed and should be replaced with an updated valve.

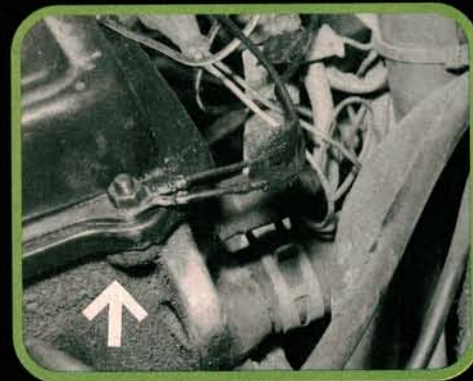
6

Jetta gasoline engines have had hydraulic cam followers since 1985, so there's a good chance the valve cover won't be removed until the gasket starts to leak oil (ours was). Vacuum leaks at the valve cover gasket can also cause idle speed control problems, especially on 16 valve models.

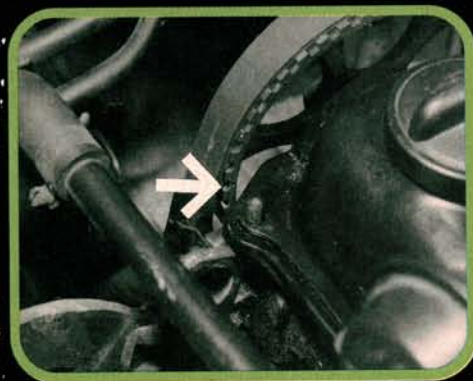
7

Timing belt replacement procedures are the same as earlier Volkswagen models equipped with the single overhead cam engine. The valves won't bend if the belt breaks, but a broken belt can do some very expensive damage on twin cam and diesel engines. Following the 60,000 mile change interval prevents problems.

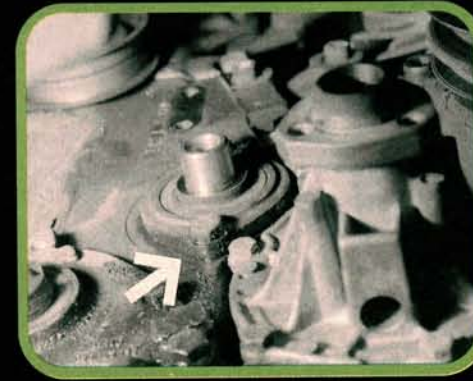
8

At 77,000 miles, our engine was already well past the recommended belt replacement interval. We also found several other good reasons to replace the belt. The camshaft, crankshaft, and auxiliary shaft seals were all leaking. The belt and sprockets must be removed to replace these seals.

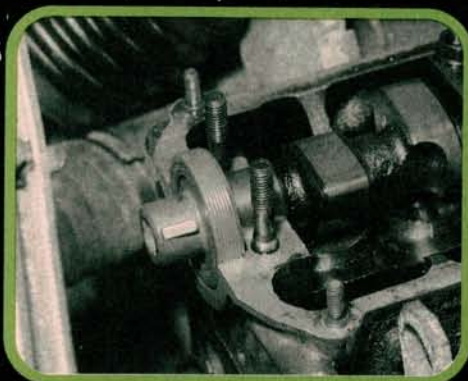
9

We didn't have the special camshaft seal remover and installer, so we removed the upper half of the camshaft bearing to replace the camshaft seal. The seal sits in a recess at the end of the bearing housing. Once the cam bearing cap is removed, the seal slides right off the end of the camshaft.

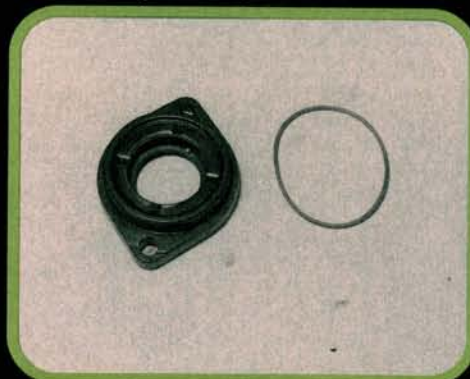
10

The auxiliary shaft seal is mounted in a separate housing that bolts to the block. Always remove the housing when replacing this seal. The large o-ring that seals the housing to the block should also be replaced. The o-ring flattens out over time and was causing one of our engine's larger oil leaks.

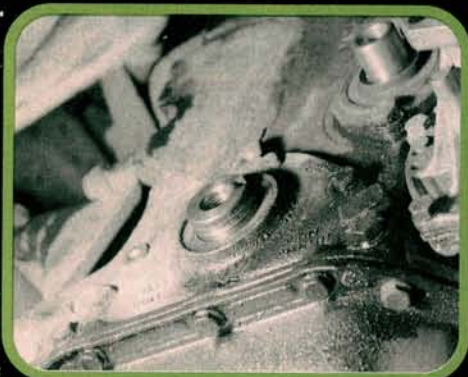
11

Unless you are particularly handy with a hook style seal remover, it may be easier and safer to remove the seal housing to replace the crankshaft seal. It's also easier to install the new seal when the housing is on the bench. The seal housing can be removed without damaging the pan gasket.

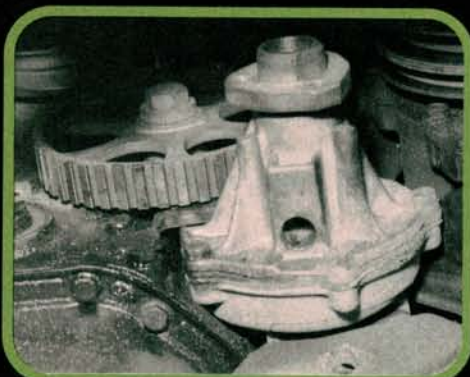
12

Take a close look at the water pump while the timing belt, sprockets and timing covers are removed. The water pump is mounted on an extension housing that bolts to the block. The housing is sealed to the block by a large o-ring. Replace the pump and housing o-ring now if either shows any signs of seepage.

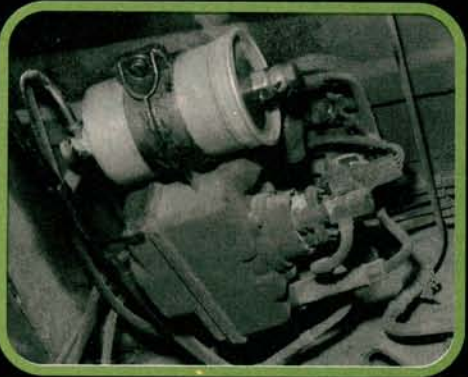
13

The fuel filter is located under the car, next to the main fuel pump. There are no flexible lines nearby to pinch with a hose pliers, so position a pan under the filter before loosening the filter banjo bolts. Use a backup wrench on the filter to properly torque the bolts during installation.

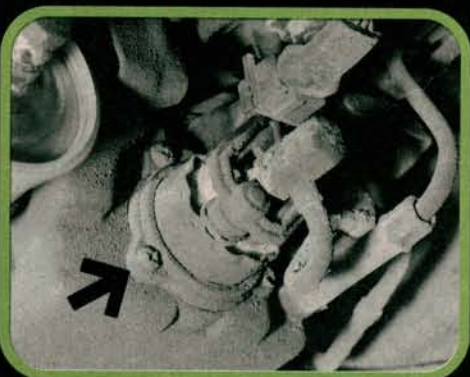
14

The high pressure, low volume main fuel pump is housed in a plastic reservoir. A low pressure, high volume prepump inside the fuel tank keeps the reservoir filled with fuel. A prepump failure will cause stalling around corners. Also check for fuel leaks between the reservoir and the main pump.

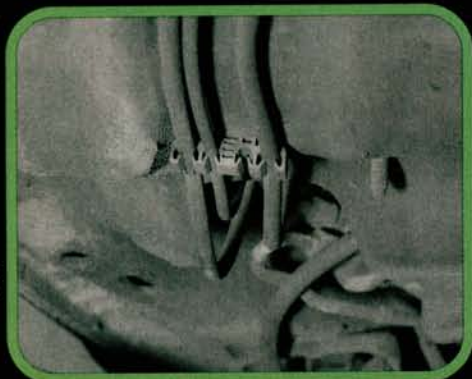
15

Digifant and KE systems require correct fuel pressure and no leaks for proper operation. The plastic fuel lines and fuel tank should give better service than the steel components they replace. Use the proper techniques (September 1989 *Import Service*) when repairing plastic lines or fittings.

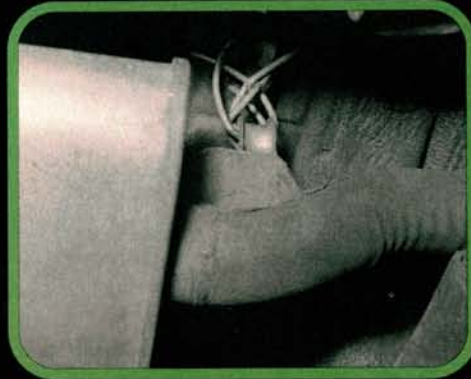
16

Use care when installing new exhaust components. Make sure all parts have adequate clearance before tightening the clamps. The rubber hangers may stretch or break, causing the exhaust to hit the rear axle over bumps or when heavily loaded. The stiff wire shown here is an imaginative repair solution.

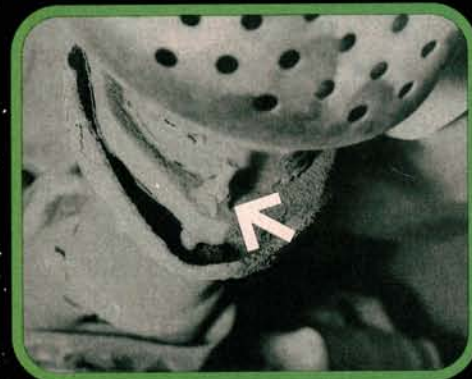
17

Rusted heat shields at the catalytic converter or front pipe are another potential source of rattles. The nuts and bolts that attach the converter to the front and rear exhaust sections like to rust away and disappear. Ceramic elements also occasionally break loose inside the converter.

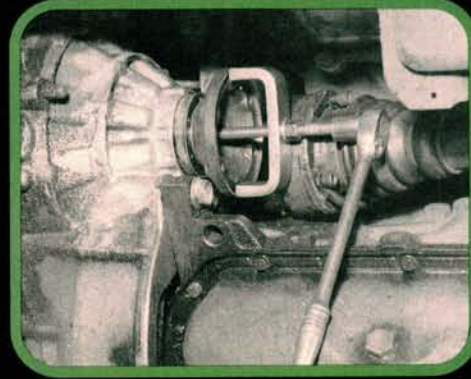
18

Separate the drive axles from the drive flanges to replace the axle seals. Clean the dirt out of the axle bolt splines before attempting to loosen them. Compress the axle flange springs, then remove the snap rings. A long bolt, nut, and GM steering column lock plate tool will do the trick.

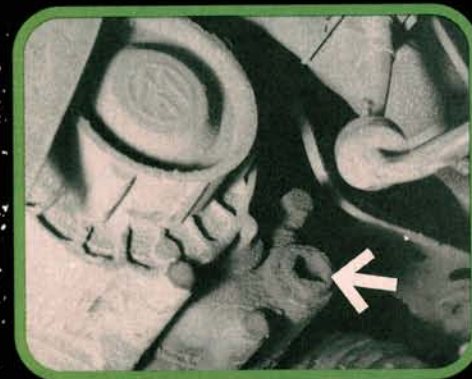
19

Early manual transaxles require a special filling procedure. Add lube through the fill hole in the transaxle until lube drips out. Install the fill plug, then remove the speedometer cable and add an additional pint. The fill hole was moved up a few millimeters on later models to make this procedure unnecessary.

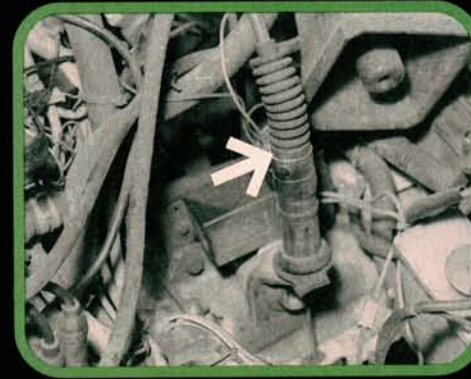
20

Some Jettas are equipped with self-adjusting clutch cables that can be identified by a large rubber boot near the transaxle end of the cable. The spring under the boot must be compressed when removing and installing the cable. A strap is supplied with new cables to hold the spring in position.

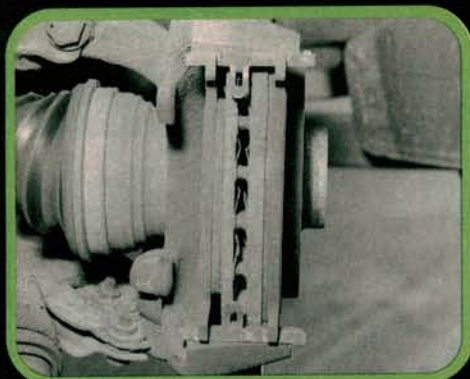
21

Disc brake noises may occur if brake hardware is missing or in poor condition. A self-adhesive shim kit (P/N 171 698 993) can be installed to correct brake squeak. Make sure the back sides of the pads are clean before installing the shims. Trim any excess shim material before installing the pads.

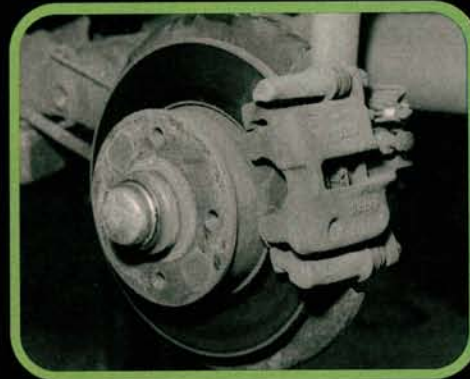
22

Rear drum brakes are used on all Jettas except GLI models, which have four wheel discs. To prevent rear wheel bearing water damage, never reuse rear axle seals following disassembly. Axle bearing dust caps should also be replaced if they are bent or otherwise damaged.

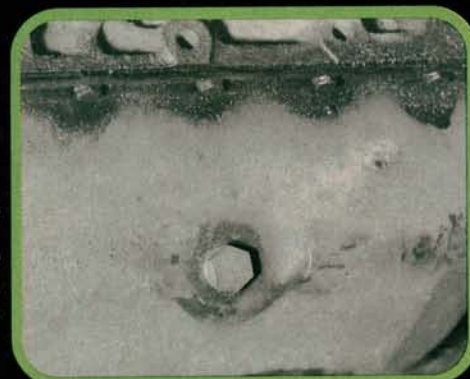
23

Lubrication specialists of the nation take note: do not overtighten the engine oil drain plug. The drain plug and oil pan only have a few threads apiece. The oil pan threads are easily damaged by overtightening. Install a new sealing washer, then torque the drain plug to 30 Nm (22 ft-lb).

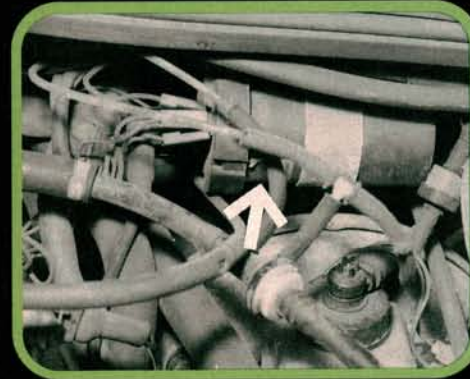
24

Check the condition of the distributor cap, rotor, spark plug wires, coil wire, and coil tower. Ignition coils with black part number 1 labels may cause accelerated secondary ignition component wear and burnout. Install an updated green label coil (P/N 211 905 115 D) if you find these problems.

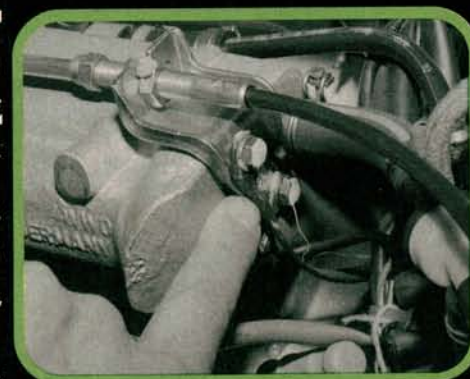
25

Both KE and Digifant fuel systems have several ground wires attached to the intake manifold (arrow). The combination of a short wiring harness and engine vibration and movement may cause one or more of these wires to break. Solder additional wire into the harness to correct this problem.

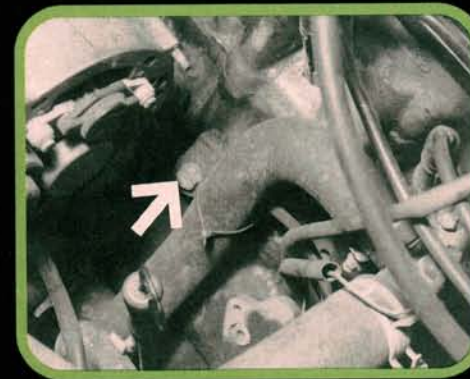
26

Replacement knock sensors are equipped with gold plated terminals. The harness connector terminals must also be replaced with gold plated terminals to assure the best possible electrical connection. Knock sensors, terminals and harness connectors are available through Volkswagen parts departments.
