Electrical Service

Electrical Gremlins

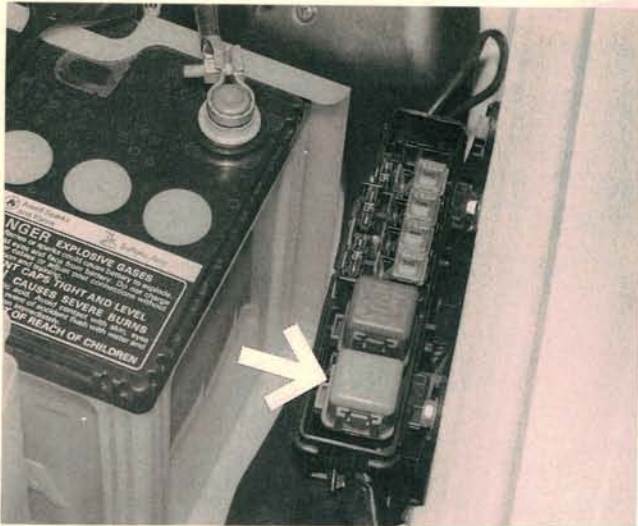
1

A poor connection at the ECCS relay on 1989-91 Maximas may cause the engine to hesitate and the tachometer to momentarily drop to zero when accelerating. This usually occurs while the vehicle is in motion and no diagnostic codes will be stored. If the fuel system checks okay and if other diagnostic procedures don't eliminate the hesitation, clean and tighten the ECCS relay connector terminals. The ECCS relay is located at the front of the underhood fuse and relay panel, next to the battery (arrow).

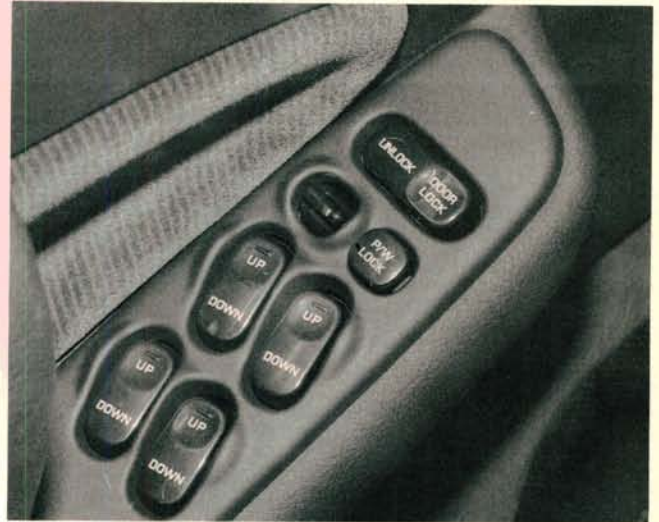
2

Using jumper cables to start a 1989 or later Maxima with a dead battery may damage the driver's power window switch. Voltage spikes caused by connecting or disconnecting the jumper cables can damage the solid state window switch. The damaged window switch causes a dead short, and the circuit breaker that protects the power window and power seat circuits will click on and off. The circuit breaker may overload too. Replacing the window switch will correct the problem, but jump starting is the original cause.

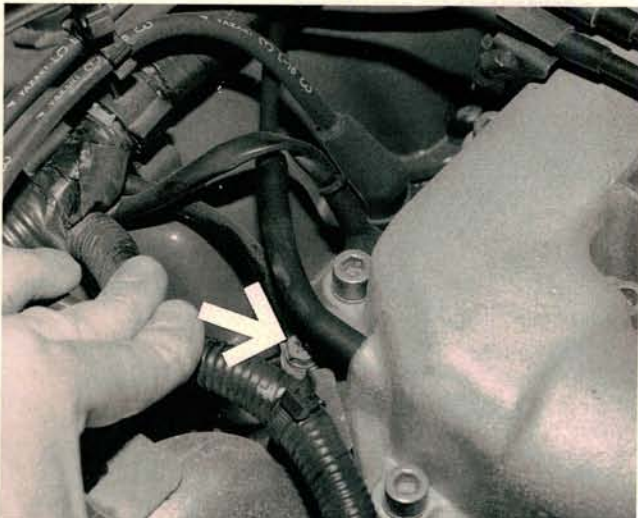
3

A damaged or broken ground wire on 1990 Maxima models may force the ECU into "limp home" mode and prevent the engine from accelerating above 2000 RPM. The broken ground wire will also cause the condenser fans to run continuously. ECU self-diagnosis will indicate a Code 43 (throttle sensor). The broken wire is located in the engine harness, near the plastic protector at the rear of the valve cover (arrow). Repair and insulate the ground wire as necessary to prevent further damage.

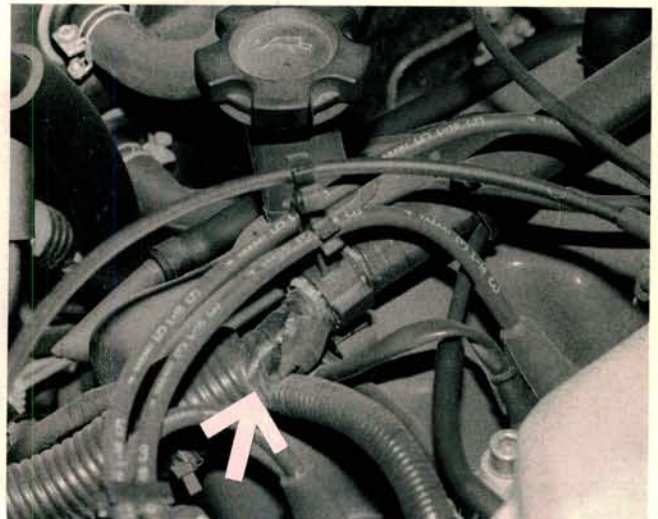
4

A shorted or damaged ECCS wire in the main engine wiring harness may cause 1989 Maxima models to buck or stall. The problem usually occurs during vehicle acceleration or braking. The green/red wire is located near the "Y" in the engine harness, next to the valve cover (arrow). Slit open the wiring harness and repair the damaged wiring as necessary. Reroute the repaired engine harness away from sharp surfaces to prevent further damage.

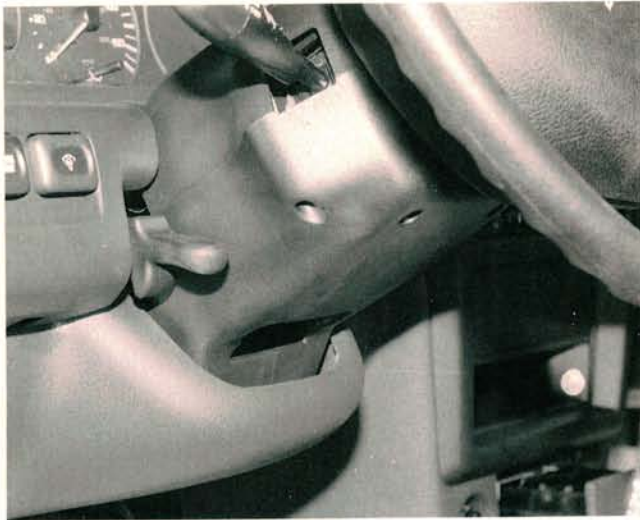
5

A damaged steering column wiring harness may cause 1989 or later Maxima models to stall when tilting the steering wheel. This problem may also occur on 1990-91 Stanza and Sentra sedans. The ignition fusible link will blow, preventing the vehicle from restarting. Remove the lower dash panel and steering column cover. Check for a damaged harness on the left side of the column. Repair the white/red wire, then add three inches of insulation on either side of the existing insulation and replace the fusible link.

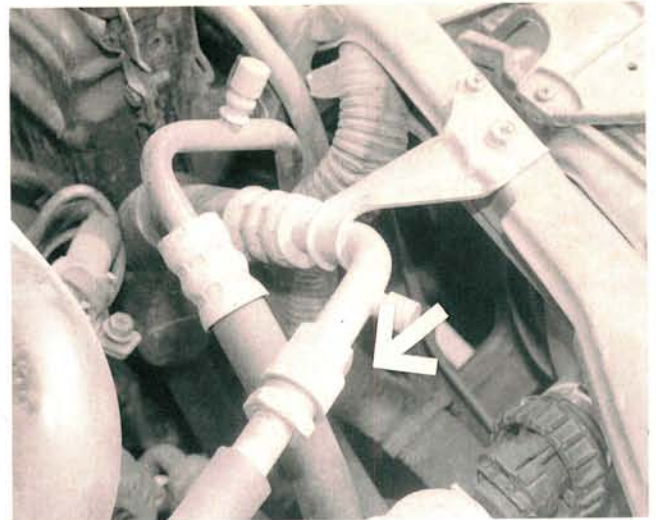
6

On 1989 Stanza models, a damaged main wiring harness may cause the 10 amp A/C fuse to intermittently blow. Check for momentary shorts while driving over large bumps, backing uphill, or decelerating (conditions that cause the engine to roll forward on its mounts). Inspect the main harness along the right side of the radiator support. The gray number 2 thermo switch wire may be grounding against the headlight bucket mounting stud. Repair any damaged wiring and reposition the wiring harness as necessary.

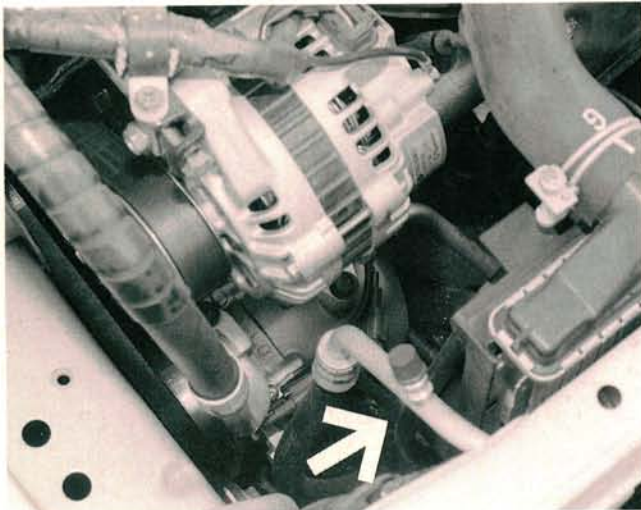
7

Moving along to 1990 Stanza models, a broken wire at the A/C compressor clutch wiring harness connector may disable the air conditioning on vehicles equipped with factory A/C. The wiring harness is attached to the radiator support with a wire tie. If the wire tie is too tight, engine movement and vibration may pull the compressor clutch power supply wire out of the connector. Repair the wiring harness and reposition the wire tie as necessary to allow for normal engine movement.

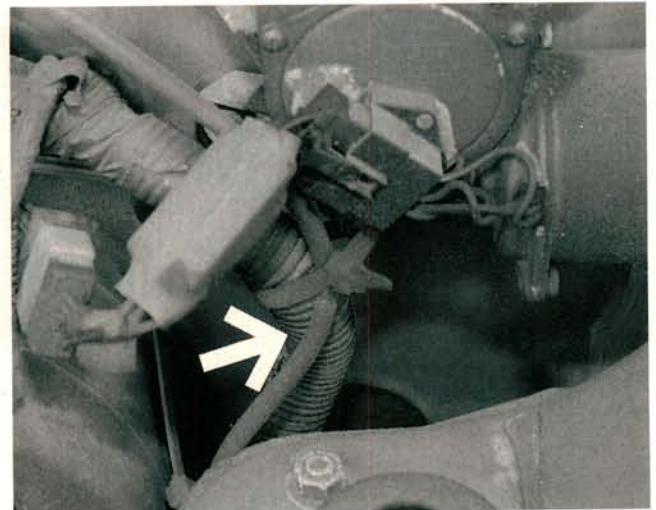
8

A main wiring harness that's corrosion damaged near the firewall may cause a no-start condition on Stanza wagon models. Check for voltage at the injectors with a DVOM. If the injectors are receiving less than battery voltage, open the main harness and look in the area indicated for a corrosion damaged white supply wire that leads from the fusible link to the injectors. Repair the damaged injector wiring, then insulate the wiring harness to keep moisture out.

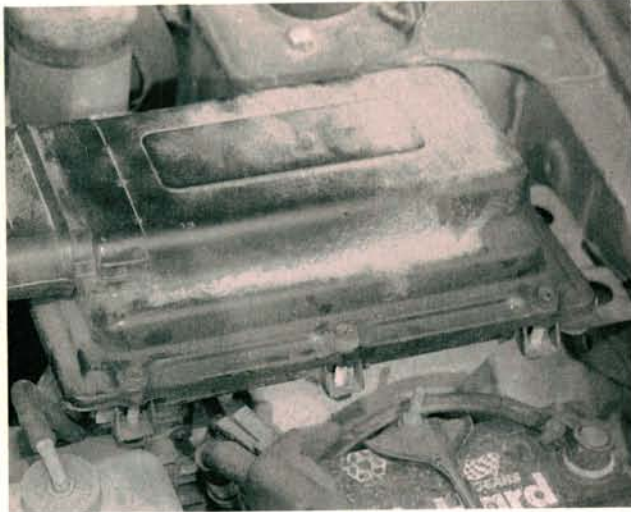
9 Before you replace a failed air flow meter on a Stanza wagon, be sure to check the air injection valve (AIV) too. A faulty AIV can damage the air flow meter by allowing moisture and exhaust gas to back up from the exhaust system and pass through the air flow meter. Remove the air cleaner and check the AIV intake at the air flow meter inlet. If you find soot or a moisture trail leading into the air flow meter, the AIV should be replaced. A leaking AIV will ruin the new air flow meter in a hurry.

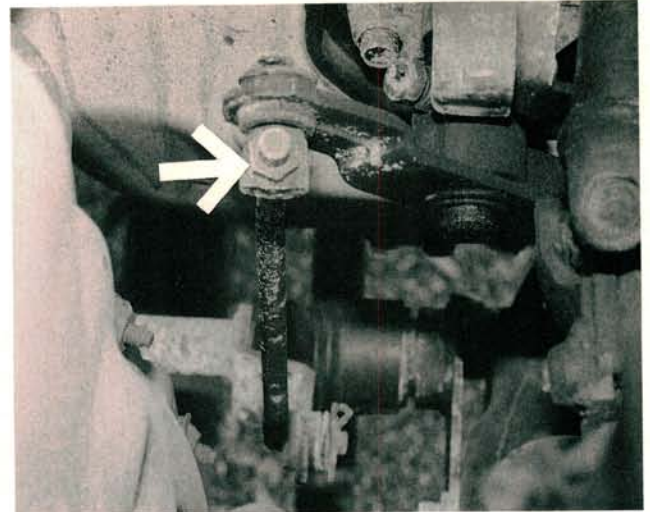
10 A misadjusted shift linkage or inhibitor switch may cause grinding starter engagement on truck models equipped with automatic transmissions and column mounted shifters. While cranking, engine movement moves the shift linkage. This causes the transmission mounted inhibitor switch to make and break the circuit to the starter solenoid. The starter then clashes with the moving flywheel as the starter engages and disengages. Adjust the shift linkage and inhibitor switch to correct the problem.

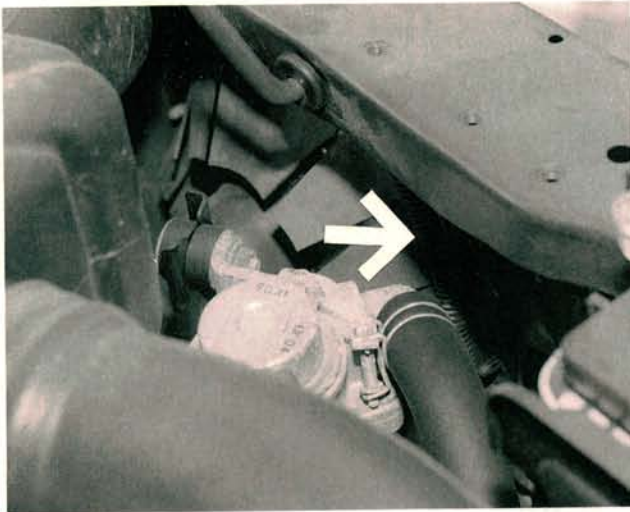
11 A damaged wiring harness may cause the horn to blow intermittently when using the turn signals on 1986 and later truck models. Check the wiring harness for chafing or cuts in the area behind the headlights and also behind the front bumper. Wiring for the turn signal lamps and horns follows the same harness. Damaged wires may be rubbing together inside the harness. Repair the damaged wiring, then isolate the wiring harness from any sharp metal edges to prevent future damage.

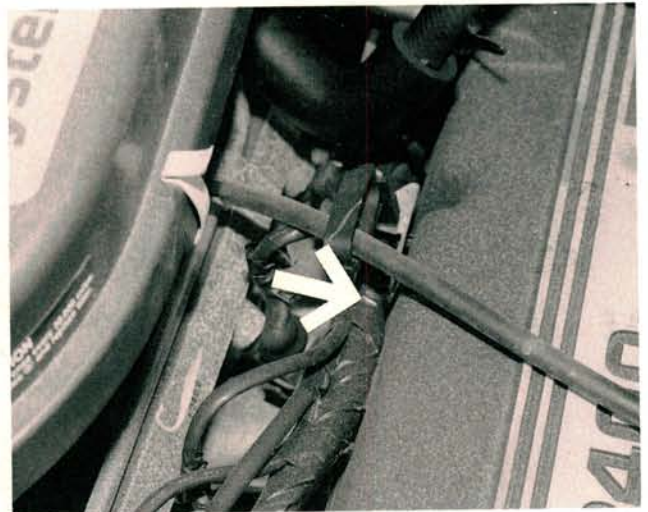
12 A poor connection at a splice joint in the engine wiring harness may cause a surge or intermittent idle fluctuation on 1990-92 truck models equipped with KA24E four cylinder engines. A loose or broken splice of four black/green wires may interrupt the reference voltage supply from the ECU to the head temperature sensor, exhaust gas temperature sensor, and throttle valve switch. Wiggling the harness may start or stop the symptoms. Open the harness, then solder the splice joint to repair the loose connection.

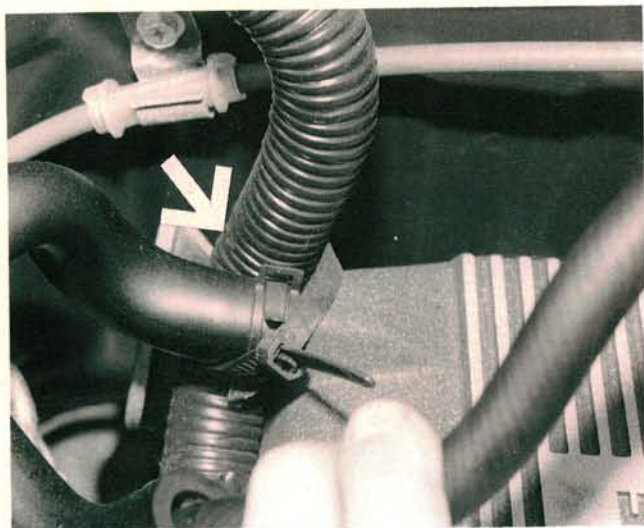
13 Also on KA24E four cylinder trucks, the same section of engine wiring harness may be damaged by rubbing against the engine lifting bracket at the rear of the engine. Damaged injector control wiring inside the harness may cause the engine to miss under load, but rev normally with no load. The number 4 spark plug may also become fouled if the injector control wiring grounds and holds the injector open. Repair the damaged injector wiring, then position the wiring harness away from the bracket.

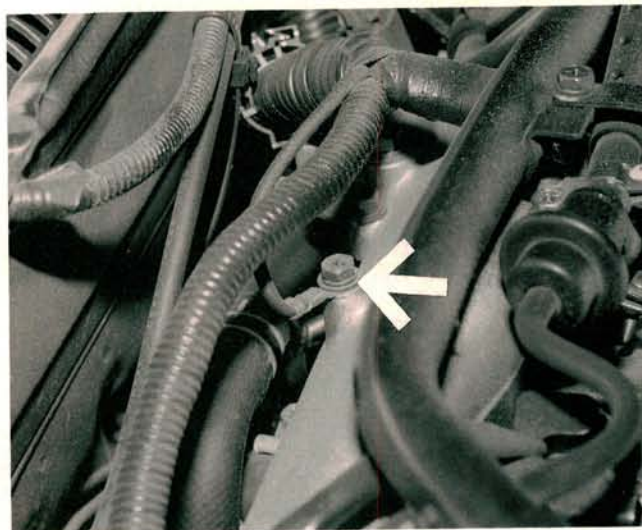
14 A loose or missing engine ground bolt (arrow) may cause an intermittent hard start on 1990 300ZX models. The engine may also run rough or the ignition power transistor may burn out, causing a no-start. This small but important bolt provides the grounding point for many components in the ECCS engine management system. Remove and clean the bolt and wiring harness eyelet connectors. Reinstall the bolt, using a drop of thread locker to keep the bolt from vibrating loose in the future.

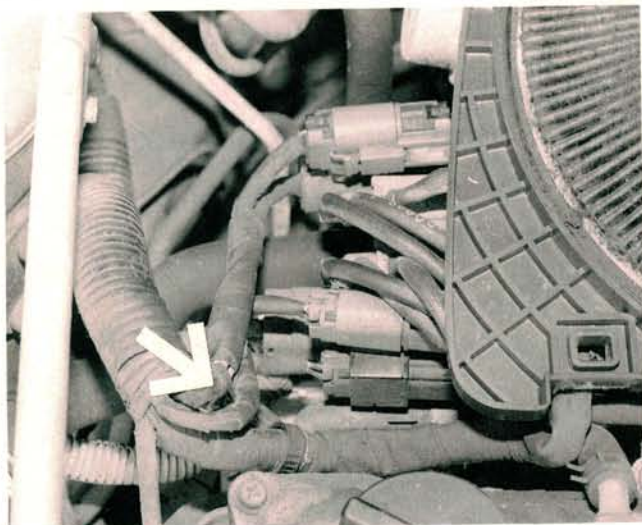
15 An open or damaged black/blue injector power supply wire may cause a no-start condition on fuel injected 1990 Sentra models. If there's no voltage at the injector connector, check for battery voltage at the injector dropping resistor. If battery voltage is present at the black/red dropping resistor supply wire, check the engine wiring harness on the right side of the engine for damage (arrow). The damaged injector wire may also short against the ground wire that's located nearby.

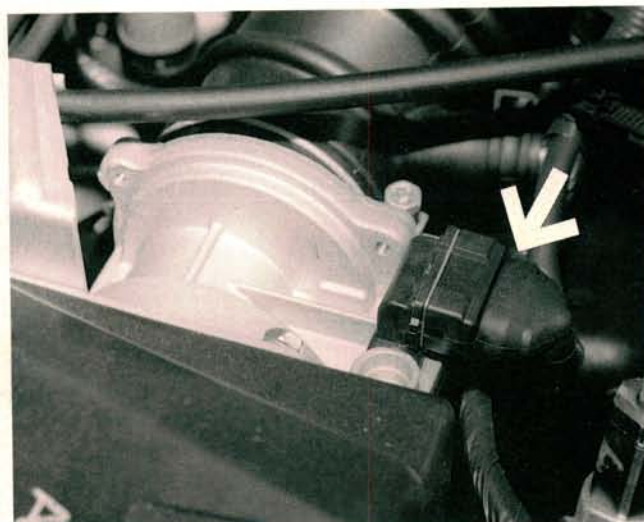
16 A poor connection at the air flow meter may cause hesitation or bucking on 1991-92 Sentra models. The hesitation usually occurs in drive, but not in reverse. Check the wiring harness near the air flow meter. Look for sharp bends in the wiring, a loose harness connector, or loose pins in the connector. Wiggle the harness to see if it affects the problem. Slit the harness cover and check for breaks in the orange or white air flow meter wires where they exit the harness shielding, and repair as necessary.

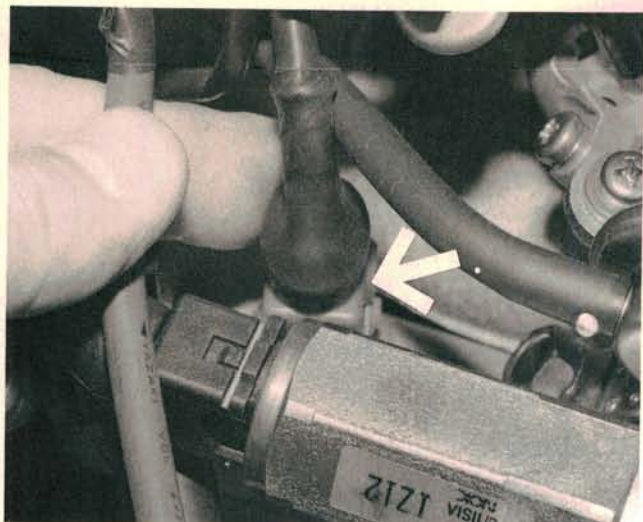
17

A poor connection at the engine temperature sensor may cause hard cold starting, spark plug fouling, or a no-start when cold on 1991-92 Sentra models. Once the engine warms up, it may start and run normally. Make sure both terminals fit the temperature sensor connector properly. Remove the connector and check for corrosion, soot, coolant, or other contamination inside the connector. If corrosion is found, remove the harness cover to check the wiring for further damage and repair as necessary.

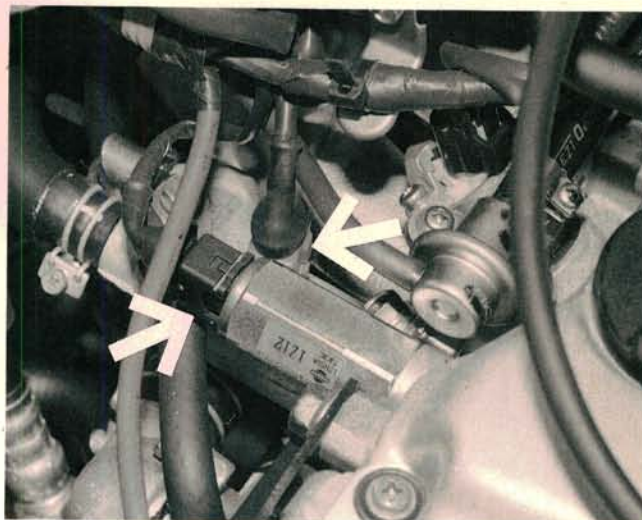
18

Reversing two engine wiring harness connectors on 1991 Sentra models causes the radiator fan to run whenever the ignition is on. The A/C is also disabled. The engine temperature sensor and valve timing control harness connectors are different colors (arrows), but they will fit the wrong component. Reversing the connectors makes the ECU think the engine is overheating, so A/C operation is disabled and the radiator fan switches on. Swap the connectors, then check the A/C and fan for proper operation.
