Our subject vehicle is a 1987 Legend with 63,000 miles on the clock. The present owner bought the car about 5,000 miles ago and was unsure of the past maintenance history. This can be an expensive gamble, especially where engine oil changes are concerned.

We will check many of the items that should be included in a 60,000 mile maintenance. While we're at it, we'll also highlight the few Legend problem areas that may crop up at this mileage.

Legendary Accuracy

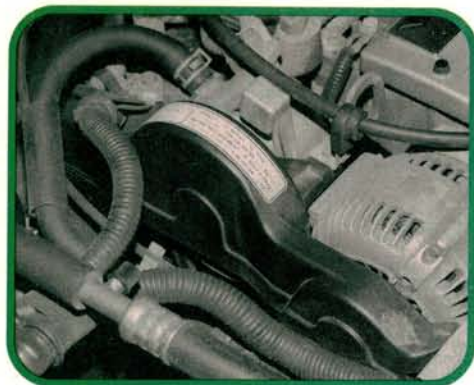
1

A timing belt replacement isn't necessary during a Legend's 60,000 mile maintenance. However, the belt wasn't meant to last forever. Our Acura sources "strongly urge" timing belt replacement at or before the 90,000 mile mark. The belt may outlast the idler pulley bearing and water pump.

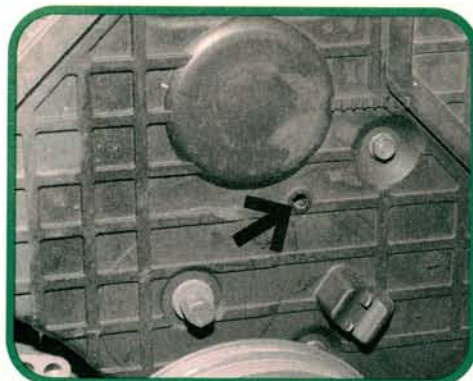
2

The first indication of a dying water pump may be coolant escaping through this weep hole in the front cover. The weep hole feeds directly from an opening in the water pump to keep water pump coolant leaks away from the timing belt. Always install a new timing belt when replacing the water pump.

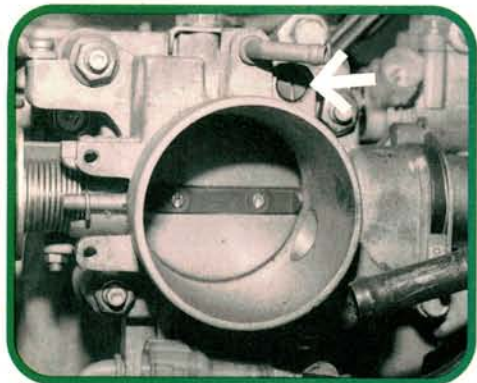
3

Remove the throttle housing air intake hose and check for throttle body deposits during a maintenance. A dirty throttle bore and throttle plate may keep the throttle from closing, causing an irregular idle speed. The base idle adjustment screw is located at the back of the throttle housing (arrow).

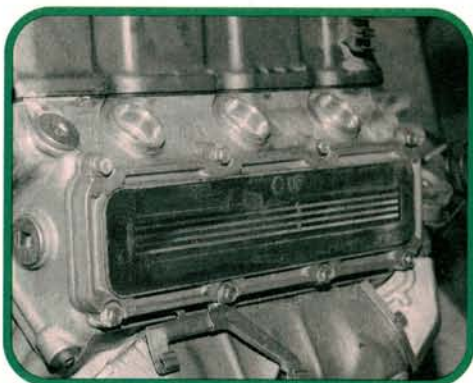
4

Legend engines have hydraulic lash adjusters, so periodic valve adjustments are not normally required. However, a complicated system of rocker arms and pushrods is used to relay the camshaft's intentions to the exhaust valves. Exhaust valve clearance can be adjusted at the exhaust rocker arms.

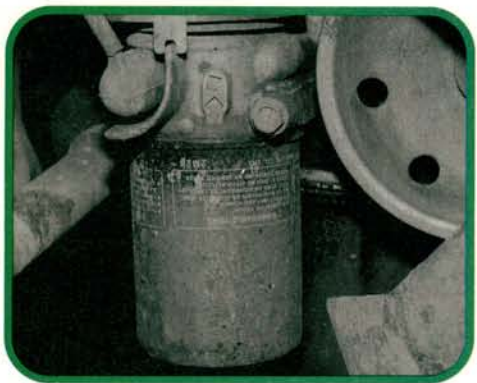
5

Dirty oil can cause a slow or sudden death for a Legend engine. A ticking lash adjuster when the engine is cold may indicate a sludged up engine. Clogged passages and oil starvation to the camshafts can also cause timing belt breakage. The cost of engine repair or replacement buys lots of oil changes.

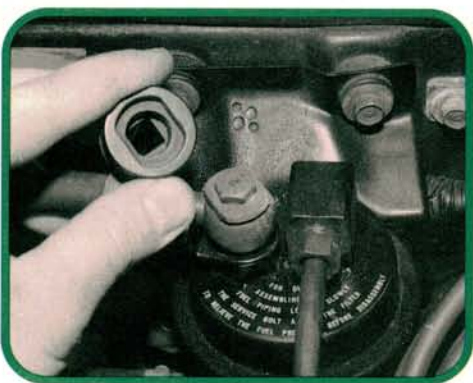
6

If you've ever replaced a fuel filter on a late model Honda, this oval shaped bolt should look familiar. Relieve the fuel pressure by first loosening the smaller hex bolt in the center of the oval main bolt. Cover the filter with a rag to catch any sprayed fuel. Use a backup wrench on the other line fitting.

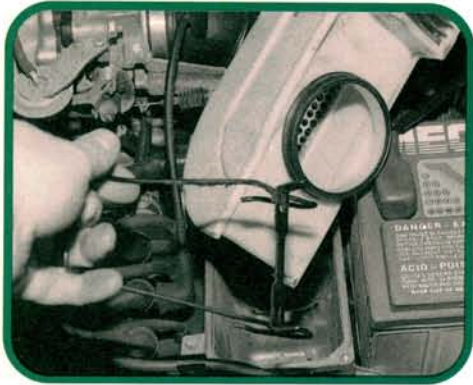
7

Remove the four air filter housing bolts, then remove the cover to access the filter. This is no one-size-fits-all filter. An opening at the bottom of the filter mates with the port leading to the throttle housing hose. A heavy spring wire holds the filter in position to seal the filter to the housing.

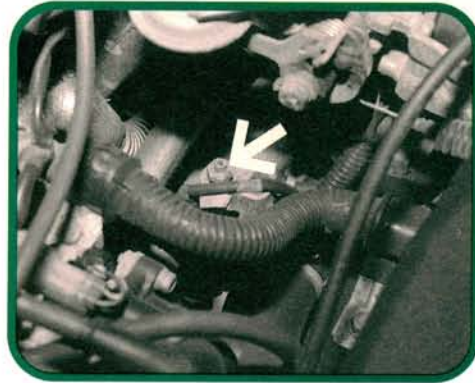
8

This bleeder screw below throttle housing (arrow) will help you get the air out of the cooling system during a coolant flush and fill. Open the bleeder screw, then add coolant to the radiator until coolant flows out of the bleeder. Close the bleeder, then finish filling the cooling system.

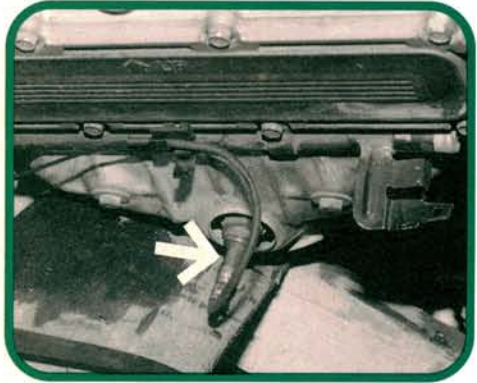
9

The single wire unheated oxygen sensors used on early Legend engine management systems have been known to die an early death. Two oxygen sensors are used, one for each bank of cylinders. The ECU monitors the sensors separately and will set either a code 1 or 2 if one of the sensors fails.

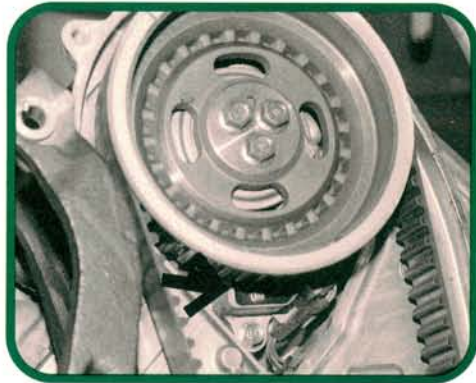
10

We also had reports of TDC position sensor failures on early Legends. A failed sensor will set a diagnostic code 8, but the engine should continue to run. The sensor is located behind the left camshaft pulley. Remove the timing belt cover, timing belt, and sprocket, then remove the sensor from the cam housing.

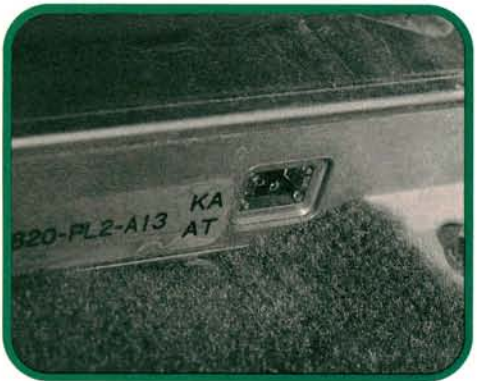
11

The fuel system ECU is located under the passenger seat and the transmission control unit is under the driver's seat. This makes them vulnerable to water damage, especially if you're in Southern California during the rainy season. Both control units have windows for diagnostic code reading.

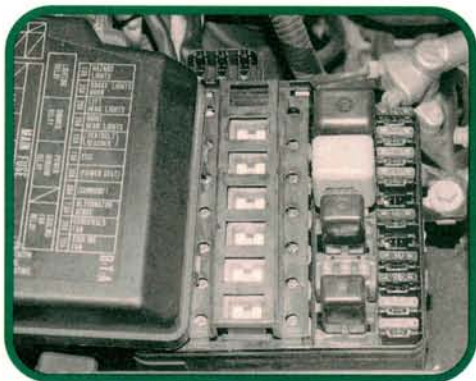
12

Disconnecting the battery clears all engine management system diagnostic codes, but will also erase all other electronic system memories. To clear only the main ECU's memory, locate the fuse panel next to the battery. Remove the ECU and Alternator Sensor fuses for at least a minute.

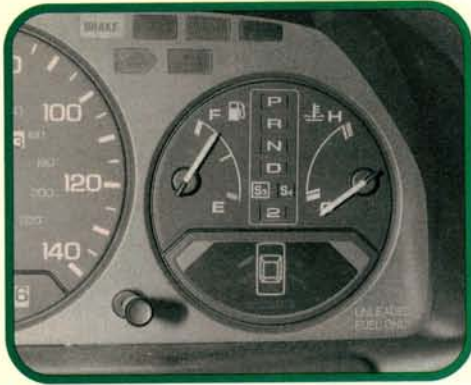
13

The transmission gear position indicator light in the center of the instrument panel will flash if the transmission control unit detects a problem with the transmission. Diagnostic codes can be read either at the transmission control unit, or by counting the flashes at the gear position indicator.

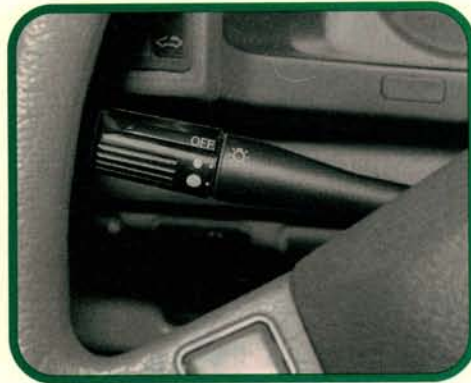
14

Intermittent operation of the turn signals, headlights, or parking lights may be caused by a bad steering column combination switch. In some cases, disassembling and cleaning the switch contacts will restore normal operation. If the contacts are damaged, switch replacement is a better alternative.

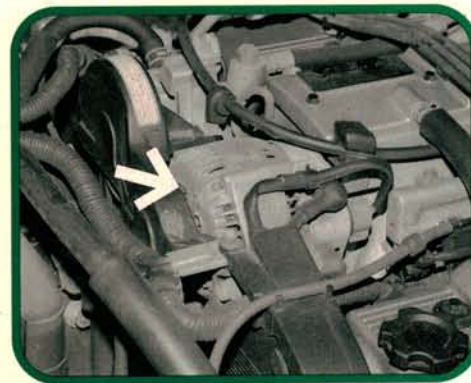
15

An updated alternator pulley and belt are available for 1986-88 Legends. Batteries discharged during slow speed, short trip operation because the original setup couldn't keep up with demand. The smaller diameter pulley spins the alternator faster for a higher charging rate at lower engine speeds.

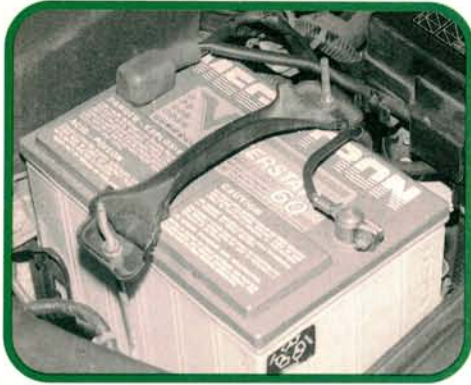
16

Batteries seem to have a shorter than normal life span, even if the small diameter alternator pulley has been installed. The Legend's many power accessories place a large load on the battery. Any replacement battery you install should be at least as strong, if not stronger than the OE battery.

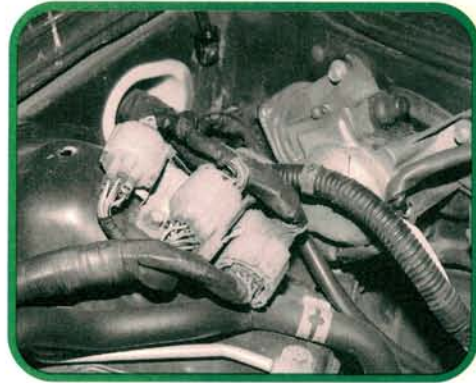
17

Engine compartment steam cleaning should be avoided. While the electrical connector insulators do a good job of protecting the terminals from normal underhood moisture, a high pressure blast of water is more than they were meant to handle. Intermittent electrical problems may soon follow.

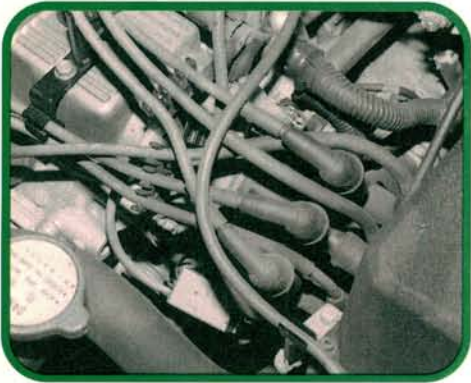
18

Some Acura specialists automatically replace the distributor cap and rotor as a part of their 60,000 mile maintenance. Rotor failures can cause the no-start and poor performance problems we've seen on other Honda products. Always install quality replacement parts to prevent later problems.

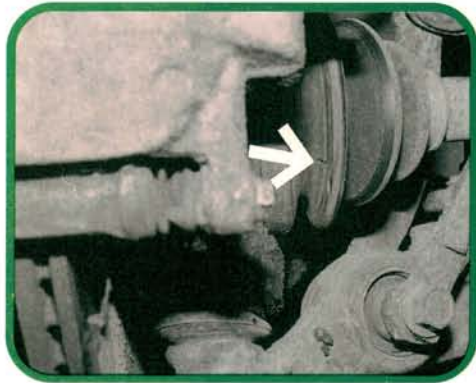
19

Check for torn outer CV boots whenever the car is on the lift for service. Torn outer boots are found more often than on other cars of the same age and approximate mileage. It may have something to do with the tightness of the turning radius putting a lot of stress on the boots.

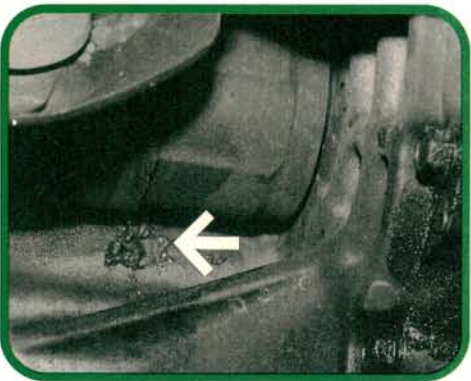
20

Inner CV boot bands may loosen over time, allowing CV grease to build up on the rear of the transmission case. If the customer complains of a burning smell, a leaking right inner boot may be throwing grease on the exhaust system. If either inner joint has been leaking, clean, repack, and re-band both joints.

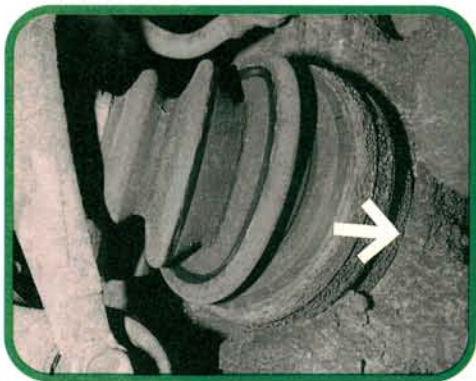
21

A loose front wheel bearing may cause a clunking noise while cornering. Press out the bearing and clean the knuckle bore. Apply a 12mm band of anaerobic thread locker to the leading edge of the wheel bearing. Press the bearing into the knuckle, then let the thread locker cure for several hours before driving.

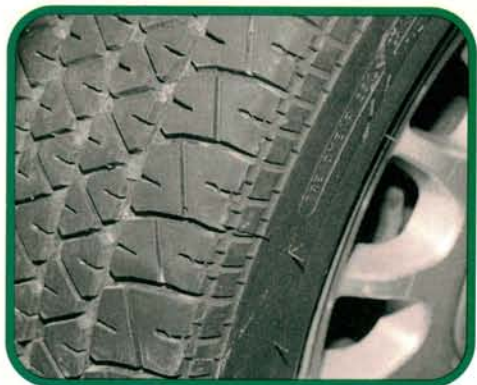
22

Tire size, design, manufacturer, and wear can all have an effect on Legends equipped with ABS. For the fewest problems, a complete set of tires from the same manufacturer should be installed. Rotating the tires regularly to maintain even wear will also prevent problems with brake pull and steering drift.

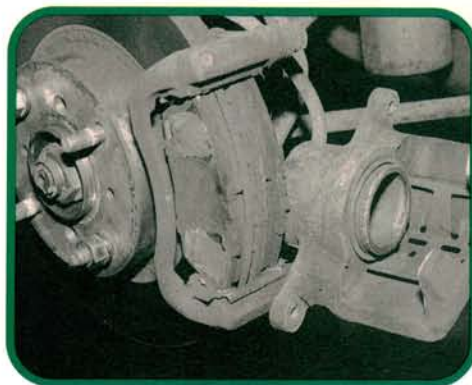
23

Every shop can't afford an on-the-car brake lathe, but Acura specifies it for all rotor resurfacing. Machining variations between the rotor and hub may cause a brake pulsation if the rotors are resurfaced using an off-the-car lathe. The difference between new and replacement front rotor thickness is only 2mm.

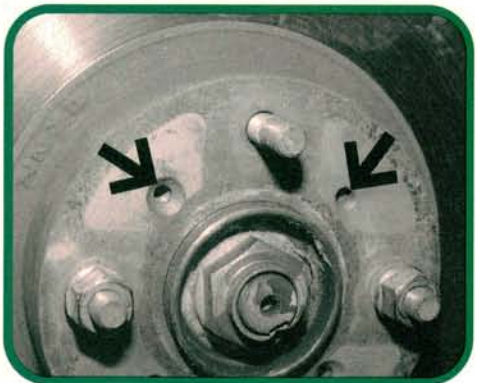
24

This Legend had a severe front brake pulsation. We knew the rotors had been removed because the retaining screws were missing and the rotors were improperly indexed to the hubs. If you must resurface rotors off the car, mark the rotors for position before removing them. This prevents stacked tolerances.

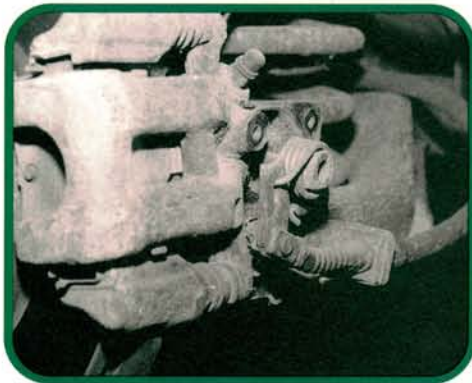
25

Rusted rear parking brake cables may bind and wear out the rear brake pads. The rear brakes are adjusted for wear each time the parking brake is applied. A low brake pedal may be caused by an owner who never uses the parking brake, especially on automatic models.

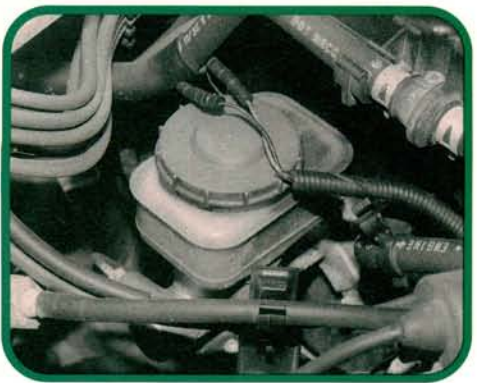
26

Flush and fill the brake fluid at 60,000 miles. This is especially important on ABS equipped Legends. Water and sediment in the brake fluid can bind up the ABS actuator and pump. Damaged ABS pumps make an expensive noise when the ABS tries to actuate. Replace the ABS high pressure hose at 60,000 miles too.

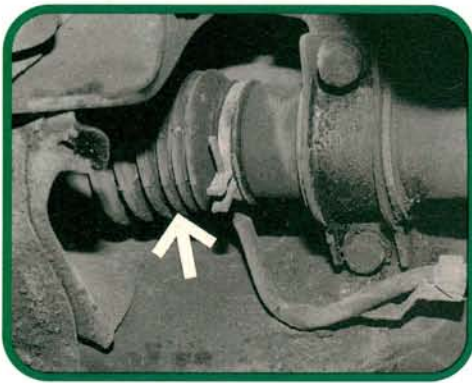
27

Leaking power steering rack seals can cause fluid to accumulate in the outer rack boots. Squeeze the boots to check for fluid inside. A fluid leak on the right side of the rack may be mistaken for an engine oil leak because the right rack boot is very close to the engine oil filter housing.
