Repair Shop

Episode Two: The Case of the Two-Stepping TPS

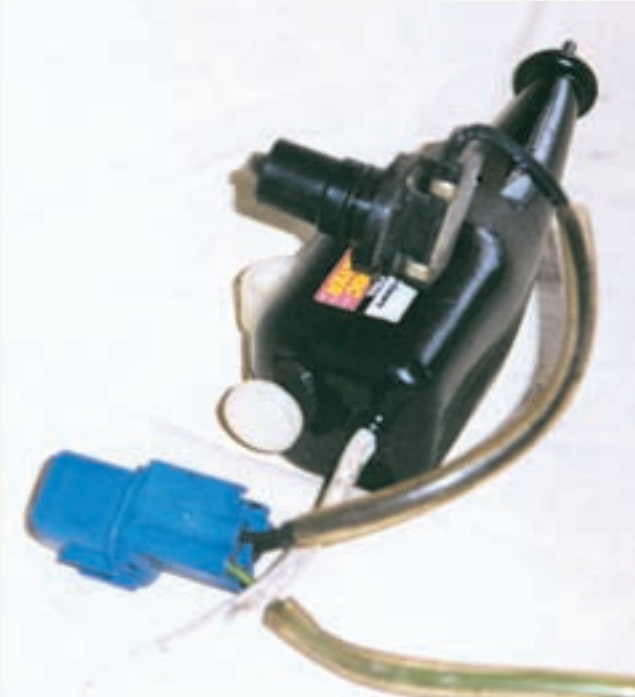
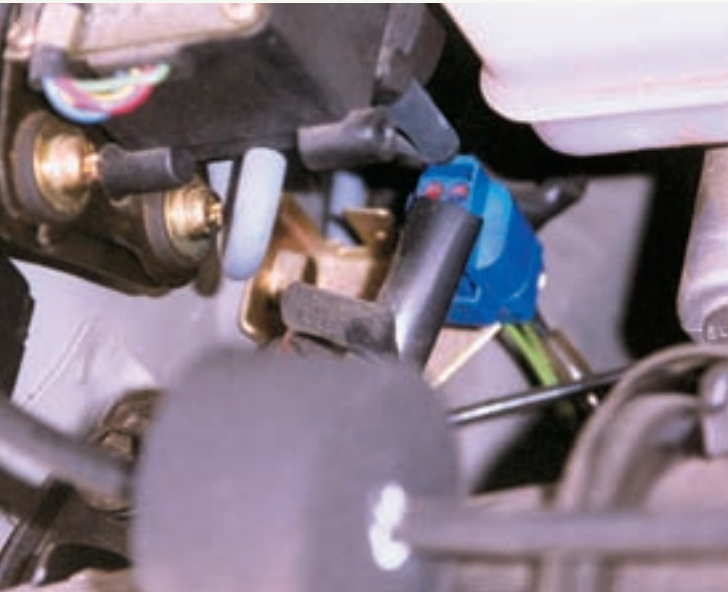
Here is one of the easy-to-see pulse generator connectors. Not the same as the one in the story — this one is actually on a Sonata. It is liable to suffer from the same 'loose-connector syndrome' because the wiring in the lower half (the pulse-generator side) hangs from the bracket. Over time and miles, vibration and transaxle movement may cause the male side of the connection to become loose inside the female side. An intermittent connection may develop.

Left: If only real life were this easy! The idea is to get the coil of the engraving pencil to induce a voltage through the windings of the component tested. An engraving pencil is a good choice because of its relatively small size, low temperature operation and hands-free on/off switch.

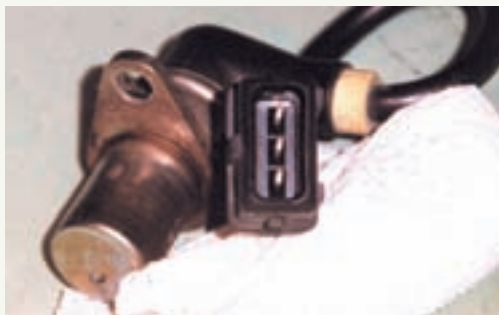
Yep, it's a crank sensor. So, what's it doing in a story about TPS's? The three metal pins inside the connector have been twisted about fifteen degrees to restore a tight fit to the main harness. Doing this cured a 'no-start' problem.
