FACTORY SERVICE BULLETINS

These suggestions and solutions for technical problems come from service bulletins published by Mercedes-Benz, selected and adapted for independent repair shops.

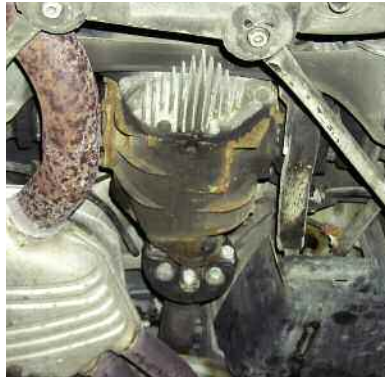
07.3-87011

Snapping or binding in rear axle when cornering or parking, all models with ASD

ASD is the automatic locking differential system, and a resistance to different wheelspeeds is an inherent part of the design. If, however, the binding or snapping is too strong for the motorist, this can be remedied by removing one friction plate per side from the differential clutch packs and replacing it with a special steel plate kit, part no. 140 350 64 23. To do this, you must remove the differential

assembly entirely, open the housing and exchange the friction discs for the steel plates.

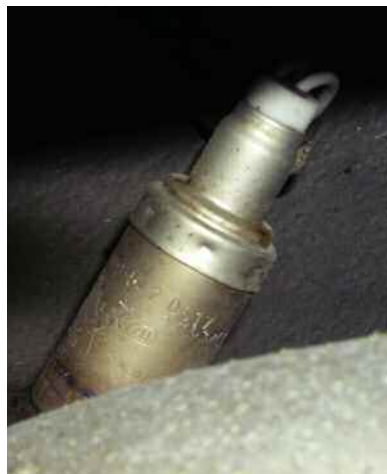
AF80.20-U-6094A

No EHA ratio adjustment and CEL on, all CIS-E engines

This unwanted new problem can be very irritating right after you've done some other job the car badly needed, not infrequently exhaust work. Here's how to solve the problem the repair caused: The most

probable cause of the problem is an intermittent or permanently nonfunctional oxygen sensor. Test for that by monitoring the oxygen sensor signal while driving (steady speed, engine at normal operating temperature, etc). Make sure the intake and exhaust systems are tightly bolted to the cylinder head and engine block. Make sure all negative electrical connections, as well as the manifold and flange bolts are tight and electrically conductive. Loosen and then retighten the oxygen sensor to be sure there's electrical conductivity through the exhaust system. If you're in doubt about these procedures, read the technical literature for removal and installation of the exhaust system before you tighten the manifold bolts.

Next check the coaxial cable between the oxygen sensor plug (G3/2x2) and the CIS-E control unit pin 8 is not shorted to ground. Do this by unplugging the control unit and checking the resistance between socket 7 and socket 8. You should find a resistance above 10 kOhm, i.e., infinite. Otherwise replace the corresponding section of the engine harness.

Another possibility is a loose connection or intermittent connection at the connector sleeve Z, a solder joint in the harness, in the CIS-E control unit connector. In that case, you can merely open the plug and resolder the connection at connector sleeve Z on socket 7. Mercedes-Benz recommends checking Diagnostic Manual Volume 2, Engine 102 (available from the company): Tests GE-04.01 and GE-04.05, tests GE-07.01 and GE-07.05. For engines 116 and 117, tests GE 08.01 and GE-08 .05.

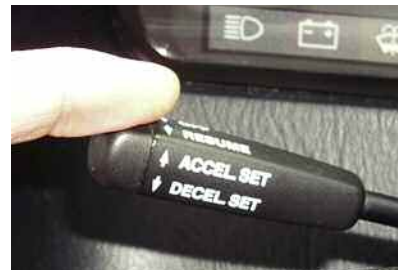
Engine surge in cruise control during 'decel,' Engine I02.96/98, I03

If a vehicle with either the I02 or I03 engine surges while the cruise control lever is held in the 'decel' position, shortening the connecting rod to the cruise control actuator by 2 - 3 mm (2 - 3 turns) from the slack position should correct the problem.

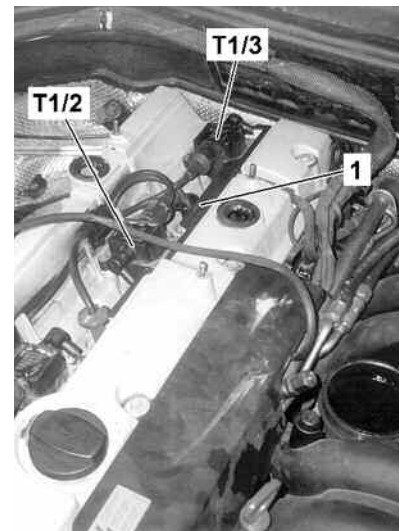
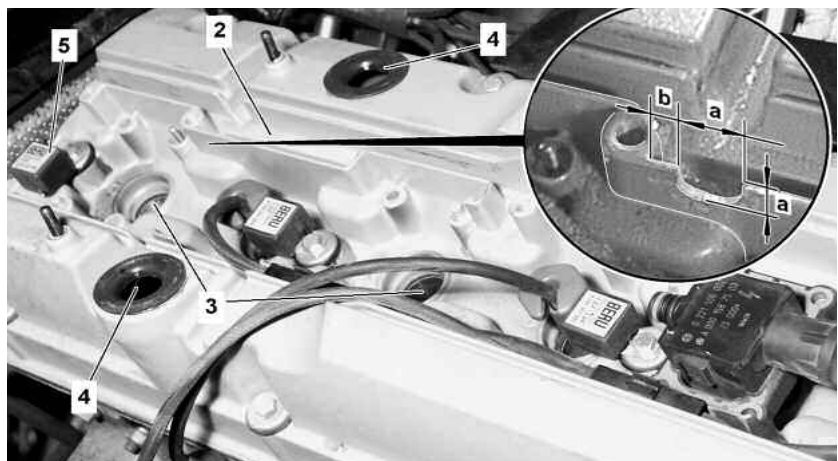
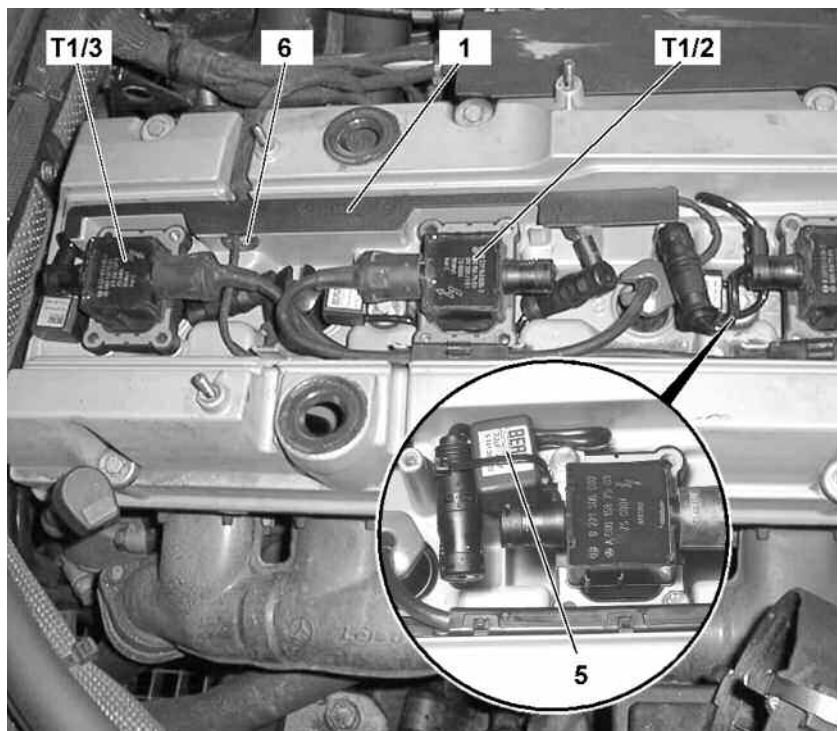
Installing interference suppression filters, engine 104

Sometimes the only way to quiet a radio is with ignition suppression capacitors or filters. To install ignition interference suppression filters, first remove the intake air pipe and the ignition wire shaft cover. Then remove the ignition coils T1/2 and T1/3. Next remove cover 1 and remove the wires from the cable shaft (2). Plug the openings in the valve cover (3 and 4), before you cut out sections in the cable shaft wall. Dimension *a* is 10 mm; dimension *b* is 7 mm. Install

the interference suppressors (5).

Re-install the ignition coils and connect the interference suppressors in the circuit 1 feed lines for the ignition coils. Route the electrical lead for ignition coil T1/3 through the cutout you made with a protective sleeve. Make sure the leads for the interference suppressors for both coil T1/2 and T1/3 are below the ignition coils, but do not pinch the wires. Finally, re-install the cover, the ignition cable shaft cover and the air intake pipe.

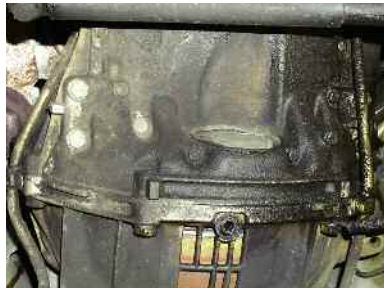
Oil leaks from rear of oil pan

Sometimes there is insufficient clamping force between the rear section of the oil pan and the lower casting of the engine block. But you can't just crank down harder on the fasteners because they have a specific torque assigned to them for proper force without stretching or distorting. If you find a vehicle with oil seepage at the back of the engine as shown here and your customer wants to correct the situation, besides replacing the oil pan gasket with a new one, apply Loctite 5900 sealer in the area in the photo, the back section of the mating surfaces between the pan and the block. Follow the original torque specifications in your service material for the fasteners, however, when completing the repair.
