FACTORY SERVICE BULLETINS

These suggestions and solutions for technical problems come from service bulletins published by Daimler-Benz, selected and rewritten for independent repair shops.

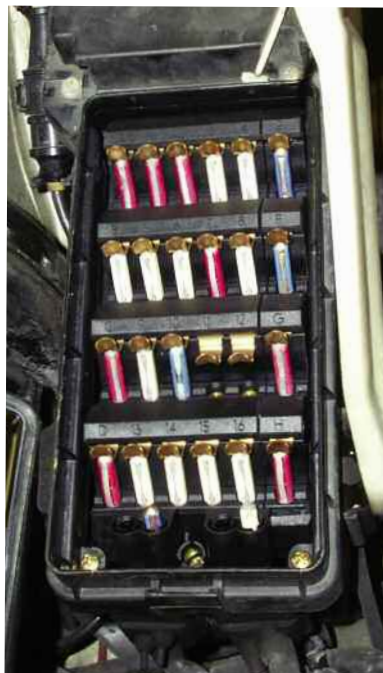
Moisture in fuse and relay box Model 124

A leak in the fuse box lid or through the rubber boot around it may allow moisture to collect in the fuse box, a condition that could eventually lead to corrosion and harness component failure. If you find a car with that condition, first remove the fuse and relay carrier and the fuse box. Replace any parts damaged by the water. Then drill a 6 mm hole in the place indicated in the illustration, the lowest point in the fuse box [P00.00-1072-01 or photograph]. Check the fuse box cover and the gasket and seal all the rubber boots on the box for leaks with sealing compound as needed.

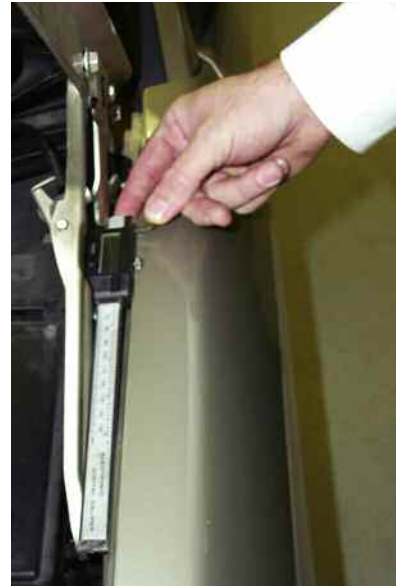
Hood hinge test All models

Here's a quick and accurate test to see whether a hood hinge has been damaged on a Mercedes-Benz vehicle: Place a short (150 mm) ruler or straightedge against the outside surface of the hinge, with the hood at the 45-degree position. If the gap between the hinge and your straightedge is 0.0 to 0.2 mm or less, the hinge is good. If the gap is greater, the hinge is bent.

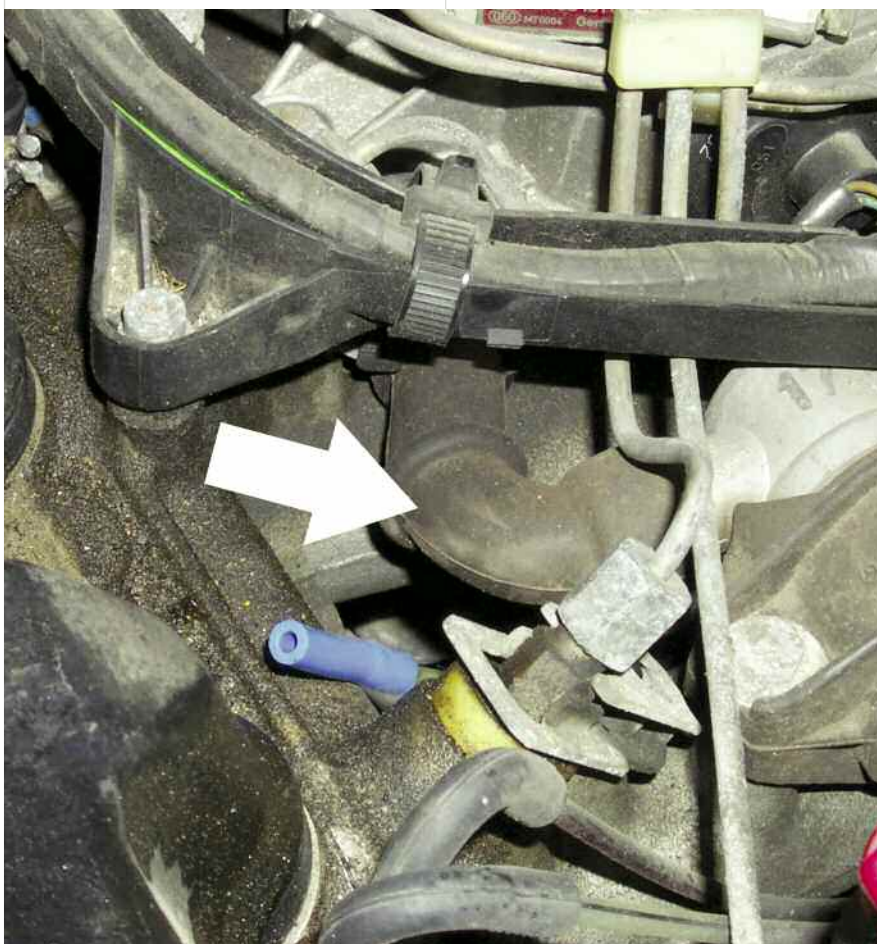
**No start
Engines 102 and 103**

Add to your no-start checks this one: If there was a backfire the last time the engine was running, it is possible the molded hose at the

idle air valve (above) fell off, allowing excessive unmeasured air into the intake manifold. While you're inspecting that hose, confirm that it does not have damage from being swollen or cracked.
