## FACTORY SERVICE BULLETINS

**These suggestions and solutions for technical problems come from service bulletins published by Mercedes-Benz, selected and rewritten for independent repair shops. Your Mercedes-Benz parts source can obtain any designated by parts number.**

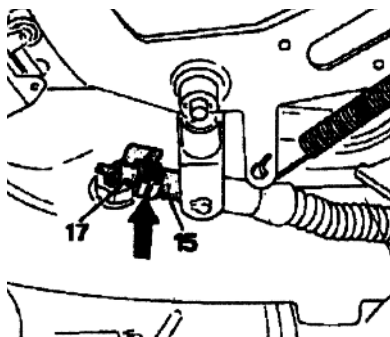
Early full-load upshifts.  
Downshifts delayed.  
Model 124 with  
transmissions 722.3 /4 /5

If the control pressure slide valve travel is insufficient, you can get just these symptoms. To set the adjustment correctly, make sure the accelerator lever on the throttle valve housing or the fuel injection pump rests against the full-load stop with the pedal fully depressed but not to the kickdown position.

On some vehicles with engine 102, the adjusting screw is too loose and does not maintain the adjustment. On them, pull off the accordion boot from the control pressure cable and press the cylindrical extension of the knurled adjusting nut together until the nut is hard to turn or works like a clicking detent when turned.

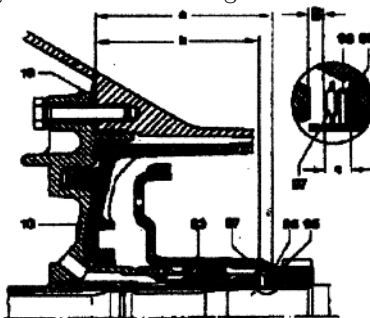
Transmission noise when  
coasting or in reverse

Unusual transmission noises on the vehicles affected may come from wear at the thrust bearing of clutch K1. The first indications of this is grinding audible when coasting or in reverse. Remove the transmission pan and check for steel shavings. Replace the transmission if you find any.

If not remove the valve body and large intermediate plate. Replace the transmission if you find steel shavings on the intermediate plate. Flush the torque converter and transmission lines anytime you find such shavings.

In the absence of shavings, remove the transmission, remove the front cover and replace the thrust washer and compensating shim. Measure the axial play of clutch K1 and correct if needed (see job 27-640, step 83). Flush the torque converter and coolant lines clean. If you find steel shavings in the cleaning fluid (usually kerosene), replace the torque converter.

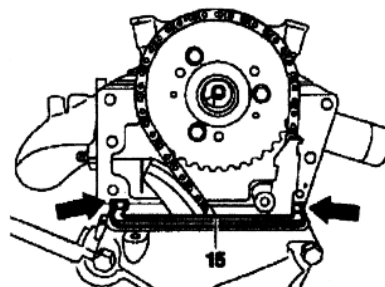
Oil leakage at  
top front cover

If oil leaks where the five parts meet between the cylinder heads gasket and the cover gasket, remove the top front cover and its gasket. Apply one drop of Loctite 5900 sealant to the right and left ends once they're entirely oil-free. This fills the gap between the cylinder head gasket and the cover gasket. This repair can't work if the parts are not entirely free of oil!

Dry the new cover gasket and insert it into an oil-dry groove in the timing case. Don't use sealant here. Lubricate the top of the gasket lightly with oil so the front cover can slide over it without damage to the gasket. Apply a thin layer of Loctite 5900 to the surfaces of the front cover that contact the cylinder head.

Press all parts joined with Loctite together for ten minutes or you can't be confident of the leak-tightness of your repair. Should this repair fail, the next step requires replacement of the cylinder head gasket.
