FACTORY SERVICE BULLETINS

These suggestions and solutions for technical problems come from service bulletins and other technical information published by Mercedes-Benz, selected and rewritten for independent repair shops.

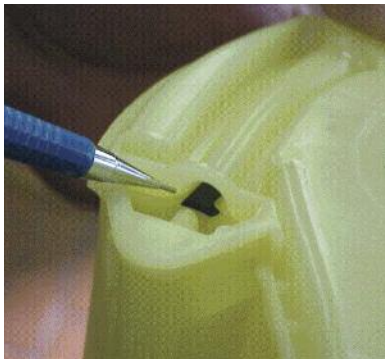
E-Class engine performance problems/Check Engine Light with Code(s) P03xx

If you encounter an E-Class vehicle (W210) with a complaint of engine misfire/lack of performance with a low fuel level (below approximately one-quarter tank) and/or “Check Engine Light” (MIL) activated with code(s) P03XX (misfire detection), a possible cause is a lack of fuel supply due to an obstructed opening to the fuel pump in the splash bowl. If the tank level at the time of misfire was low, it is possible that the condition was caused by insufficient fuel entering the splash bowl, thus failing to feed the fuel pump. This is probably due to foreign material blocking the fuel supply hole. During a low fuel level condition, fuel enters only through the supply hole at the bottom of the splash bowl.

Note: Make sure the codes are stored with fuel level at one-quarter tank or below (see freeze frame data), i.e. below the top of the upper splash bowl rim, and that no fuel can enter the splash bowl from the top opening. If the misfire can be duplicated and/or misfire code(s) are set again during the procedure in Step 4 and 5, or fuel pressure starts to fluctuate during procedure in step 4, replace the fuel tank. If, on the other hand, during Step 4 no misfire is observed and/or no misfire code is set, and the fuel pressure remains stable during Step 5, the cause for the customer complaint is something other than described above and needs to be further diagnosed.

1. Ensure all related systems are working and within specifications – repair as necessary.
2. With your scan tool, check the freeze frame for “fuel tank level.” Write down the freeze frame data and clear OBD memory.

3. Lower the fuel level in the tank to approximately the same level or lower than indicated in the freeze frame.

4. Try to duplicate the condition as far as load and rpm are concerned as indicated on the freeze frame and see if the engine misfires and a code is set.

5. Connect a fuel pressure gauge and drive the car with high load/rpm while monitoring the fuel pressure. It should remain constant.

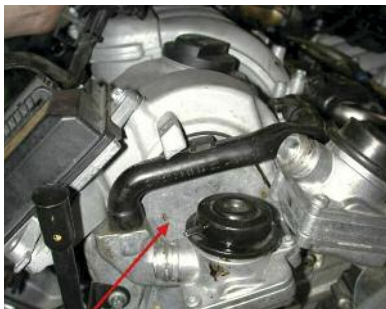
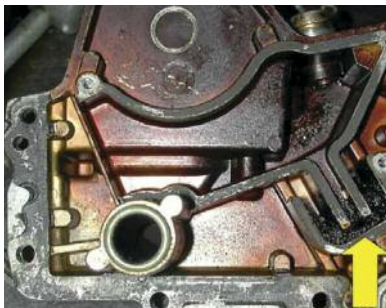
M137 Engine Running Complaints With Blue Smoke and/or Hydrocarbon Odors During First Start Up

Engine running complaints/misfire in conjunction with blue smoke and hydrocarbon odors for several seconds during first start-up, and/or an excessive amount of standing oil in the intake manifold with an M137 engine may be due to a PCV (positive crankcase ventilation) System intake assembly (front cover, right cylinder head) oil condensation drain that is clogged with oil sludge.

Remove and disassemble the front cover assembly of the right cylinder head (refer to WIS document AR01.30-P-5700L, up to and including step number 14). Inspect the oil condensation drain for clogging and clean out the oil sludge blocking the drain. Reassemble and reinstall the front cover assembly of the right cylinder head.

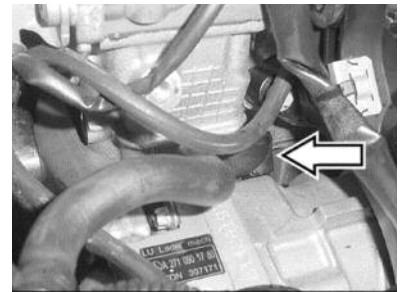
C230CL 1.8 Kompressor Engine Performance Complaint

Engine vibration, rpm fluctuations at idle, or poor accelerator response along with codes P2020 (P0172), P2046, P201C or P201A may be caused by a tear in the partial load vent hose at the connection to the crankcase. Air will bypass the mass air sensor – i.e. unmeasured air will enter the intake – causing the engine to run lean.

1. Remove the supercharger. Refer to WIS document AR09.50-P-4705OK.

2. Remove and install partial load vent hose for crankcase ventilation.

3. Install the supercharger according to the WIS document above.

Note: Use a “click clamp” as specified in parts information for securing hose. Ensure that the clamp is positioned as close to the end of the hose as possible and fastened tight.
