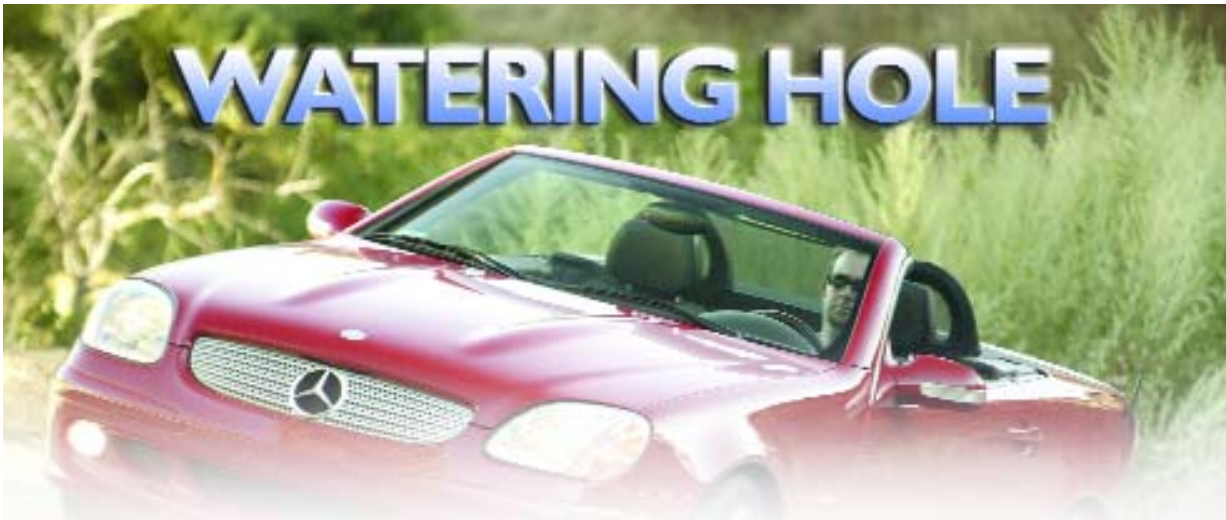
You're starting to see where we're going with this? How about strange malfunctions in the central locking system and the anti-theft alarm (ATA) of SLK models? The uninvited moisture has a way of penetrating the electrical connectors at the pump, migrating along the wires or the pneumatic line. This raises havoc and causes consternation among technicians presented with complaints about glitches in these two security-related systems.

But how is the water getting into the trunk where it doesn't belong? In other words, you've got to locate the leak. First, perform a water penetration test using a garden hose. In the SLK, a possible entrance point is the rear seal of the Vario roof. Water penetrates from under the seal and over the metal fold into the trunk, then drips onto the trim and runs along the longitudinal member and the cables into the pump's connector. The seal has an elastic sealant (except for over the metal fold). This might not be sufficient. The seal or the metal fold may be too small, or maybe the metal fold is wavy (the seal can't compensate for the waves).

Another potential leak point is between the Vario roof rear lower seal the trunk seal on the quarter panel (they cross over each other). Perhaps the shell of the vehicle is not within the specified dimensions in this area (especially the metal fold for the trunk seal) so that the seal "tips" to the side when the trunk lid is closed. Or maybe the seal for the roof or the trunk is not within specs.

There is also the possibility of leaks at the water drain hose of the rear fender. The water runs between the seal and the body cutout because there is not enough clearance for the seal. This may be the result of the seal not been snapped into place properly. Or, perhaps the cutout isn't within the specified dimensions, or the seal groove is too big.

So, before you go crazy following wiring diagrams and trying to outguess the electronic logic, do a simple visual exam – as they say in the medical profession, look for horses before you look for zebras. If you find H<sub>2</sub>O at the pump, pull the harness connectors and see if the terminals are wet and/or corroded. Clean them thoroughly, or replace the metal contacts. A moisture-dispersing spray will help. Chances are good this will be the fix.

Regardless, fix the leak, then install the repair wiring harness (Part Number A170 540 35 09) and rotate the pump 180° from its original position – refer to WIS document AR80.20-P-2710G. This lengthens the lines and forms a loop so that the water that would otherwise run down the lines will now drip off at the lowest point of the loop.
