FACTORY SERVICE BULLETINS

These suggestions and solutions for technical problems come from service bulletins and other technical information published by Mercedes-Benz, selected and rewritten for independent repair shops.

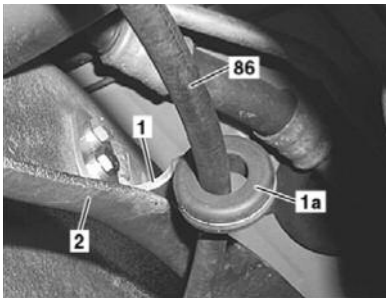
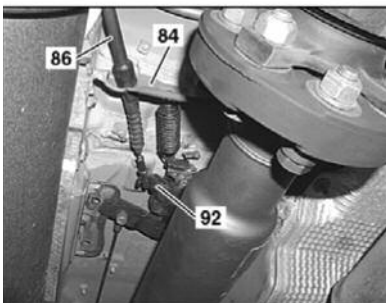
Noises from Parking Brake Cable

CL and S-Class, '00 through '04

A complaint of a noise coming from the rear of the vehicle may be due to a broken parking brake cable bracket. The original brackets are welded to the rear axle carrier and may fail from normal vibration, allowing the cable to rattle against the carrier or the sub frame.

Replacement brackets bolt on. Use the following procedure:

1. Pretension the parking brake's automatic cable slack adjuster (92 in the illustration). Refer to WIS document AR42.20-P-0520-01A.

2. Unhook the left and right parking brake cables (86) from the automatic cable slack adjusters and unclip them from the retaining plates (84) mounted on the undercarriage (Unclipping Tool W129 589 11 63 00 is available).

3. Bolt on the new brackets (1), then install their rubber grommets (1a). You can make grommet installation easier by coating them with liquid lubricant (Naphtolen H, BR00.45-Z-1003-06A).

Note: Always replace both brackets even if only one is broken. Break off an unbroken bracket by bending it back and forth until the metal fatigues to failure, then file or grind down any sharp edges on the carrier.

4. Clip the left and right parking brake cables into the retaining plates and hook them back into the automatic cable slack adjuster.

5. Slacken the automatic cable slack adjuster. Refer to WIS document AR42.20-P-0520-02A.

Note: On vehicles that do not have pre-drilled holes in the rear axle carrier (2) for the brackets, you'll have to drill your own. Refer to WIS document AR42.20-

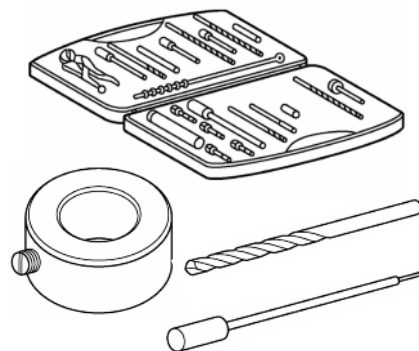
Repair Kit for Glow Plug Threads in Cylinder Head

Save that expensive cylinder head! A repair kit is now available for damaged glow plug threads and/or broken off glow plugs. It makes it possible to accurately drill out the glow plug bore and install a threaded insert.

The repair kit can be ordered as a Special Tool (611 589 00 99 00), and costs \$650. Also, the wear and tear components of the kit can be individually ordered as needed, along with additional replacement threaded inserts.

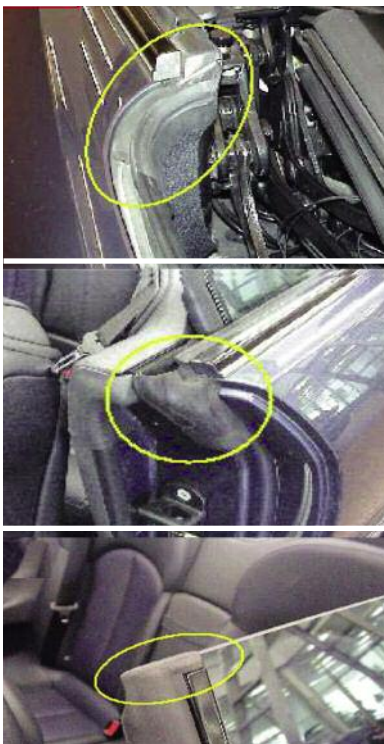
Cracking Noises from the Soft Top Seals with Roof Closed

CLK

This noise is probably caused by the sliding coating on the seals wearing at differing rates. If the coating is worn away, the seals can make cracking sound at the contact points while the vehicle is being driven.

It is not necessary to replace the seals to quiet things down. Instead, treat the areas shown in the illustrations with special sliding compound (A001 989 50 51) as follows:

1. Clean the contact points on the seal on both sides.
2. After cleaning, apply the special lubricant to the dry seal and allow it to soak in for approximately 20 minutes.
3. Open and close roof several times.
4. Remove any of the excess lubricant.

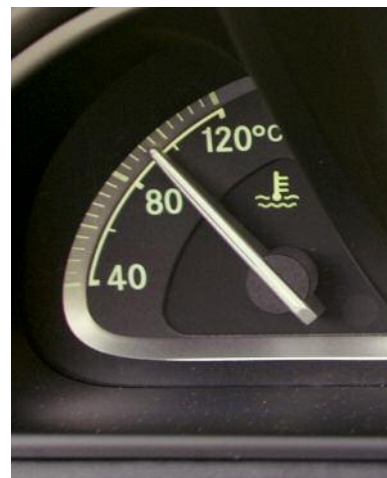
Tire Pressure Monitoring System Implausible Fault Messages

SL500

Implausible fault messages in the instrument cluster and/or implausible body electrical system function in Model 230.475 vehicles may be the result of a hardware fault in the tire pressure monitoring system control unit, which may impair CAN-B operation. This can cause malfunctions in the

instrument cluster and display instruments (jumps in fuel level or temperature indicator, for example). Various warning and fault lamps may go on and off in cycles, or exterior lights switch on and off without obvious cause. Depending on the duration of the malfunction, fault codes (CAN communication disturbance) may be stored in various control modules linked to CAN-B, such as tire pressure monitoring, SAM, EIS, lower control panel, vehicle power supply control module, automatic air conditioning, instrument cluster, etc.

The solution is to replace the tire pressure monitoring control module (N88), Part Number 001 820 95 26.
