FACTORY SERVICE BULLETINS

These suggestions and solutions for technical problems come from service bulletins and other technical information published by Mercedes-Benz, selected and rewritten for independent repair shops.

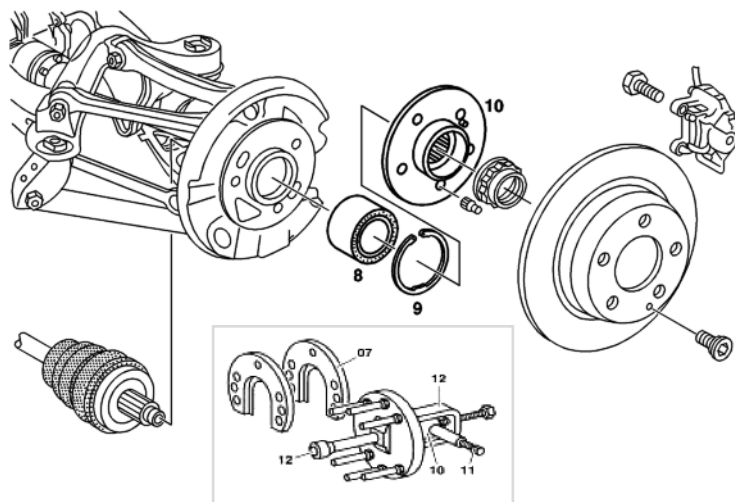
Modification of Special Tool for Pulling Axle Halfshaft with Double-Row Tapered Roller Bearings on Models 124.090/092/193/290

These models have a rear axle halfshaft with double-row tapered roller bearings. These bearings can only be pressed out of the rear halfshaft flange with the wheel carrier removed from the vehicle, then by the use of a stationary hydraulic press.

These bearings require an extraction force three times that required to pull the double row ball bearings used on

other models. The regular M-B puller (Special Tool number W202 589 04 43 00) is not designed to handle such forces. As a result, the removal of rear axle half shafts with the double-row tapered roller bearings is not possible.

The special tool puller must be modified with a shear pin, which is installed at the pressure screw of the hydraulic press. The shear pin will shear at a force of 40 Nm, thus preventing any further pressure build-up at the hydraulic press and making the operation (except on Model 124.090/092/193/290) safer (the pin will shear). The modified pressure screw is available with the shear pin as a spare part under Special Tool Part Number W202 589 04 43 11.
