FACTORY SERVICE BULLETINS

Anti-Corrosion Coating on New Brake Discs

Steering Wheel Twitch During Brake Application

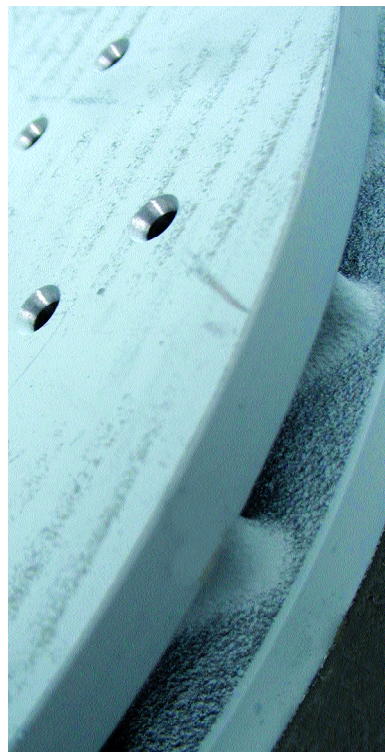
If you've been buying new O.E. rotors from your local Mercedes-Benz dealer's parts department, you've noticed that they're covered with a flat gray anti-corrosion coating. It seems that some technicians are worried that this may cause braking problems, and perhaps contaminate the new pads, so they spend time removing the coating with various solvents, mild abrasives, and even steam.

This is an entirely unnecessary waste of time. True, the old protective coating used over a decade ago (a blue glaze) did need to be eliminated before the rotor was installed, but the present day coating is effectively removed during the first brake application and will not affect the performance of the brakes.

However, you may notice the following conditions immediately after these new discs are installed:

- Braking-related noise during the first few brake applications.
- Parking brake squeal (parking brake not applied) with

moving vehicle until the brake shoes are seated.

- Odors related to the first time the brakes are used with substantial force.

These conditions will disappear after applying the brakes several times. Therefore, a thorough test drive by the technician before delivery to the customer is recommended to avoid unnecessary complaints.
