FACTORY SERVICE BULLETINS

Leak at Steering Rack Connection

Models 203, 209, 211 & 230

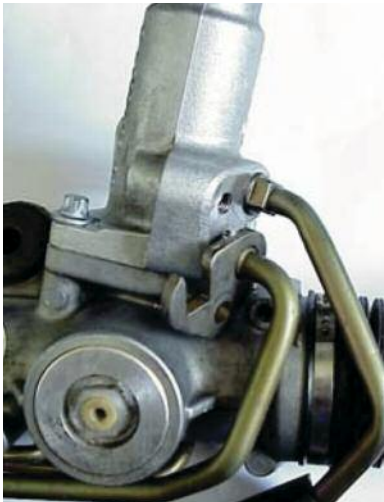
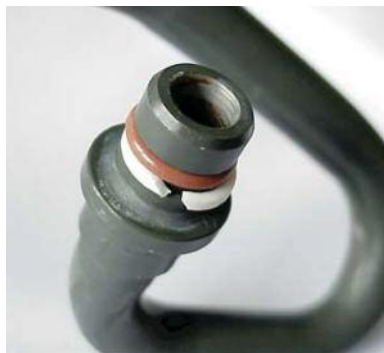
If you encounter leakage at the steering rack connection in the above models, the cause may be damage to the sealing ring of the hydraulic lines. In such instances, replacement of the rack will not resolve the situation. Instead, replace the

sealing ring at the steering gear connection. Refer to complete work instructions (including torque values) in WIS document AF46.20-P-4044AU. The parts needed are two O-rings (A 027 997 95 48) and one supporting ring for the steering rack high-pressure line connection (A 005 997 76 40).

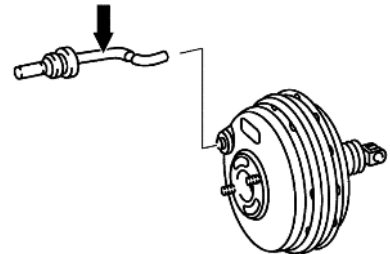
If the brake pedal is hard to apply on these models, the cause is probably a combination of cold start vacuum equalization, engine fast idle necessary for catalyst warm up, and vehicle position.

1. Replace the existing brake booster hose with the modified brake booster hose (part number A 170 430 1729 for Model 170.447 and A 202 430 6029 for Model 202.024).

2. Replace the existing crankcase vent hose between the oil separator and the air filter housing (Figure 2) with the modified crankcase vent hose (part number A 111 018 33 82 for Model 170.447 and A 111 018 31 82 for Model 202.024), and connect it to the venturi on the brake booster hose.
