FACTORY SERVICE BULLETINS

Cannot Aim Headlights Model 220 as of model year 2003

ESP Ground Connection

Fuel Tank Noise

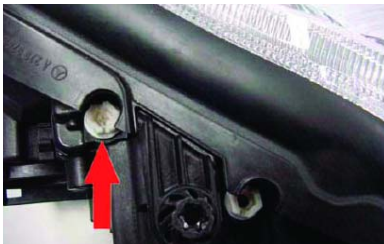
If the low beam or fog lights are always too high or too low, no matter how much you adjust them, the connection between the low beam and fog lights may be disconnected. To fix the problem:

1. Adjust fog lamp using vertical adjusting screw.

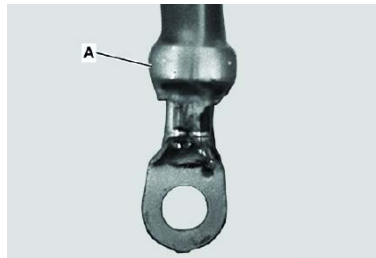
Connector:

The ESP ground connection, located just ahead of the left shock tower, may not be properly installed. The ESP control module harness plug should also be checked for moisture intrusion.

7. Install new heat shrink tubing onto ESP Control Module ground wire (thick wire), ensure that the heat shrink tubing stops where removed (A in illustration) and does not cover crimped end.

8. Place the 6 x 1.2 mm washer onto the ground stud at W16/3. Install thin ground wires first, then reinstall the ESP ground wire (thick wire) and secure with the previously removed ground nut, tightening the nut to 10Nm.

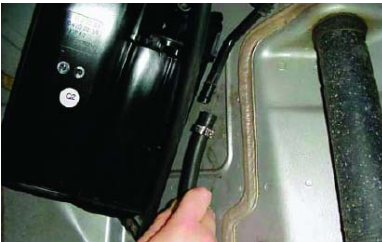
Tapping noise coming from the rear of the car, near the fuel tank, may be caused by noise in the purge line. The condition can be solved by installing a restrictor (P/N A203 476 03 32) and clamp (P/N A005 997 19 90).

1. Remove right rear wheel and its housing to reach the area of purge line.

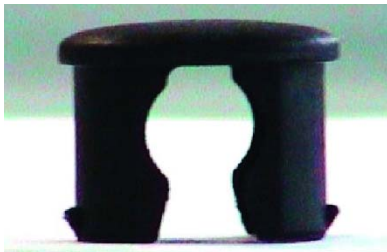
If your customer complains that the front or rear door stop is loose because the plastic retainer at the rod end has broken, you can now just replace the retainer (P/N A221 727 12 14). You do not have to replace the complete door stop.
