FACTORY SERVICE BULLETINS

Rear Axle Noise

Model 199.376,
VIN 000018 to 000897

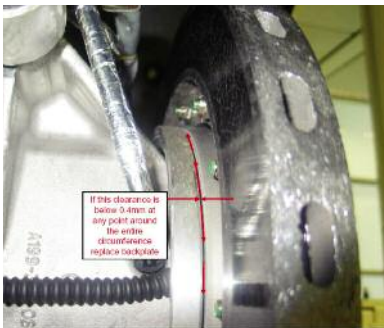
A grinding noise from the rear axle on these vehicles may be caused by inadequate clearance between the rear brakes and the backing plate. Check the clearance. If there is less than 0.4 mm space at any point between the brake disc and backing plate, the backing plate must be replaced.

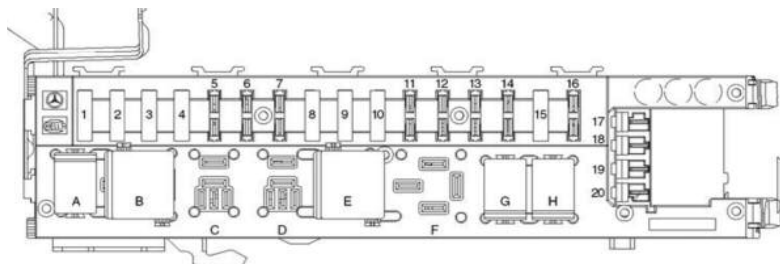
If the power outlet (cigarette lighter) doesn't work, check for a

missing relay in slot "F" and/or a missing 15A fuse in slot "12" of the Rear Signal Acquisition and Actuation Module (SAM). Install a new relay and/or fuse if either part is missing.
