Another Mystery Solved

Hesitating Corolla with MIL

By John Anello

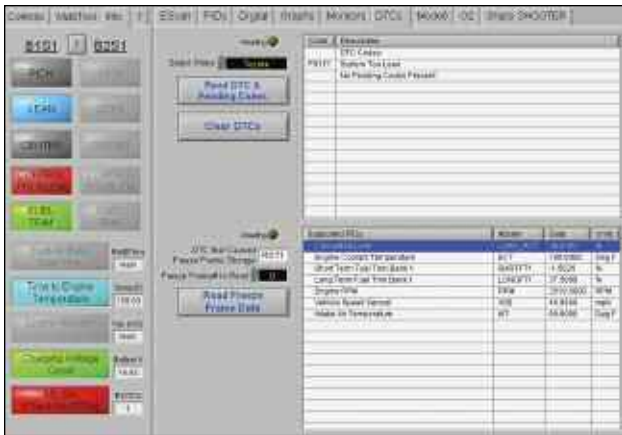
Figure 1

By analyzing the freeze frame data (Figure 1) you can see that the vehicle was traveling under a 38% calculated load at about 46 MPH and 2,500 rpm. The long-term fuel trim (LFT) reached 37%. This was an indication that the PCM had a report from the oxygen sensor of a lean condition or low oxygen sensor voltage. When the oxygen sensor voltage drops below 0.45 the PCM commands more injector on time. It accomplishes this by fuel trim. Fuel trim is a modifier to the original fuel injection equation. In all MAF-equipped cars, the PCM takes in a signal (input) that tells it how much air (by weight not volume) is entering the engine. It then commands the injection on time (output) so the air/fuel mixture will be correct for the operating conditions of the power plant. The oxygen sensor reports the resultant air/fuel status to the PCM. The short-term fuel trim (SFT) then commands the injector on time in the opposite direction of the oxygen sensor report. If the report from the oxygen sensor is lean (low voltage) the fuel trim moves to a positive correction factor (adding fuel). If the report from the oxygen sensor is rich (high voltage) the fuel trim moves to a negative correction factor (subtracting fuel). This will allow the oxygen sensor to change its output and then start to move toward 0.45 V.

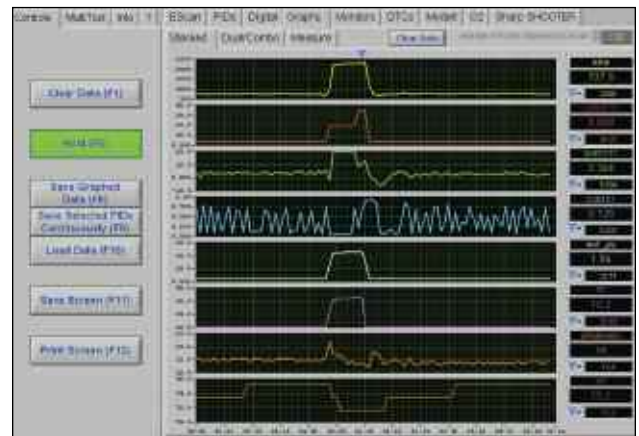
Figure 2

To find the cause of the fuel control problem I engaged the graphing mode selecting the appropriate PIDs. I power-braked the engine in drive at about 2,200 rpm (Figure 2). I could immediately see the graph for the O2 sensor flatten to about 100 mV. At the same time, the trims rose to almost 20% before the LFT trim rose again to about 34% to get the O2 sensor to start switching. The graphing of PIDs is very helpful to get a good visual of what is actually going on. It allows you to get a better understanding of how the PIDs hold a relationship with one another so that you can better hone your skills to come up with a proper diagnosis. Okay, I now confirmed the lean problem, but I still needed to dig deeper.

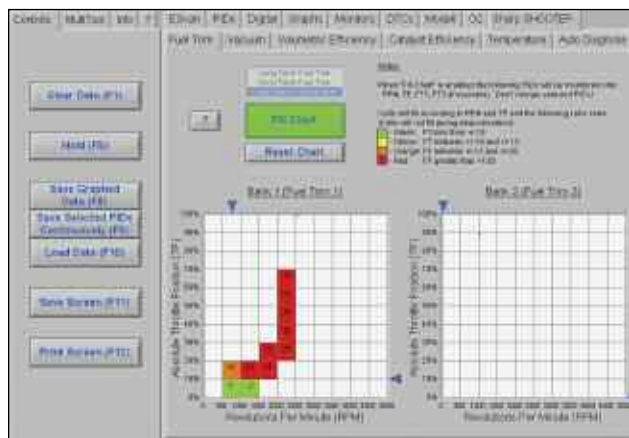
Figure 3

I next moved on to the EScan tool I was using has a “Sharp Shooter.” Here is where the action begins and the excitement increases. I first selected the Fuel Trim grid to again verify the trim problem. This grid is designed to fill cell blocks, which mimics the way the PCM would monitor cell blocks for proper fuel control. The visual aspects of the color grid reveal the fuel trim problem at a glance. By again power-braking the vehicle at about 2,500 rpm (Figure 3), I saw the same results as in the graphing mode, but with a quicker understanding of where the problem lies just by looking at the color of the blocks — green indicates that the fuel trims are good, while yellow, orange, and red are indications of a fuel trim problem.

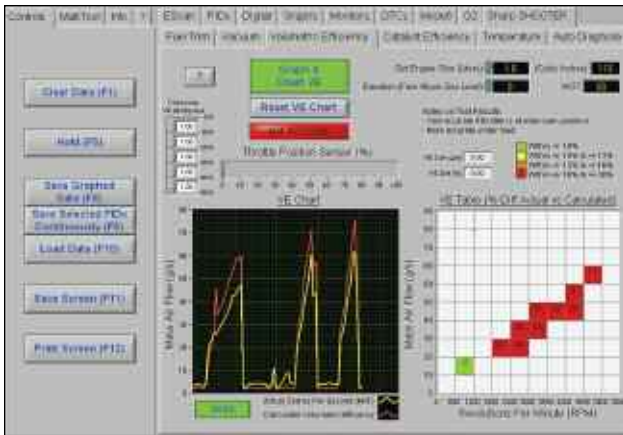
Figure 4

The tool graphs the expected (red line) and actual (yellow line) readings as you drive the vehicle. I made three hard accelerations from a dead stop (Figure 4) and you can see immediately that this Corolla had a volumetric efficiency problem. The VE table was showing readings that were low by about 30%, indicated by the red cells. Knowing this was a fuel trim problem ruled out a clogged exhaust or valve train efficiency trouble. If the volumetric efficiency of the engine was low and the MAF sensor had reported the correct airflow for this engine,

the fuel trim chart would have been green. This indicates that the PCM did not need to correct the original fuel injection equation. Since the fuel trim chart was red, this was an indication that the trim had to change the original fuel equation and add fuel to try to maintain the proper air/fuel mixture. Since the VE showed a very low reading and the trim chart showed very large corrections, this had to be MAF sensor related and not a fuel pump problem.

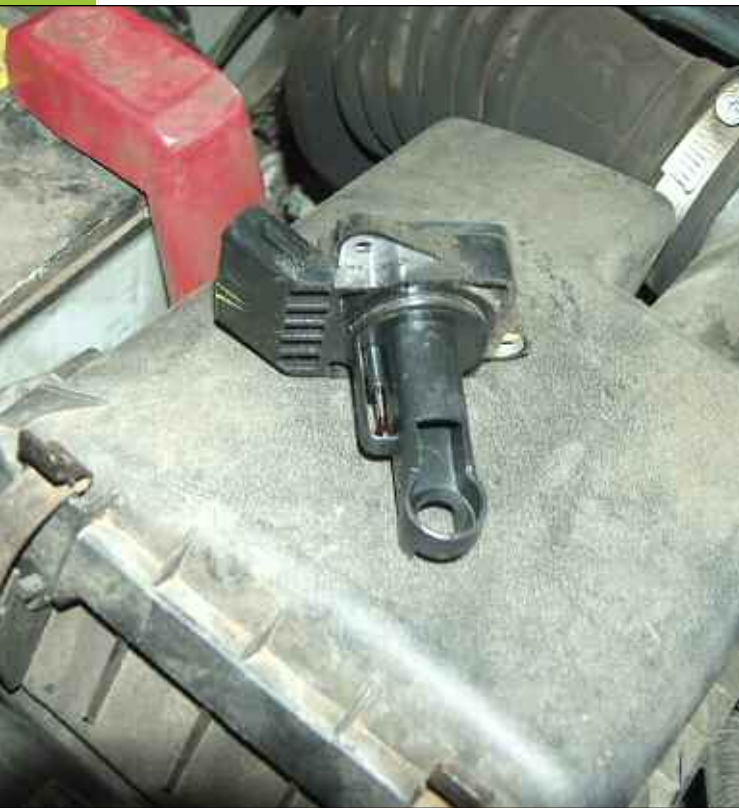
Figure 5

I removed the MAF sensor and inspected the air cleaner housing and duct for any restrictions or leaks and found none. Looking at a MAF sensor (Figure 5), many people get confused by the *intake air temperature-sensing* device on the outside and mistake it for the *MAF sensing element*. They clean the intake air temperature-sensing unit and then reinstall the sensor in the MAF sensor housing. This is just what this shop had done. By looking through the top of the sensor (Figure 6), you can see the MAF sensing element. This one was still very dirty, so I blasted it with electrical cleaner.
