FACTORY SERVICE BULLETINS

These suggestions and solutions for technical problems come from service bulletins and other technical information published by Mercedes-Benz, selected and rewritten for independent repair shops.

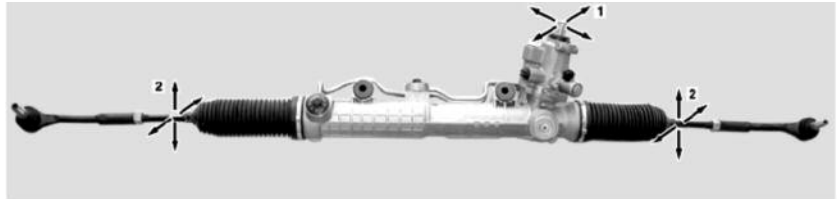
Figure 1, Item 1 and Item 2

When testing for rack and pinion play, radial movement of the steering coupling at the input of the control shaft (Figure 1, Item 1) is not relevant for evaluating play in the steering box. This does not have any influence on the operation of the rack-and-pinion steering system, or the play in the steering system and on the driving dynamics of the vehicle.

The same applies to radial movement at the rack/tie rod (Figure 1, Item 2), especially when the wheels are turned all the way to one side. In this position the rack is extended to one side and acts as a larger lever where supposed play can be felt even more (checking play at the outer and inner joints remains the same). Radial movement when applying pressure when the rack is fully extended to one side or the other is normal and is due to the construction of the steering system.

The steering wheel must be turned slowly while watching the rims move. The rims must start to move before the steering wheel is turned at most approx. +/- 1 degree. During this movement, a steady increase in pressure can be felt in the steering wheel. This delay in reaction is a result of the elasticity of the steering system (steering connections, etc.) and is not a fault. In order to properly evaluate play in the rack-and-pinion steering system, only the axial movement of the rack in relation to the steering box is relevant (Figure 2, Item 3).

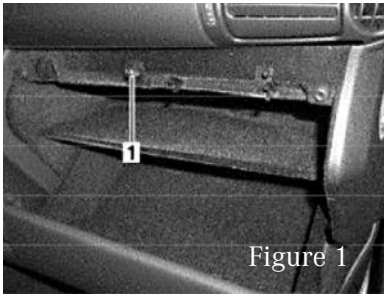
Figure 1

For Model 203 – Up to VIN A113578 or F083917 and 209 – Up to VIN F105129 or T024760, the noise may be caused by the glove box lid rubbing against the striker (Model 203, Figure 1/ Model 209, Figure 2)

To correct the problem, lightly grease the striker with Special Sliding Compound, P/N A000 989 36 60.

may be caused by insufficient preload for the glove compartment lid. For Model 203 vehicles, increase the preload by moving the striker forward. (#1 in Figure 1). For Model 209 vehicles, increase the preload by adjusting the buffers (Figure 3, arrows). For Model 209 vehicles with a CD changer, also make sure the glove compartment lid is not striking the CD changer.

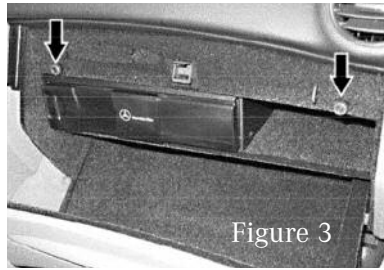
Figure 3

For Model 203, Up to VIN A114580 or F098332; and for Model 209 vehicles, the noise

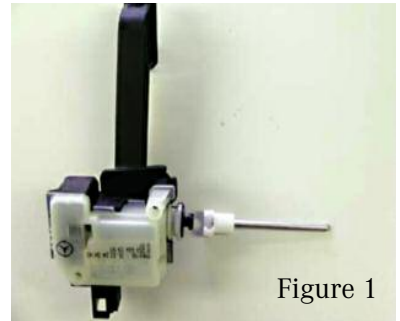
Figure 1

If a customer cannot open the fuel filler flap from outside the vehicle, the the locking rod on the actuator motor may be unclipped. A modified bracket for the tank flap lock actuator motor must be installed to correct the problem.

4. Replace the old bracket (Figure 1) for the tank flap locking actuator with modified bracket P/N A203 820 66 14 (Figure 2).
