FACTORY SERVICE BULLETINS

“ESP Visit Workshop” Displayed In Instrument Cluster

All Model 203 Vehicles,
As of August 1, 2001
Series Production

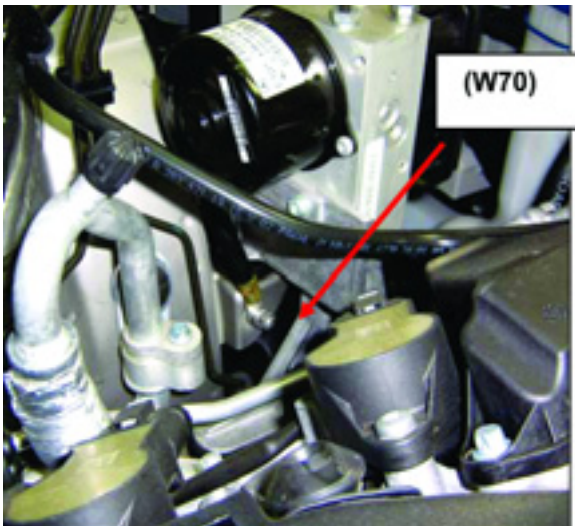
If “ESP – Visit Workshop” is being displayed in the instrument cluster, and for vehicles with an automatic transmission, the selector lever cannot be moved from position “P” after the engine is started, and various fault codes are stored in the relevant control units, perform the following repair.

The conditions listed above are caused by an inadequate ground connection at the ESP (W70) ground point (Figure 1, arrow) due to the heat shrinkable tube protruding under the ground cable lug’s attachment point.

2. Tighten the nut on the ground bolt (W70) to 8 Nm.
