FACTORY SERVICE BULLETINS

Engine Performance Complaint from “False Air”

Model 203.040/740

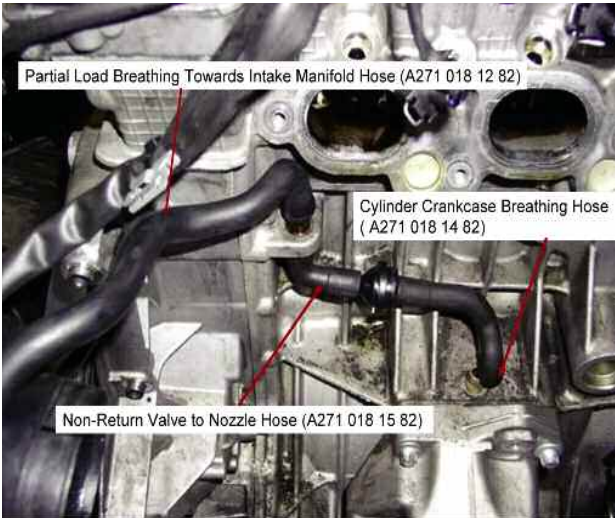
If you receive customer reports in the above model of the engine vibrating, rpm fluctuations at idle or poor accelerator response with codes P2020 (P0172), P2046, P201C or P201A in the engine control unit, please perform the below procedure. The partial load breathing towards intake manifold hose, cylinder crankcase breathing hose or the non-return valve to nozzle hose may be torn at the connection to the crankcase. Air will bypass the air mass sensor, i.e. unmeasured air will enter the intake, causing the engine to run lean.

- 1.Remove compressor (supercharger). Refer to WIS document AR09.50-P-4705QK.
- 2.Remove and inspect the partial load breathing towards intake manifold hose, cylinder crankcase breathing hose and the non-return valve to nozzle hose for crankcase ventilation. If damaged, replace as needed. Refer to Figure 1 for details.
- 3.Install compressor (supercharger). Refer to WIS document AR09.50-P-4705QK.

- Use “click clamp” as specified in parts information for securing hose.
- Ensure that clamp is positioned as close to the end of the hose and fastened tightly.
