FACTORY SERVICE BULLETINS

Whining/High-Pitched Whistle Coming From Front of Engine

All Light Truck Models Equipped with Engine M272 or M273

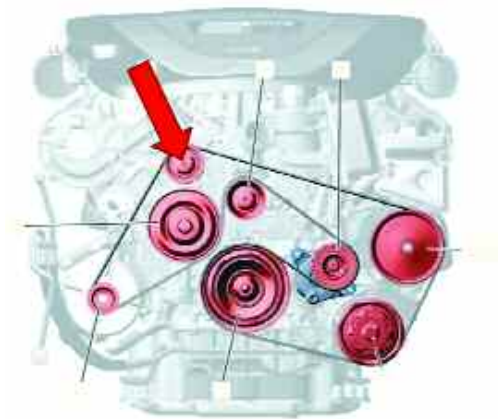
A whining or high-pitched whistling noise coming from the front section of the engine may be caused by a faulty upper idler pulley. To resolve, replace the upper idler pulley with a new unit. The pulley is supplied as a package containing the mounting bolt, dust cover and spacer. Fit the spacer between the timing case cover and guide pulley.

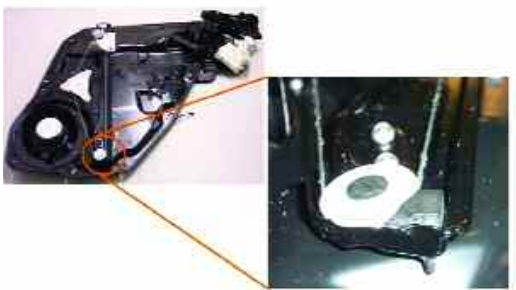
A knocking noise that occurs when the power window is operated downward and reaches the lower limit position may be caused by a broken plastic limit stop. To remedy, perform the following.

1. Remove door lining. Refer to WIS document AR72.12-P-1010GZ (164) or AR72.12-P-1010RT (251).
2. Remove door module. Refer to WIS document AR72.12-P-0103GZ (164) or AR72.12-P-0103RT (251).
3. Remove broken limit stop from door.
4. Install new limit stop (Figure 1).
5. Reinstall door module. Refer to WIS document AR72.12-P-0103GZ (164) or AR72.12-P-0103RT (251).
6. Reinstall door lining. Refer to WIS document AR72.12-P-1010GZ (164) or AR72.12-P-1010RT (251).
7. Renormalize power windows.
