No Codes? No Problem!

We've all gotten used to starting a driveability diagnosis with the help of a DTC or two. Don't panic when no codes are present. Instead, apply a logical procedure.

Recently, our shop had a good customer bring in her 2004 Nissan Maxima Her complaint was,

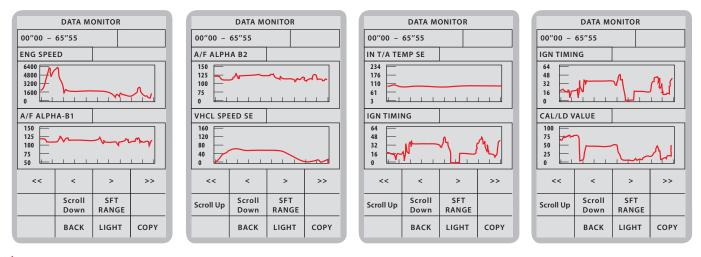
Figure 5: Reviewing the data after a test drive.

Back in the shop, we took a closer look at the data (Figure 5). The key pieces of data are the Calculated Load (CAL/ID), A/F Alpha-1, A/F Alpha-2, rpm and Throttle Position.

What we found in the data, as we noted during the test drive, is that the A/F Alpha would rise directly when the MAF rate (as indicated by Calculated Load) would increase. We also noted that the highest load reading we could achieve at Wide-Open Throttle was in the high 70% range. Normally, we expect the A/F Alpha not to trend with the Mass Air Flow rate, and to stay at 100% A/F Alpha ± 10%. Further, we expected this vehicle to be able to achieve at least 90% Calculated Load. Clearly, was not occurring.

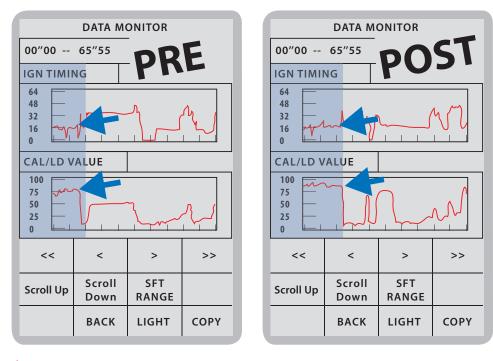
Figure 9: Calculated load is now much closer to 100% during WOT.

As can be seen in Figure 9, the Calculated Load has changed drastically. At WOT, the timing is not greatly affected, but, as shown in Figure 10, during steady acceleration and cruise conditions, the timing is advanced significantly more with an under-reporting MAF, which caused the "marbles" sound.

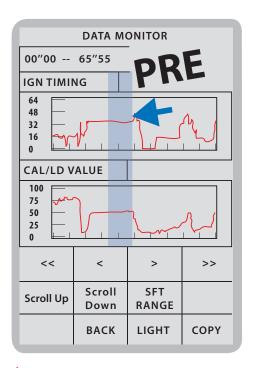
Figure 10: Ignition timing was substantially advaned with the old MAF.
