Another Mystery Solved:

The Auto Tech on Wheels tells us how he used high-tech means to justify trans removal to find the real cause of a no-start

A shop called me in to investigate a no-start condition on a 1996 Dodge Caravan with a 3.3L engine (**Figure 1**). This shop only had a scan tool in its arsenal of diagnostic equipment. No scope, no graphing meter combined with a component tester, not even a repair information system. With no codes in memory, the techs resorted to the “feels like” tactic. They used their best instincts to replace parts associated with their visual inspections and old-school test procedures.

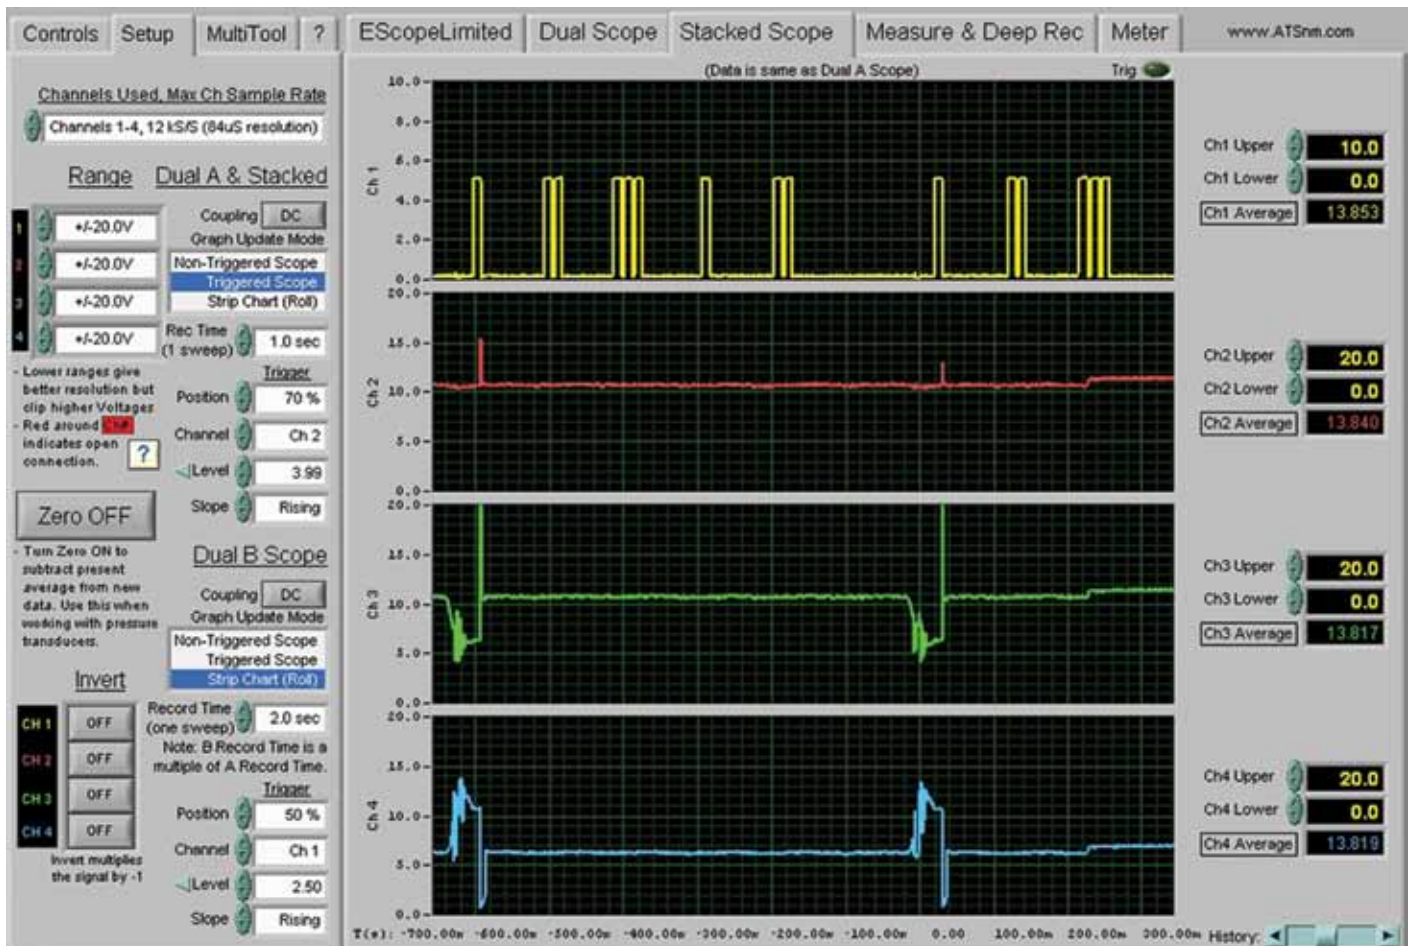
Figure 2

the only one firing during cranking. The other coils did not fire at all. At this point I decided to hook my scope up to some selected signal lines to get a visual concept of what was going on exactly. I used my EScope Limited 4-trace scope and placed my channels on the cam sensor and all three coil drivers. As I cranked the engine, I could see that the cam sensor was providing the proper signal pattern, but the PCM had a problem controlling the coil drivers (Figure 2). One driver attempted to

ground the coil while another driver was held on for as long as 600mS of on-time. By current ramping the one working coil against the crank and cam signals (Figure 3) I could see that the coil driver was maintaining about 8.5 amps of current for almost one camshaft revolution. There is no way any driver would hold a coil primary that long unless that driver was in love and just did not want to let the coil go. It was a relationship that went bad, and no one was around to give advice

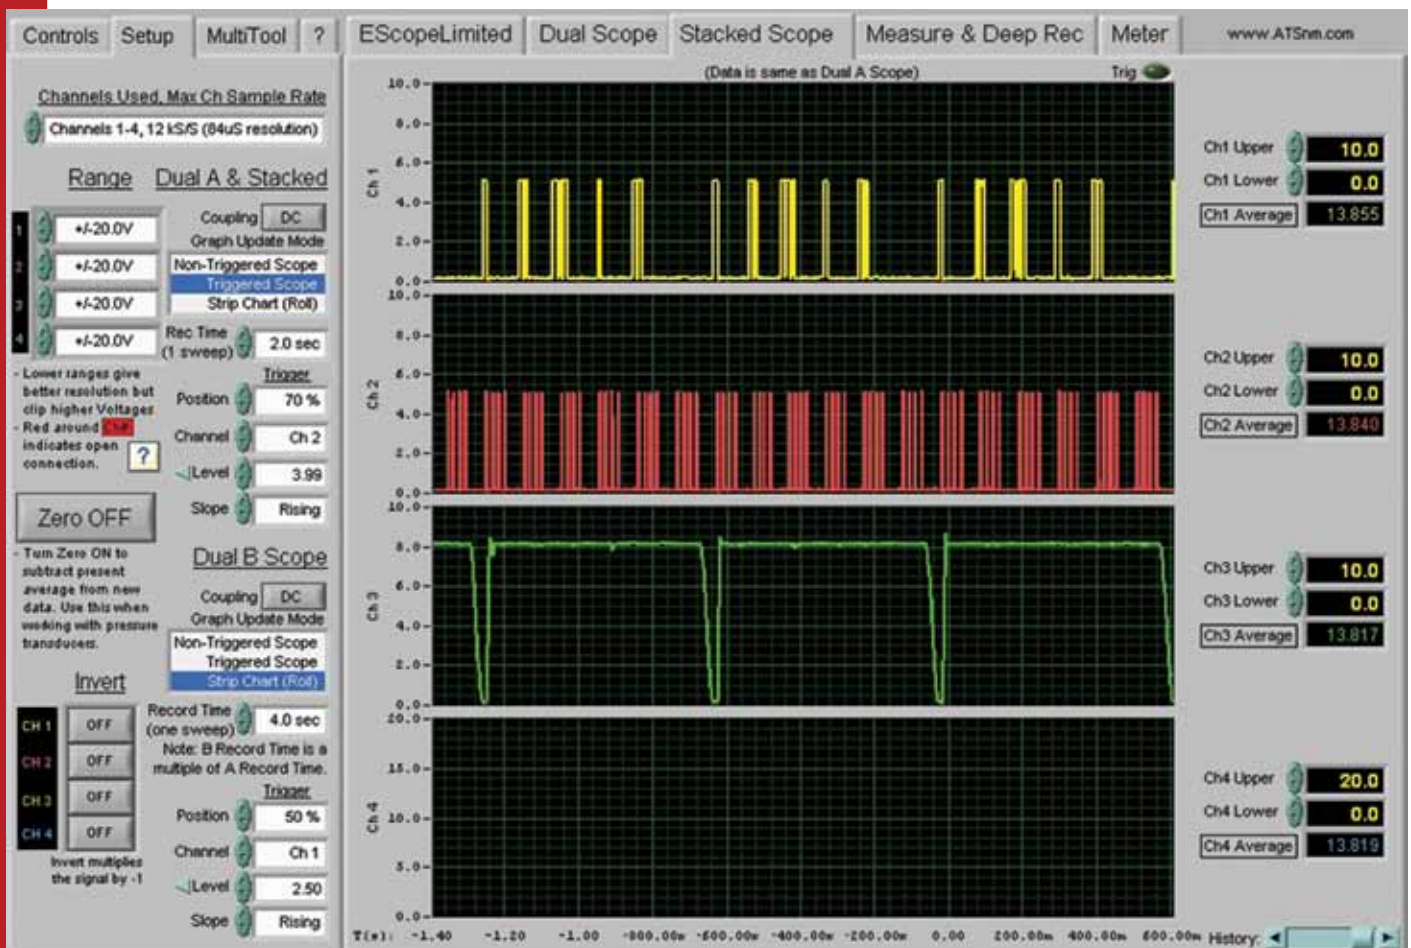
Figure 3

to just let go. That got me wondering if this might have caused the failure of the coil driver in the old PCM.

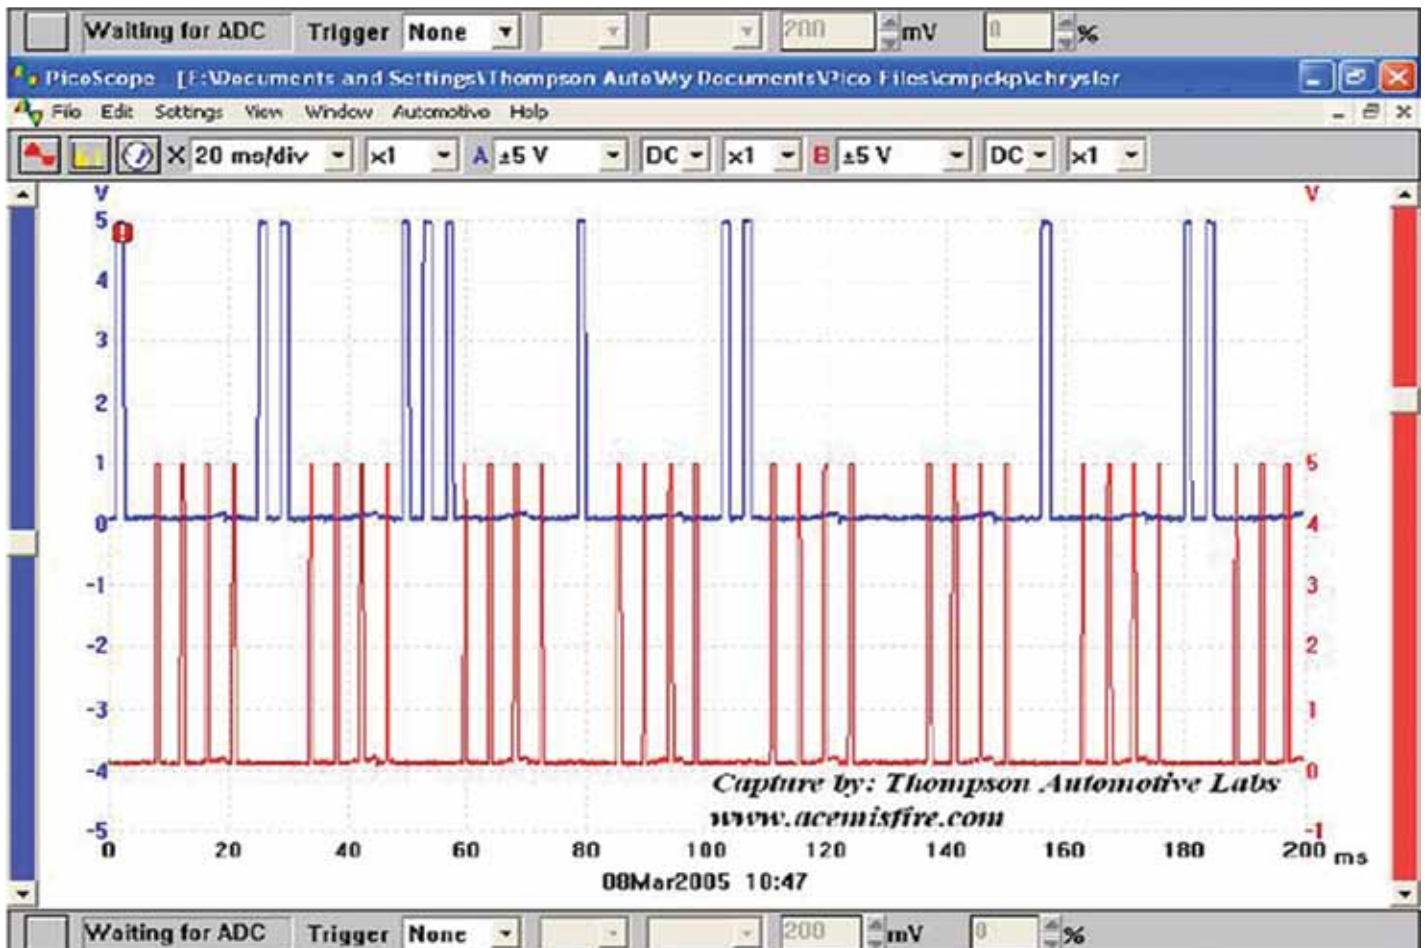
Figure 4

seemed to be producing the proper patterns with correct amplitude, but I needed to compare their synch correlation. I used my Ace Misfire crank/cam waveform database and pulled up a known-good crank/cam pattern for this vehicle (Figure 4). You can see how the cam sensor pattern repeats the 1-2-3-1-2 pattern while the crank signal repeats the 4-4-4-4-4-4 pattern. It is between where the cam pattern ends and begins that there should be equidistant 4-4 patterns. I

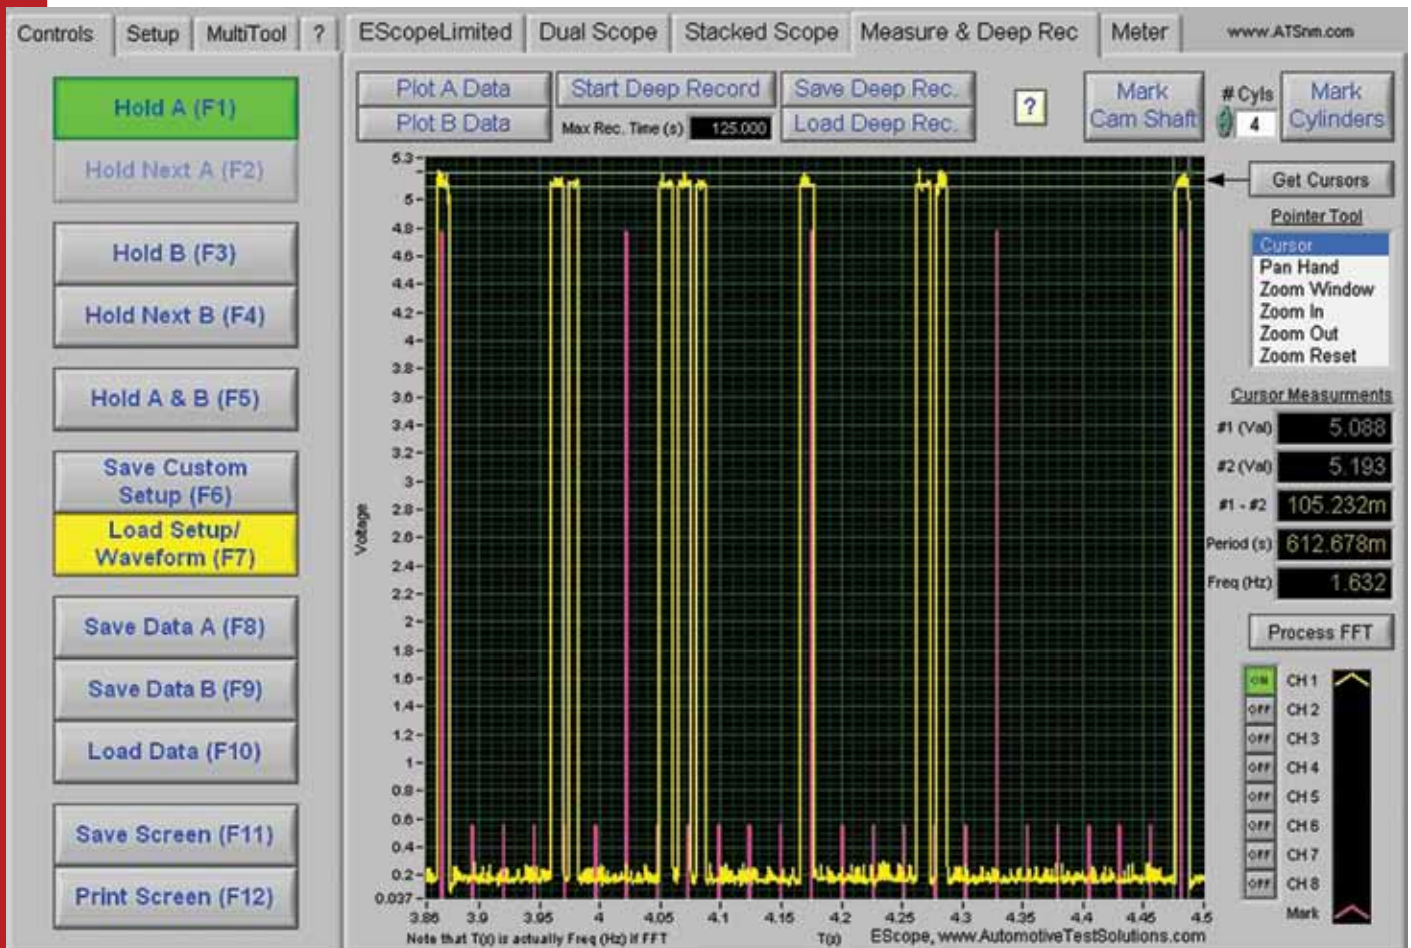
Figure 5

imported the cam sensor signal into the measuring section of the scope (Figure 5) and placed cursors to show one complete event of the cam sensor. By hitting the Mark Camshaft button, the program automatically placed five purple cursors on the screen creating four divisions each representing 180 degrees of crankshaft rotation and five smaller purple cursors creating six subdivisions each representing 30 degrees within each 180 division.

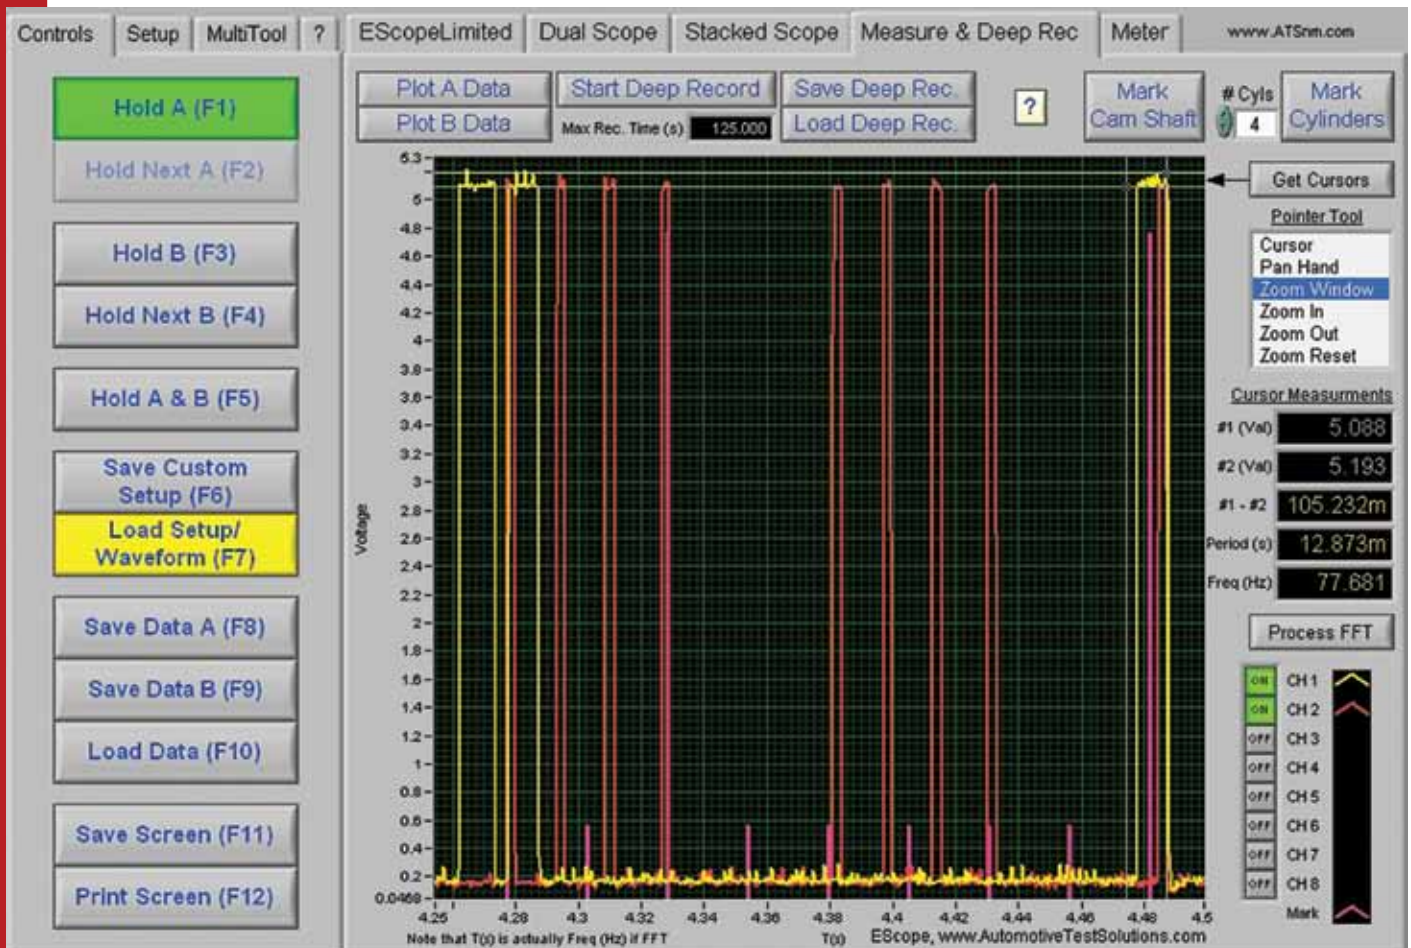
Figure 6

I superimposed the crank signal on top of the cam signal and zoomed in on the end and the beginning event of the cam signal (Figure 6). Notice how the crank signal has shifted at least 30 degrees to the left. This indicated that the crank and cam sensors were not properly synched. The cam sensor indexed off the front of the engine while the crank sensor indexed off the torque convertor at the rear of the engine. Now, I had to decide whether this

was caused by a problem in the front or rear of the engine. With 108,000 miles on the clock it was a better sell from a maintenance point of view to disassemble the front of the engine to inspect the timing chain components than it was to pull the transmission to check the flywheel assembly. The cause at this point could be a jumped timing chain, sheared crank keyway, sheared cam gear roll pin, or even a damaged flywheel. There was no flywheel noise while cranking the

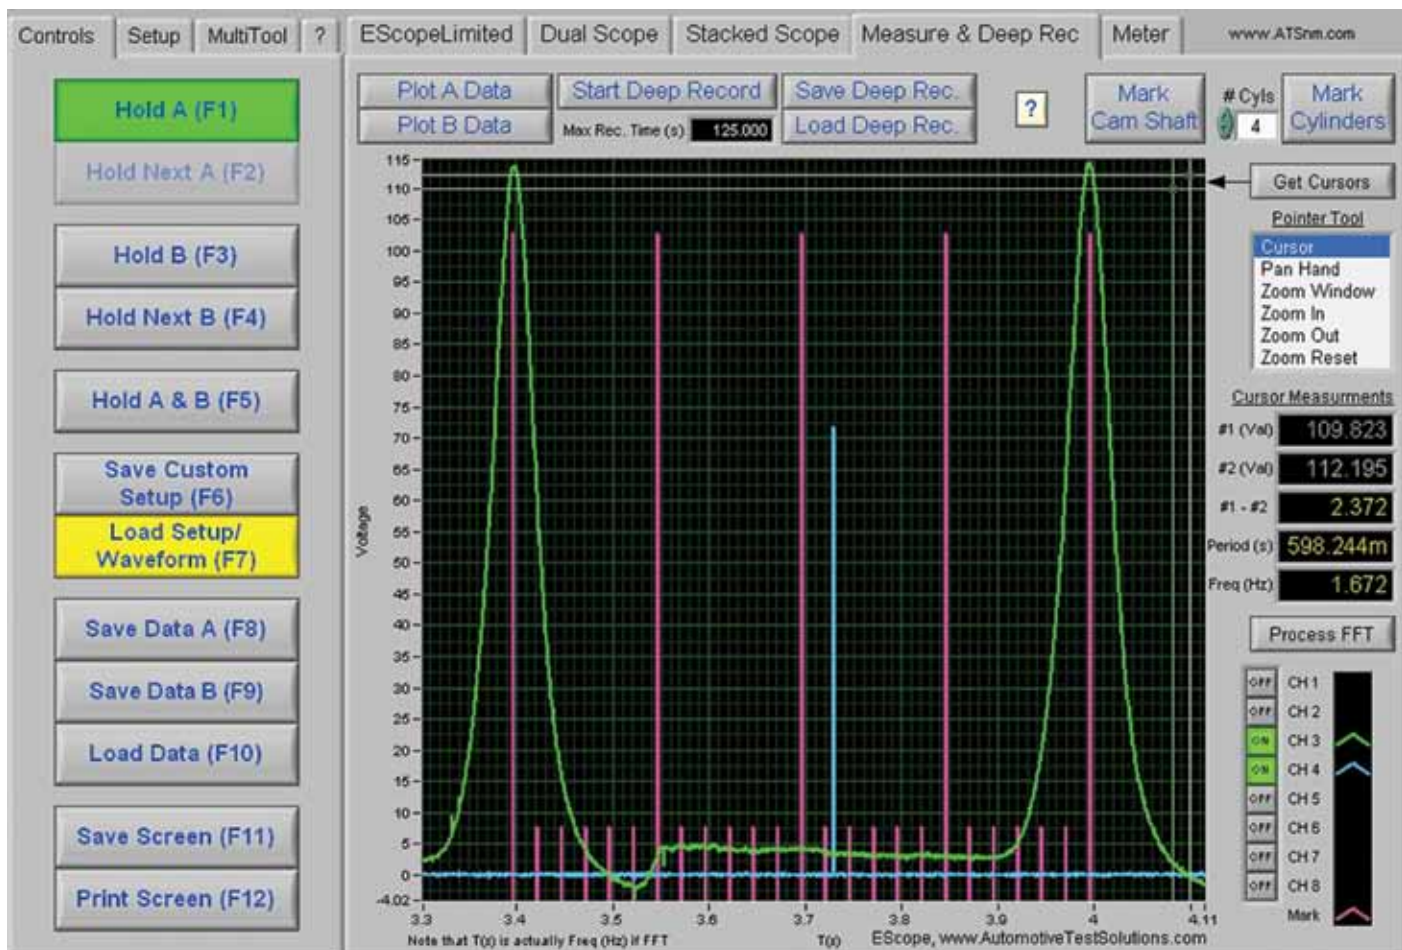
Figure 7

are laid out. The lowest point (u-curve) before BDC of the power stroke is where the exhaust valve begins to open. This I have found to be about 30-45 degrees before BDC of the power stroke on most of the cars I have been checking. The waveform pattern (**Figure 7**) shows the exhaust valve to be opening close to 30 degrees before BDC of the power stroke. The spark was occurring only once in the cylinder when it should have occurred twice. The ignition only fired the waste spark and fired wrong at about 40 degrees after TDC of the

exhaust stroke. This was due to the incorrect coil primary control caused by the crank/cam correlation problem.

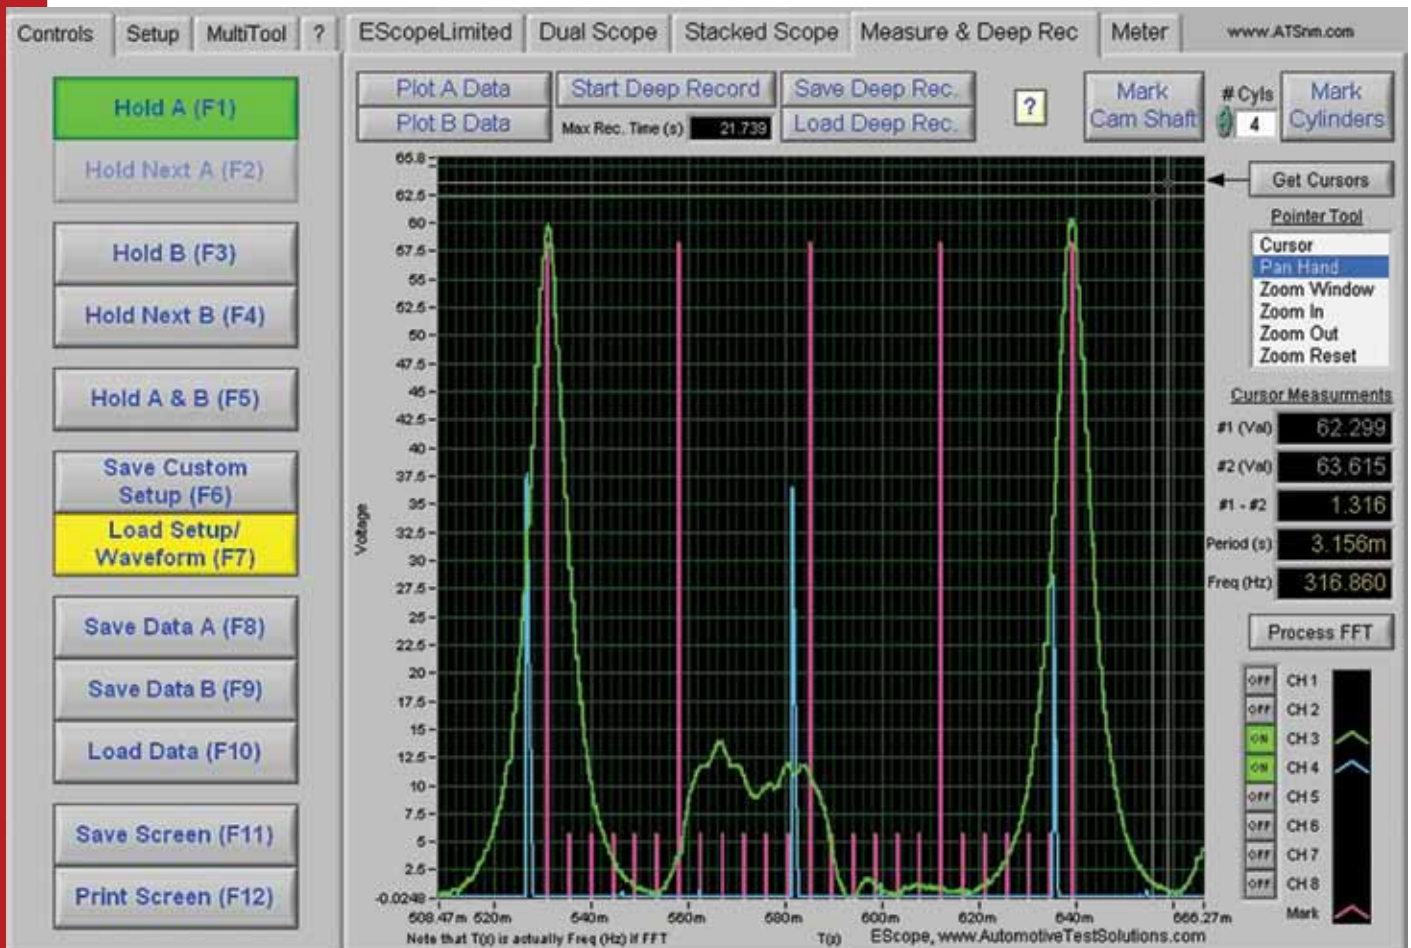
Figure 8

By viewing a known-good pattern of a 1997 Dodge Caravan with a 3.3L (**Figure 8**) you can see that the exhaust valve opening event is happening at about 30 degrees before BDC of the power stroke. This file was from a running engine,

so the advance timing was added to the base timing to bring the timing to about 25 degrees (always use the first rise of the inductive clamp square waveform) before TDC of the compression stroke for ignition spark and 25 degrees before TDC of the exhaust stroke for waste spark. This method is such a great way to learn about combustion strategy and, at the same time, give you another weapon in your arsenal to fine tune your diagnostics as far as which direction you want to head in. Even if this had been a dual cam set-up, you would have had no problem in finding out which cam was off from spec without even pulling a timing cover. Just by having this information validated from doing other known-good vehicles, it was safe for me to instruct the garage to pull the transmission and inspect the flywheel.

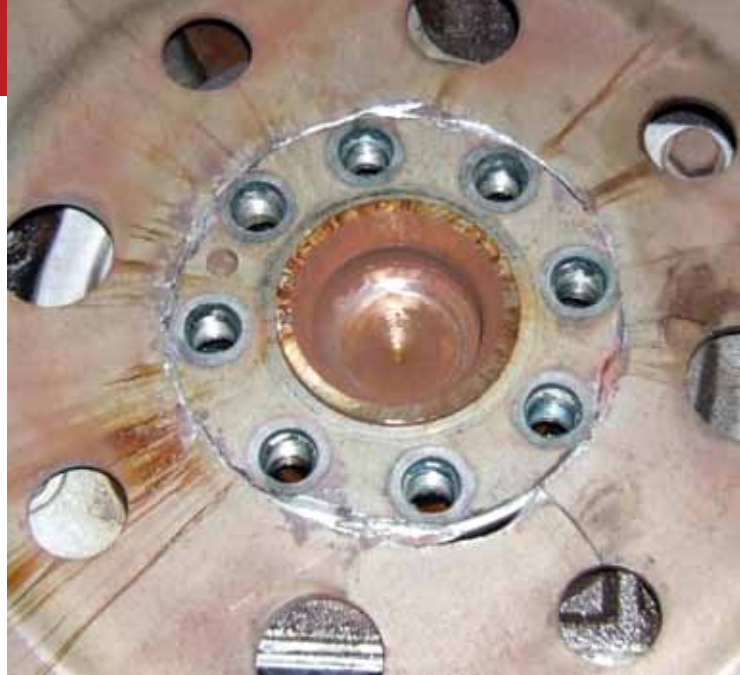
Figure 9

About an hour later the shop called to tell me that the transmission was pulled and I needed to come back to see the damage they found. When I arrived there at the end of my day, I was amazed. The center of the flywheel was completely cut out from the rest of the flywheel like a cookie would be cut out of rolled dough. The center piece spun slightly and wedged itself in place (**Figure 9**). The

amazing thing was that there was no noise associated with this flywheel while cranking. I helped the garage remove the flywheel and placed it on the ground. I pushed on the center piece and it fell out. The only thing holding these pieces together was the center thrust plate and flywheel bolts.

This flywheel was like a wheel of fortune just making the shop spend time and money without a cure in sight, and at the same time sending them on a wild goose chase. It held the torque converter and provided the crank triggers necessary to start the engine. Who would ever think a flywheel could break clean and spin, yet go undetected? I hope this story sheds some light on the value of a scope, which allows you to see beyond the normal reach of a scan tool.
