by John Anello

Figure 1: 2003 Nissan 350ZX

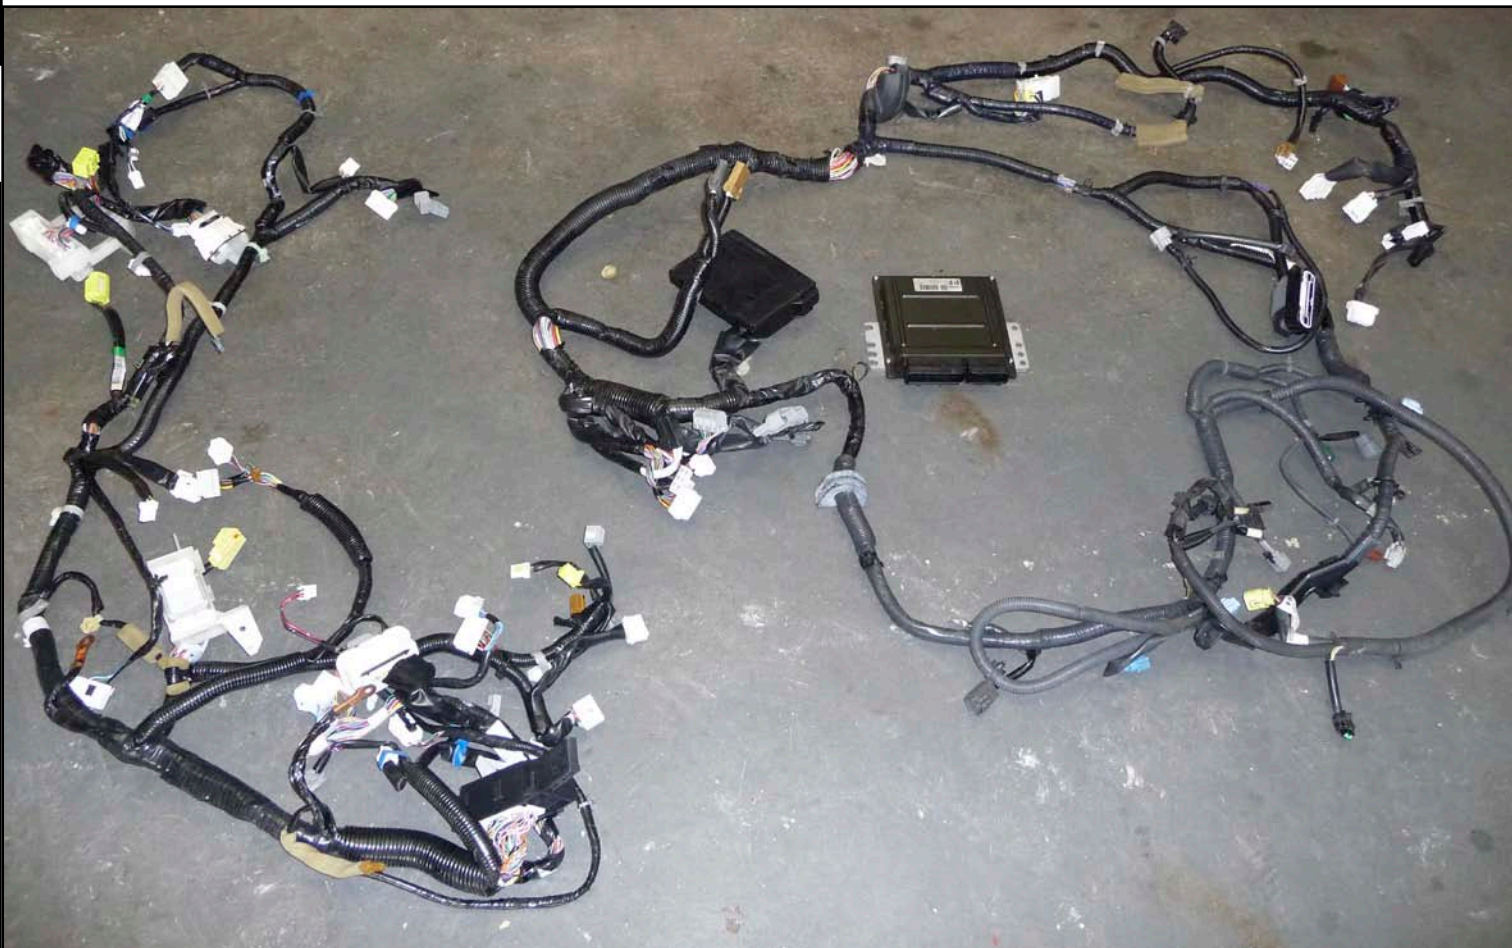
could accommodate a clutch assembly. The entire engine harness, dash harness and PCM were also replaced from the salvage vehicle (**Figure 2**) to accommodate the different components and wiring used for manual transmission operation. The salvage PCM was the same year application, but would not start the vehicle because the PCM was locked out due to the onboard immobilizer system not recognizing it as the original PCM from the car. This particular vehicle used immobilizer keys that were paired to the BCM and the BCM was paired to the PCM. The shop had to install the BCM, ignition lock cylinder and the immobilizer keys from the salvage car to get this vehicle to run.

Figure 2: The entire Engine harness, dash harness and ECM were also replaced from the salvage vehicle.

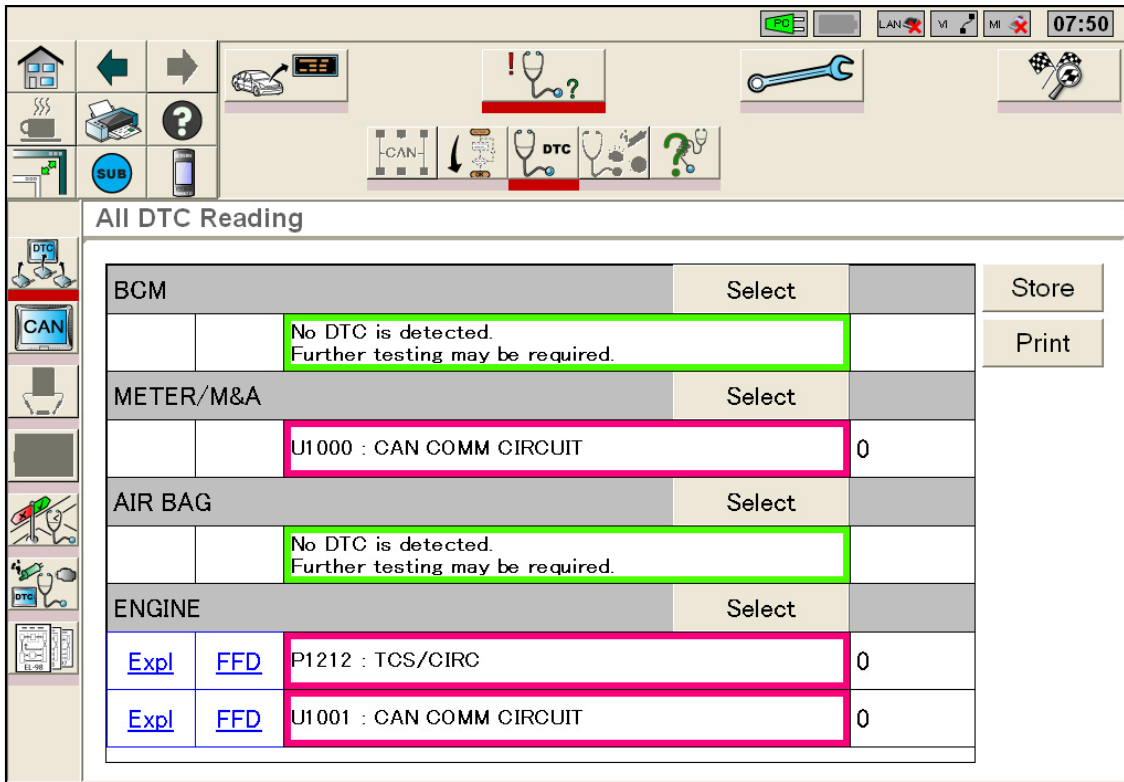
Figure 3 Above: Nissan Consult III scan tool and pulled codes from the entire vehicle.

When I arrived at the shop, the engine started and ran, but would not throttle up properly. There was also a check engine light (MIL) on. I hooked up my Nissan Consult III scan tool and pulled codes from the entire vehicle (**Figure 3**). The PCM stored codes P1212 (TCS circuit fault) and U1001 (CAN communication circuit). These codes were related to the ABS unit missing off the network, but there were no codes related to the throttle control unit. This vehicle had a working throttle, but it just had no power on acceleration. Whenever I get a no-power complaint without a misfire, I steer myself in the direction of checking for lean operation, clogged exhaust, or ignition/valve timing issues. Most of my no-power complaints fall into these categories.

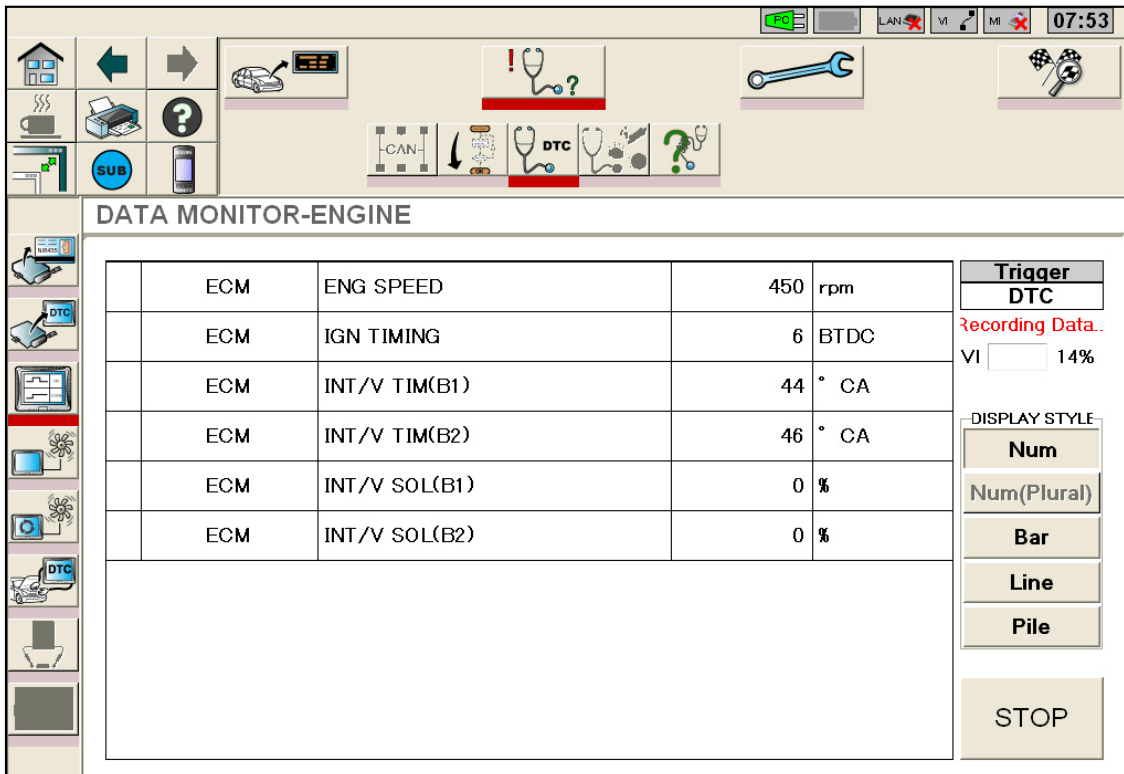
Figure 4 Below: You could see that at idle each cam gear was off by at least 45 degrees.

It was simple enough for me to look at scan data just to see if the valve timing was an issue. This engine has variable cam timing and uses two cam sensors to calculate the movement of the cam gear actuators on each bank. With the variable timing solenoid commands off, the cam gear positions should be near zero degrees. When I viewed the data (**Figure 4**), I could see that at idle each cam gear was off by at least 45 degrees. I then asked the shop if maybe the timing chain had not jumped and if he checked it. He told me that the engine ran perfect before the transmission was put in. I knew that the PCM had to index its readings off the flywheel to determine banked cam timing, so I made the suggestion that the shop pull the transmission so that we could check the flywheel together.

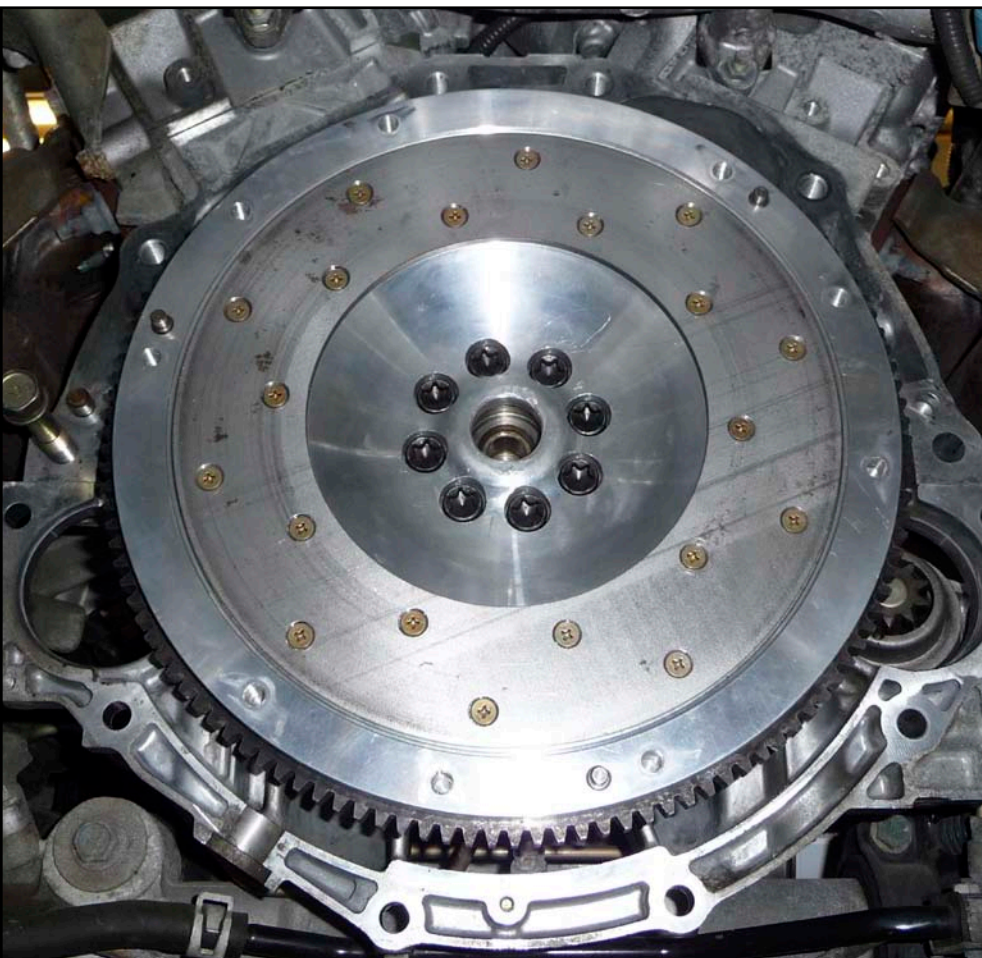
installed (**Figure 5**) and I stood there wondering how it could ever have been installed correctly. It was not a factory flywheel, but one purchased through the aftermarket. There was no dowel hole visible from the front. I removed the flywheel to inspect where the dowel actually was located on the end of the crankshaft (**Figure 6**). I carefully did not lose the position the shop had installed the flywheel in, and flipped the flywheel over (**Figure 7**). You could

Figure 5: The flywheel they installed.

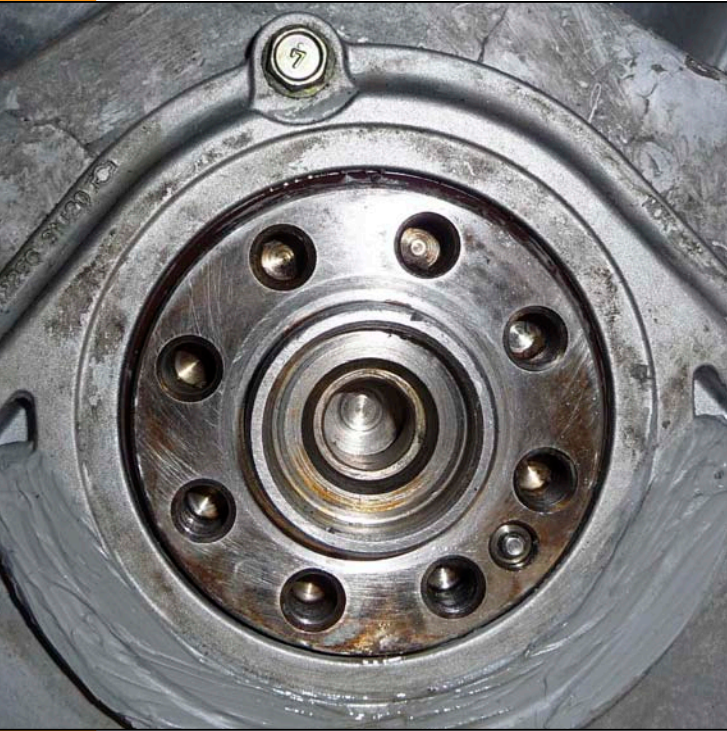
Figure 6 Above: Removed the flywheel to inspect where the dowel actually was located on the end of the crankshaft.

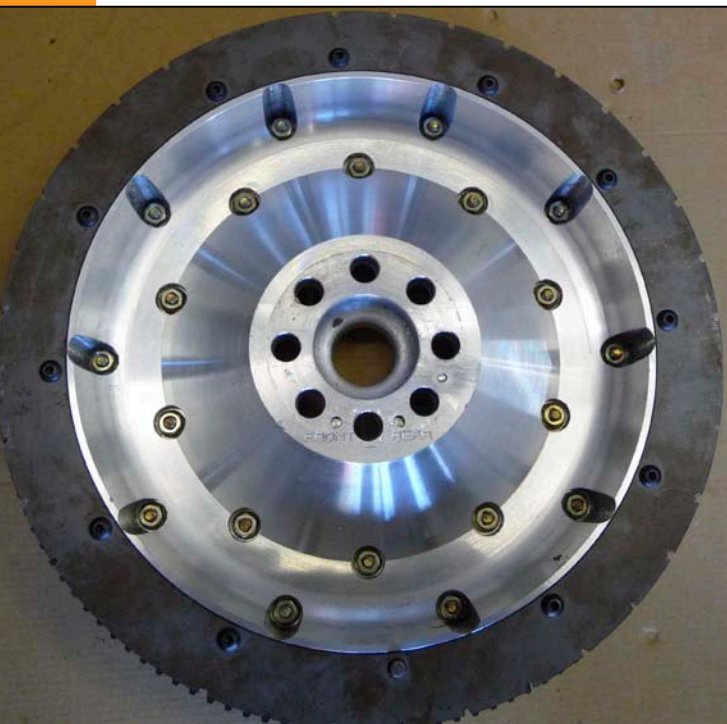
Figure 7 Below: flipped the flywheel over without losing the position the shop had originally installed.
