# Grease Lightning

I was called to a shop for a surging idle problem on a 1994 Chevy Camaro with a 5.7L Engine (Figure 1). The shop had scanned the ECM for codes and found no codes in memory but noticed that the ECM was not controlling the idle properly. The IAC counts were very erratic and the engine would race up and slow down for no reason at all. When the vehicle was cold there were no problems but as soon as the engine got hot that was when all the fun started. The shop had recently tuned up the engine about 2 months earlier replacing spark plugs, spark plug wires, PCV valve and filters. This problem just started within the past week.

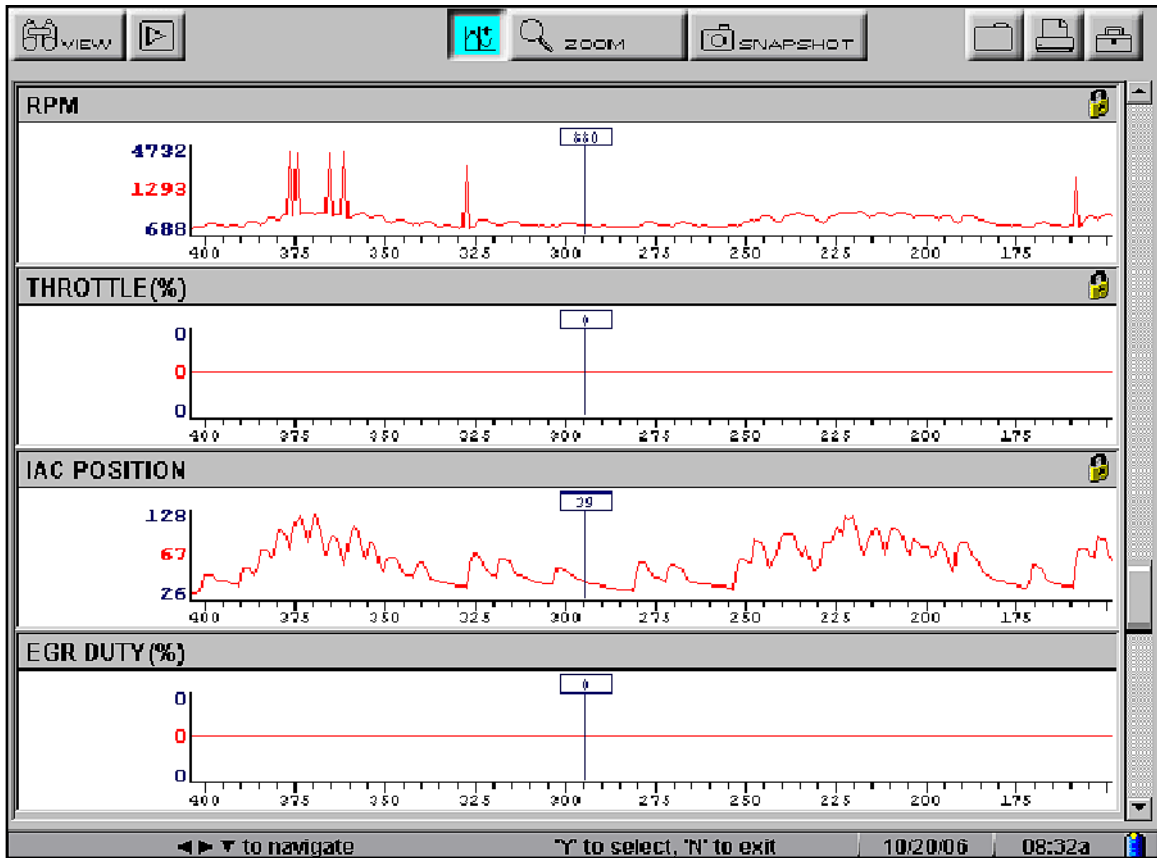
Figure 3 (Opposite Top): ECM was seeing false high RPM inputs and was only doing its job to counteract the high RPM's by moving the IAC motor accordingly.

While graphing the data (Figure3) I was able to see what was finally going on. The ECM was seeing false high RPM inputs and was only doing its job to counteract the high RPM's by moving the IAC motor accordingly. The culprit had to be the crank angle sensor because it was responsible for RPM input. I backed the MODIS out of its scanner mode and placed it into a scope mode to get a better look at what was going on with the crank angle sensor. I tagged the low resolution signal, high resolution signal and the coil primary and everything seemed fine except for one primary pattern showing a higher than normal spike (Figure4). Then the engine raced up again

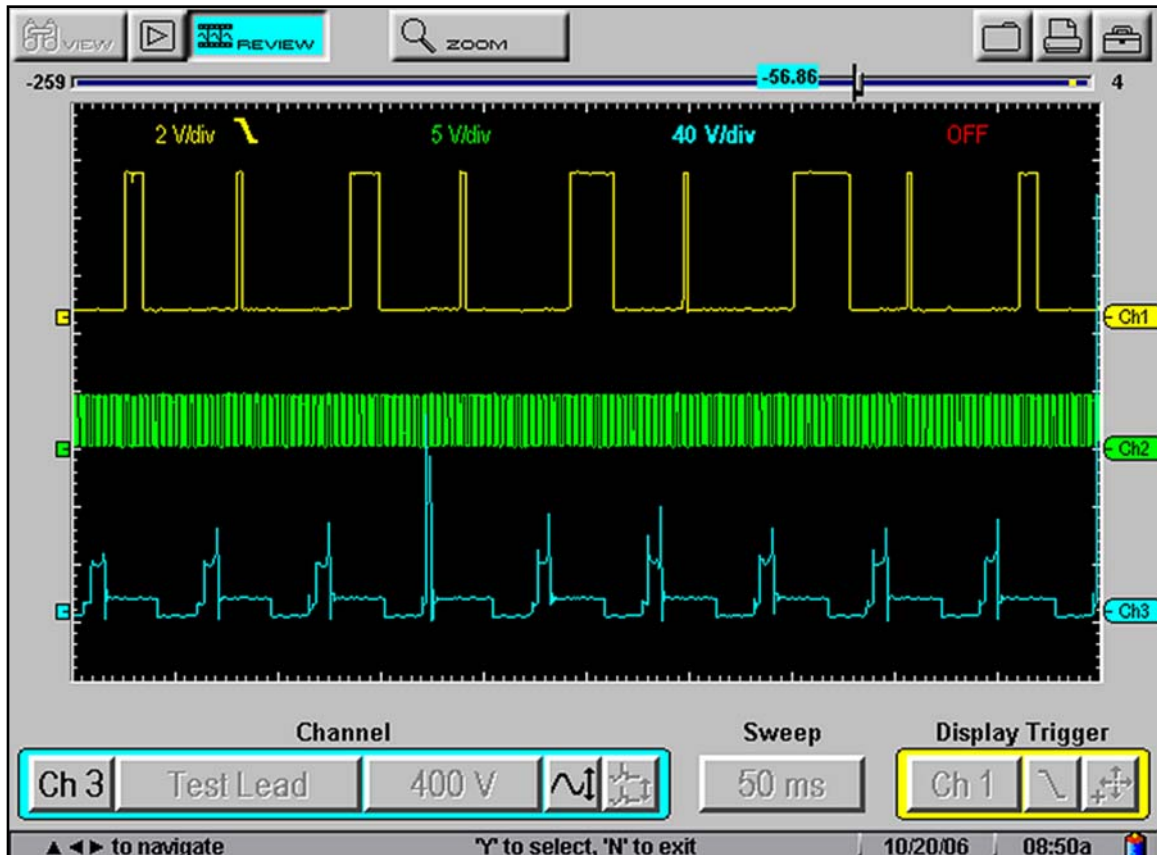
Figure 4 (Opposite Bottom): The low resolution signal, high resolution signal and the coil primary and everything seemed fine except for one primary pattern showing a higher than normal spike.

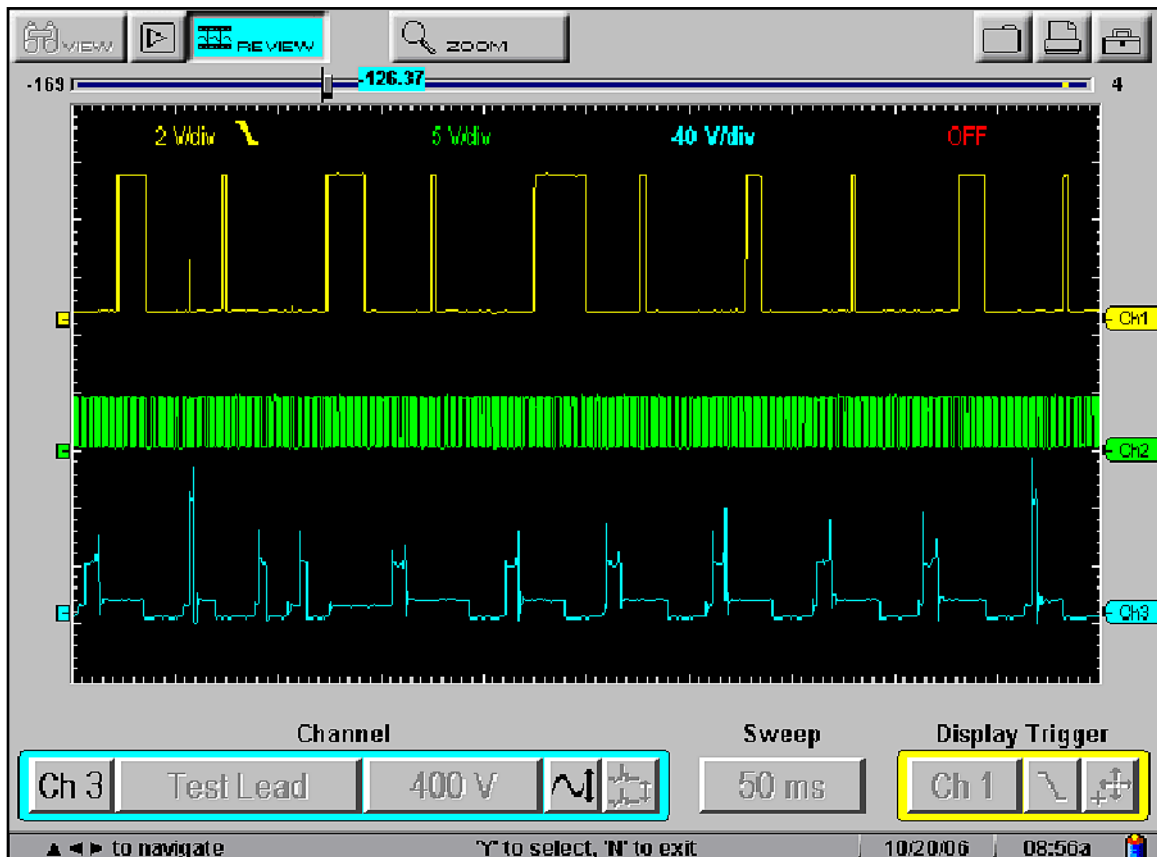
Figure 5 (Below): the coil trigger was erratic at one point but just prior to the event the low resolution signal had a spike in its pattern

and at this point I stopped the scope to play it back. I quickly saw that the coil trigger was erratic at one point but just prior to the event the low resolution signal had a spike in its pattern (Figure5). By looking a little closer you could see that this spike was caused at the exact time that one primary pattern was spiking. The spiking event would occur every one revolution of the low resolution sensor every time one particular cylinder was fired. I wanted to get a closer look at the secondary patterns because it seemed that the spike was caused every time that one cylinder's primary was released to create secondary voltage.

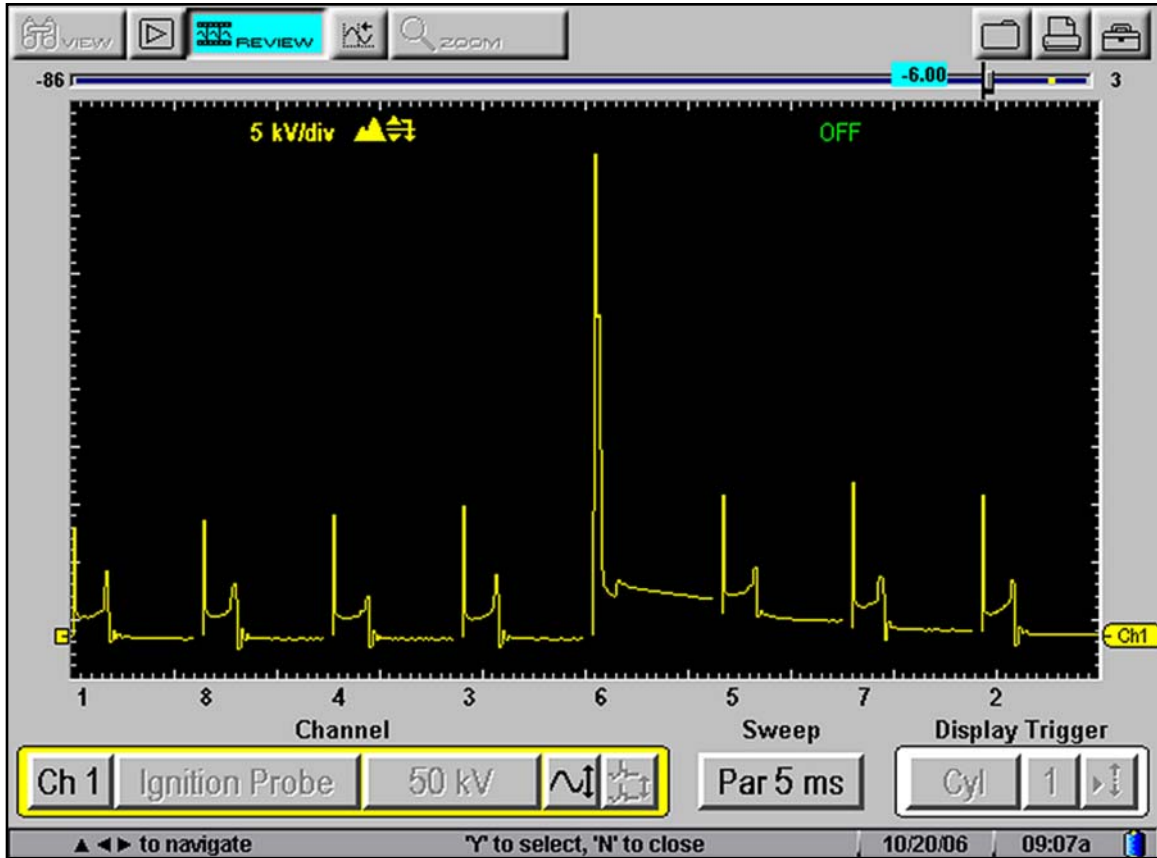
Figure 6 (Opposite Top): the analyzer in parade mode to view all the cylinders and I was stunned to see that the #6 cylinder was spiking close to 45 KV's

I backed the MODIS out of the scope mode and went next into the engine analyzer section. I placed the analyzer in parade mode to view all the cylinders and I was stunned to see that the #6 cylinder was spiking close to 45 KV's (Figure6). This car had a bad plug wire that was kicking back high KV's into the distributor housing causing a corruption of the low resolution signal. Think about this poor crank angle sensor only trying to do its job while getting hit with some serious lightning bolts. Just imagine you going out to the back yard during a stormy night while carrying in some wood for the fireplace and then all at once a lightning bolt heads your way. Do you really think that you would continue walking to the house carrying the wood or would you drop the wood and run for your life?

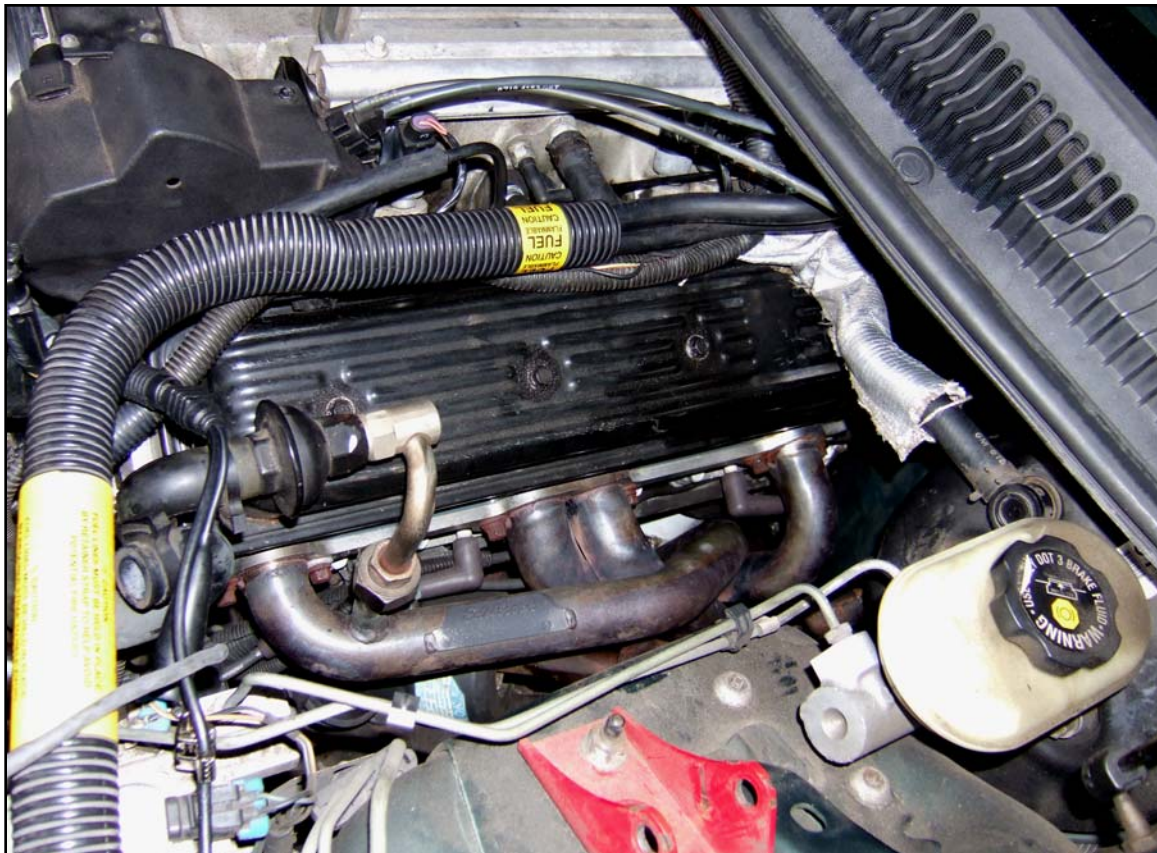
Figure 7 (Opposite Bottom): Someone had changed the stock exhaust and installed header pipes

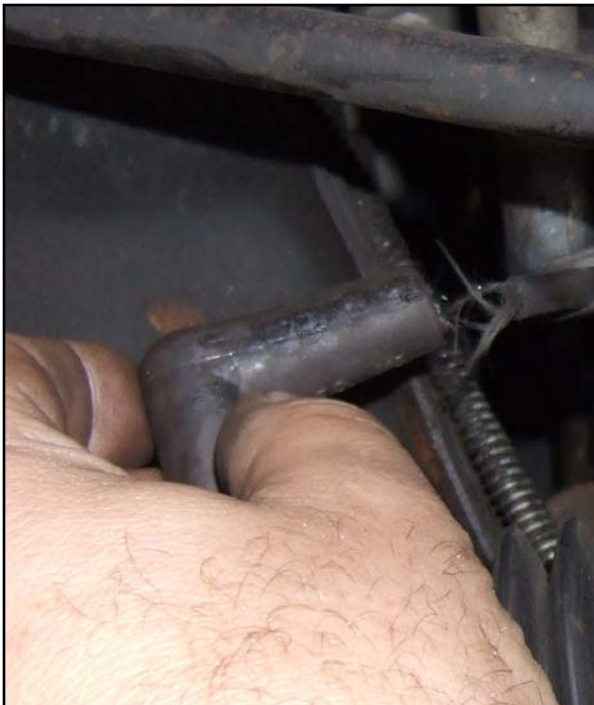
Figure 8 (Below): We lifted the vehicle and removed the #6 spark plug wire and the boot actually separated itself from the wire.

I took a closer look at this engine and noticed that someone had changed the stock exhaust and installed header pipes (Figure7). There was no room to get at some of these plug wires from the top of the engine. The #6 plug wire was only accessible from underneath the vehicle. We lifted the vehicle and removed the #6 spark plug wire and the boot actually separated itself from the wire (Figure8). By the looks of the boot end you could see that these new wires were exposed to some serious heat. I had suggested that maybe the owner may have to invest in another wire set that would be able to handle the heat from these header pipes.
