~~MISTAKEN IDENTITY~~

by: John Anello

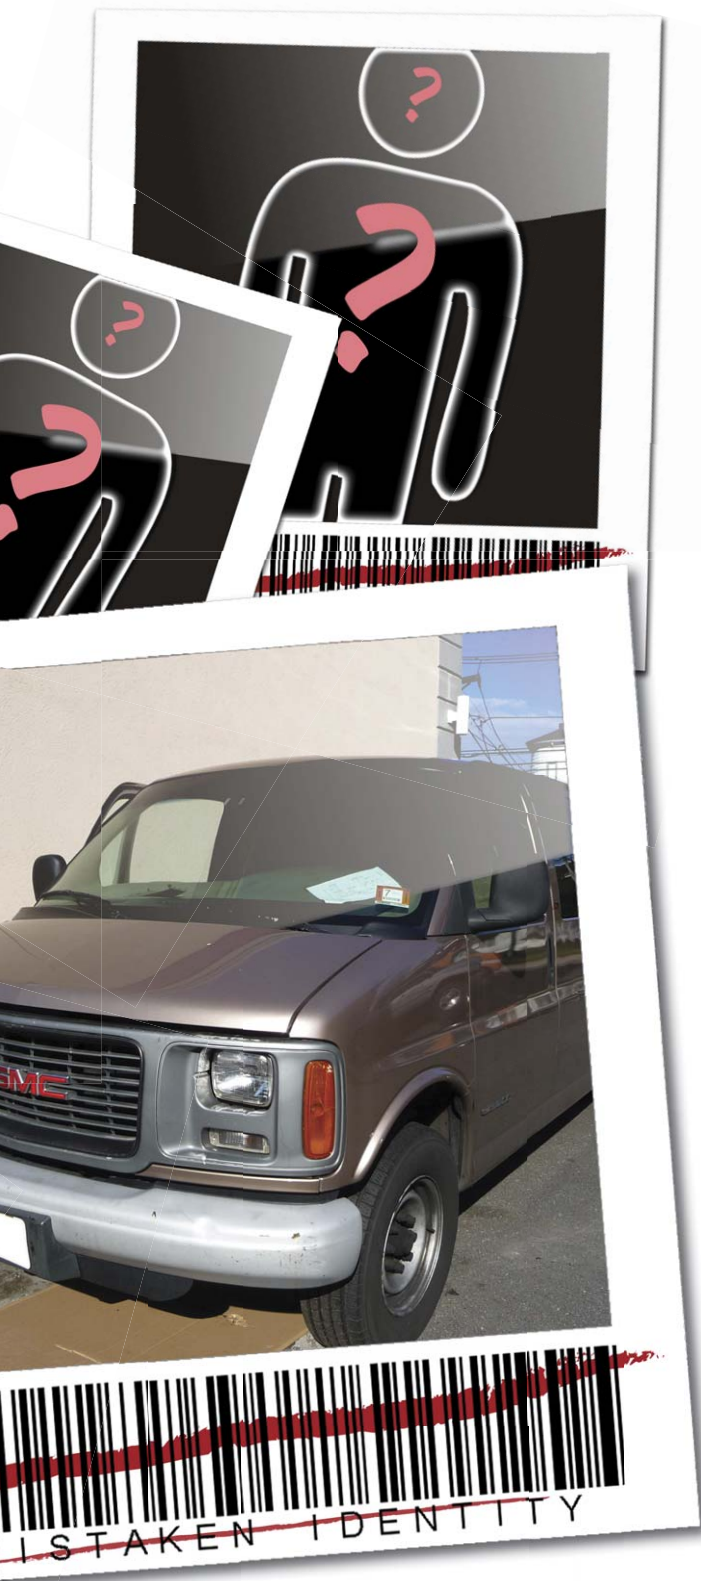
Figure 1: 1997 Chevy van with a 5.0L engine with a hard start no start problem.

I was called to a shop for a complaint on a 1997 Chevy van with a 5.0L engine (Figure 1) with a hard start no start problem. The shop had just replaced the engine because the old engine had a lower knock in it caused by a worn bearing. The old engine did run and the customer drove the van to the shop with no problem other than the knock in the engine. This is a situation that many of us have been in before working in the automotive field at one time or another. It's a bad feeling to drive a vehicle into the shop and later having to push it out. The blame solely lies on the shop even if it isn't the fault of the shop because a jury conviction will sway to the customer's side in court in this case.

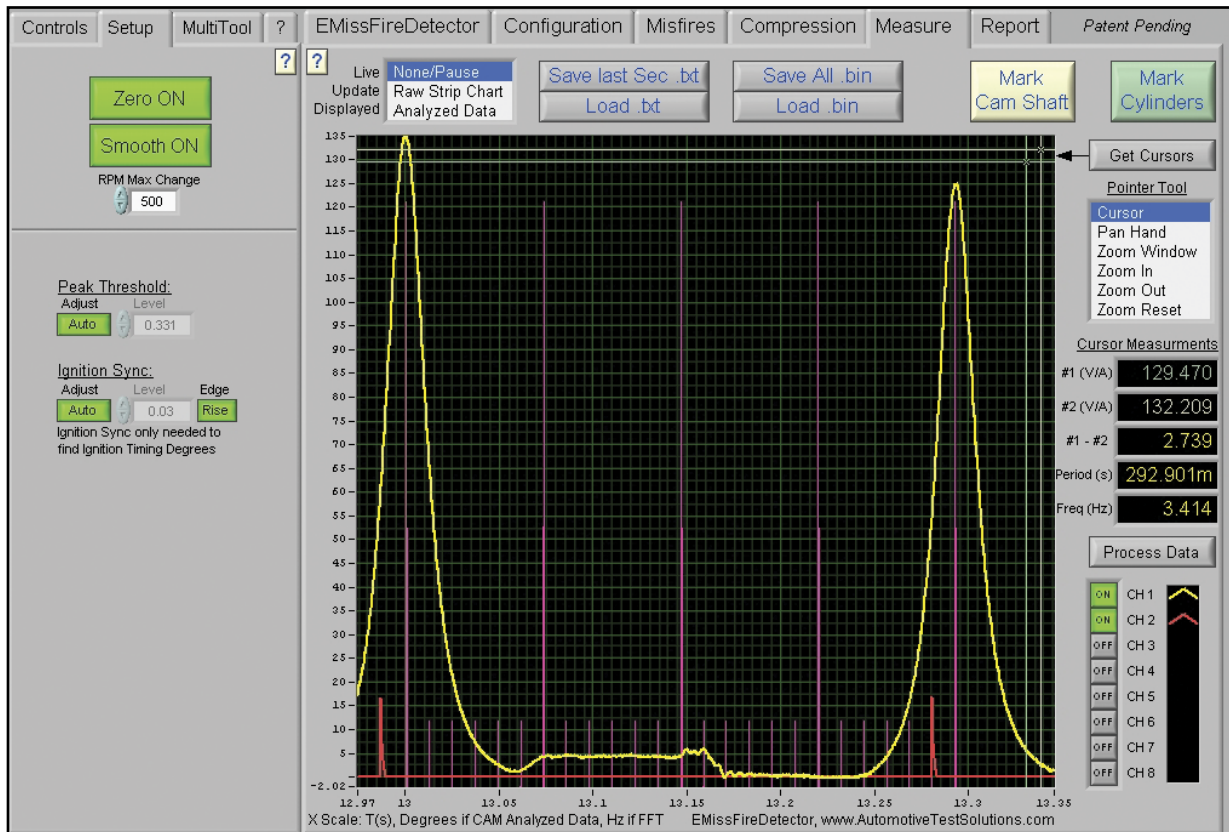
Figure 2: cranked the engine and captured a waveform

on the pressure transducer to check valve timing and another scope lead on the inductive clamp placed around the plug wire for the same cylinder with a spark tester to check spark timing. I cranked the engine and captured a waveform (Figure 2). Each large purple cursor represents 180 degrees of crankshaft rotation while each small purple cursor represents 30 degrees. The large pressure peak represents TDC compression and the first large purple cursor after the large pressure peak represents BDC of the power stroke. After the peak rise the waveform should drop drastically and starts to rise about 30-45 degrees before BDC of the power stroke. This is the point when the exhaust valve will begin to open. By viewing this waveform it was determined that the valve timing was correct.

If you look at the red synch waveform representing spark timing you can see that the spark was occurring about 30 degrees before TDC compression while cranking the engine. The only way this could happen is if the crank and cam sensors were out of correlation.

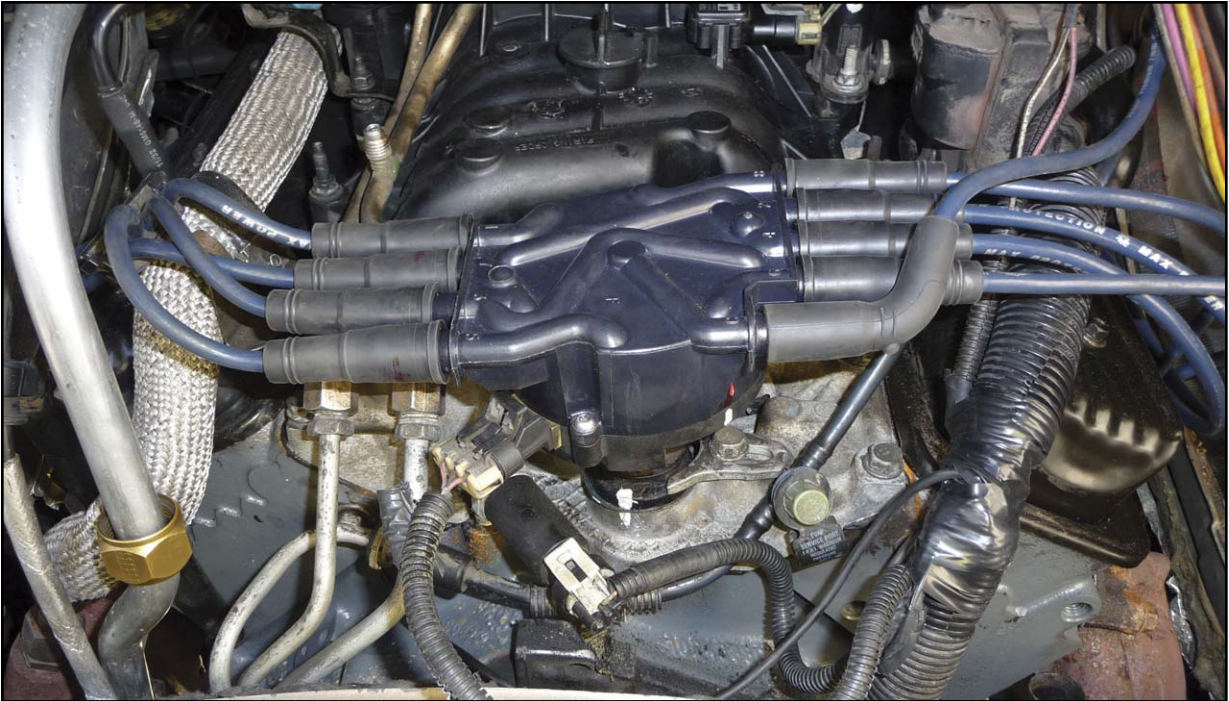
Figure 3: The distributor housing base was marked with the intake manifold to guarantee a correct orientation of the distributor housing location.

mechanic and questioned his ability to set the distributor in properly. He gave me a look like “Are you kidding me dude?”. But I had to ask anyway because the waveforms don’t lie. The mechanic proceeded to show me how he was careful to mark the distributor housing base with the intake manifold to guarantee a correct orientation of the distributor housing location (Figure 3). He next schooled me about the same distributor being used for both the 4.3L and 5.0L and how there were two different positions to index the rotor to the distributor housing (Figure 4). The 6:00 position as viewed in Figure 4 was labeled with a number 8 for correct orientation. It was then only a matter of dropping the distributor into place on TDC compression for #1 cylinder which he did three times.

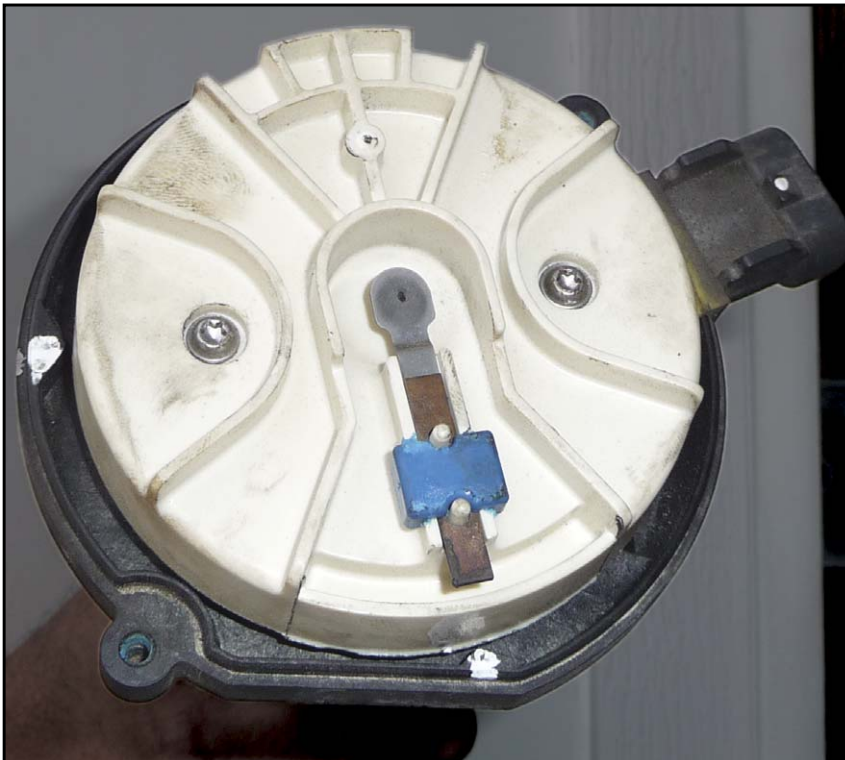
Figure 4: the same distributor being used for both the 4.3L and 5.0L and how there were two different positions to index the rotor to the distributor housing.

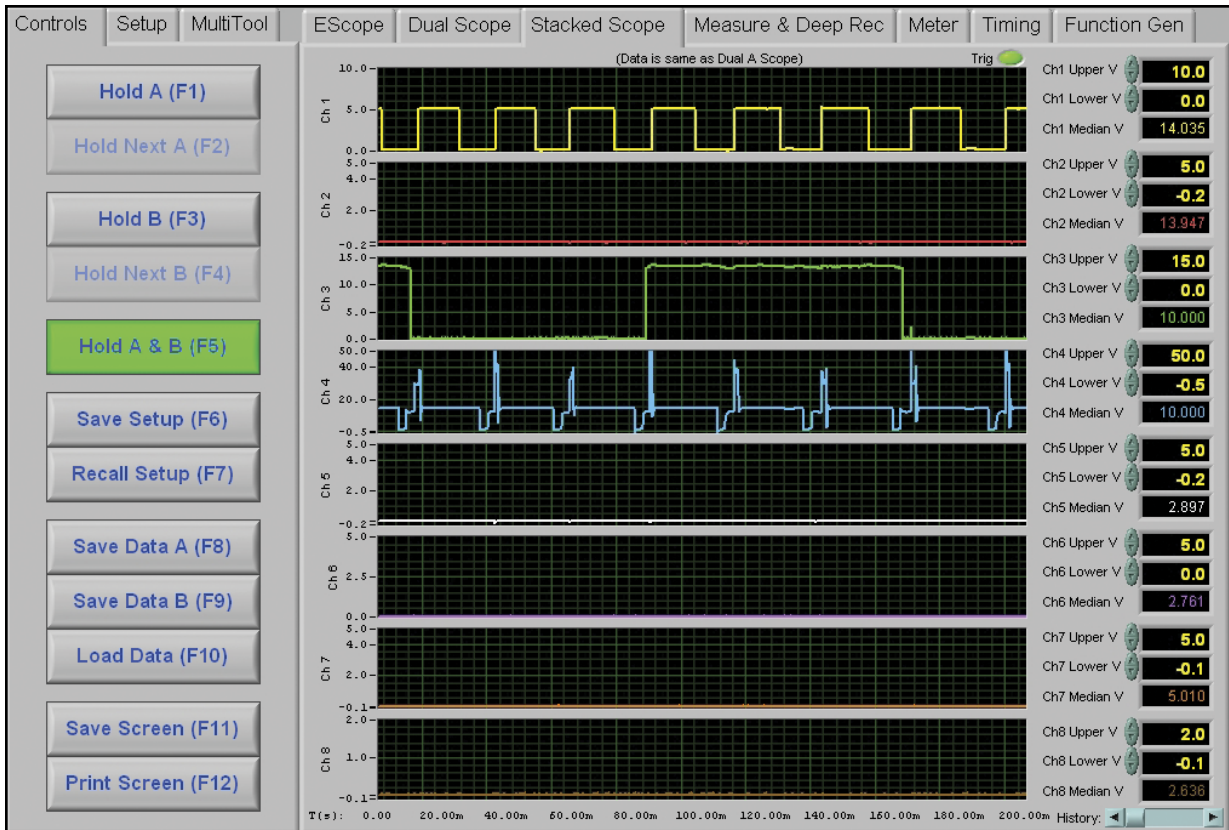
Figure 5 (Above): cranking the engine I captured a waveform to compare with Figure 6 (Below).

Automotive Labs (Figure 6). As I looked closer at both waveform files I noticed that the one captured from the vehicle showed only 6 coil firings with one revolution of the distributor and looking at the crank signal I only saw 6 square waves.

This engine had to have a wrong crank trigger wheel in it.

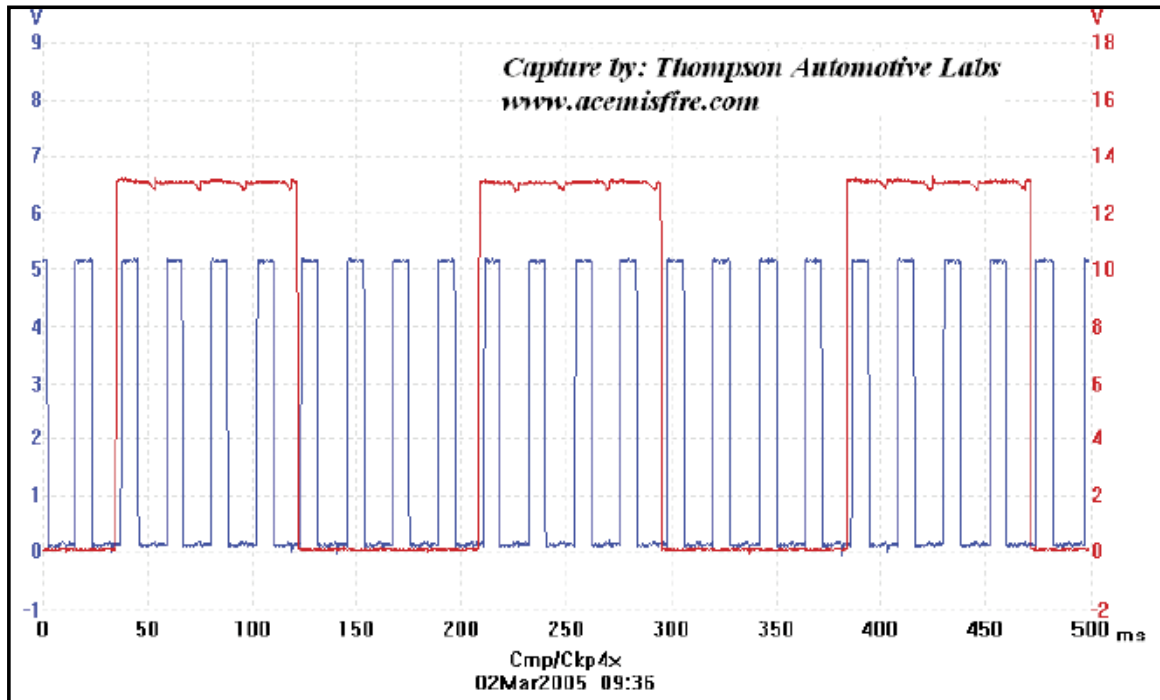
Figure 6: a good known waveform from Thompson Automotive Labs (6M 5.0 --Index).

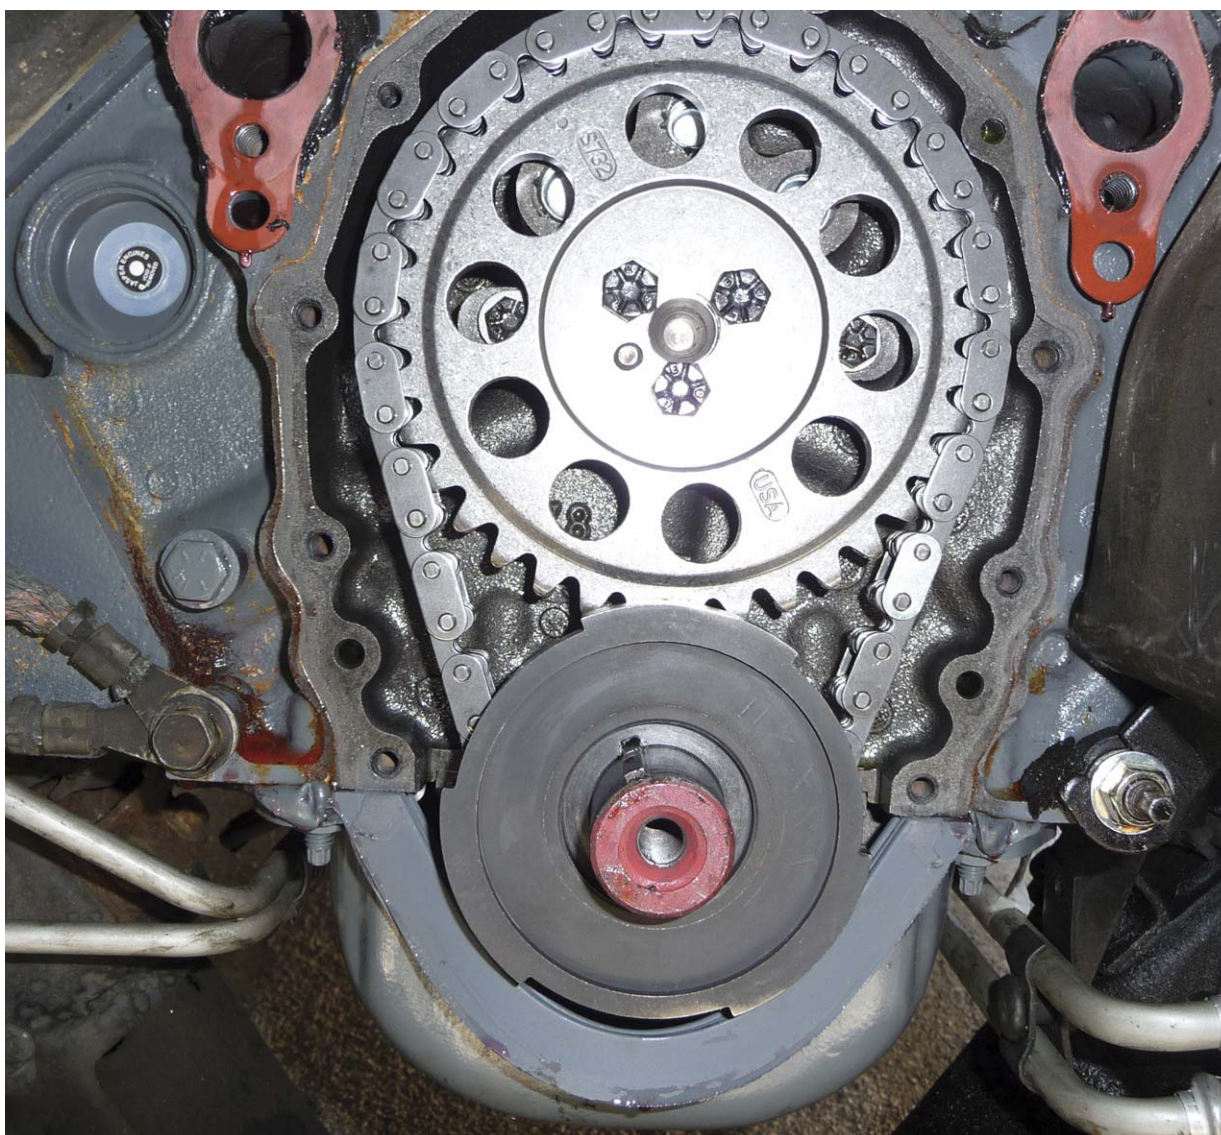
Figure 7: The engine rebuilder had accidentally installed a trigger wheel onto the crankshaft for a 6 cylinder engine instead of one for an 8 cylinder.

revealed, to our surprise we found our culprit (Figure 7). The engine rebuilder had accidentally installed a trigger wheel onto the crankshaft for a 6 cylinder engine instead of one for an 8 cylinder. What a nightmare unveiled! I kind of felt sorry for the shop for all the time they had into dealing with this dilemma. You can't always trust parts you buy and now it's a point where you can't even trust a rebuilder to do his job.

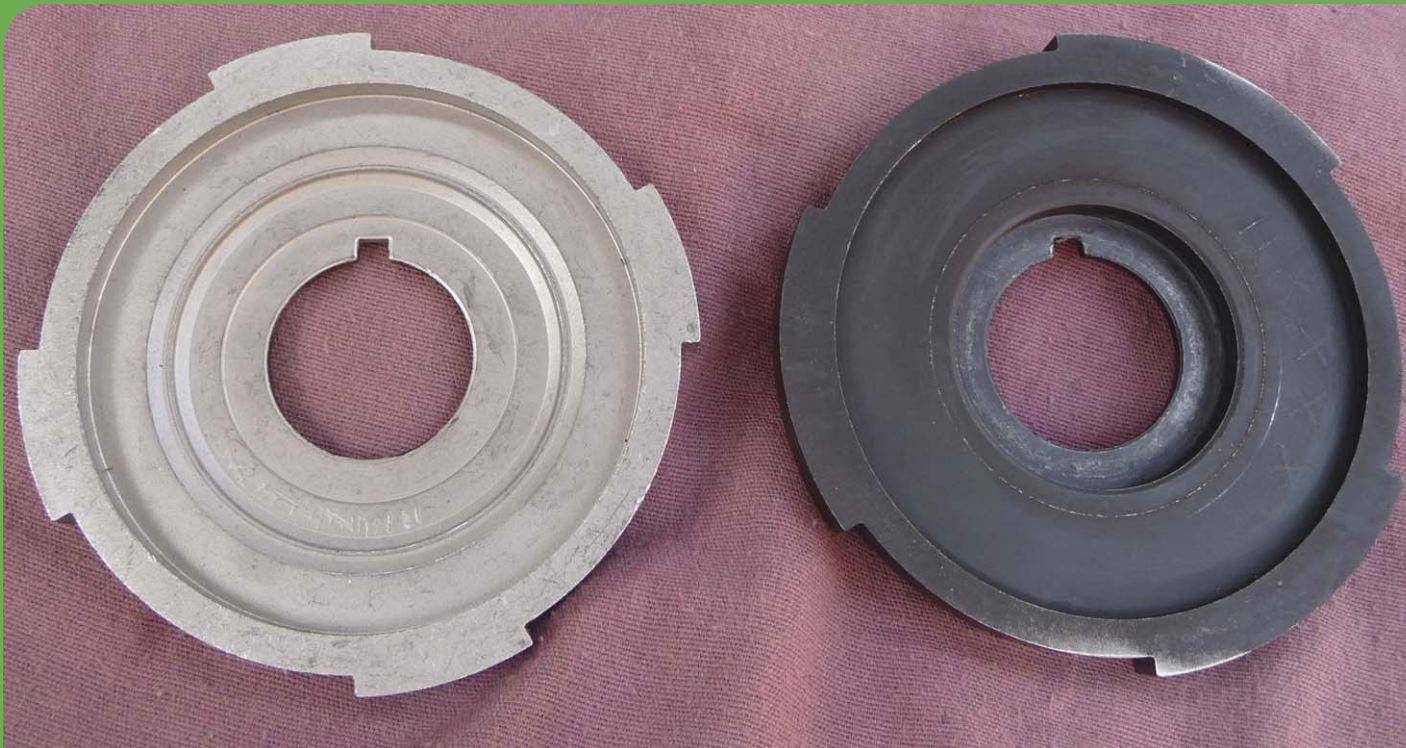
Figure 8: Both trigger wheels are configured to fit on the same crankshaft with no problem. The correct one had four triggers per revolution, instead of three.

trigger wheels side by side that they are both configured to fit on the same crankshaft with no problem at all (Figure 8). The only difference here was that the correct one had 4 triggers per revolution. The mystery was now solved but this was some battle for the shop who could not be paid for all their lost time and unwanted parts. The rebuilder did however apologize and said plainly "It Happens!" I just hope that this one will help to teach you to never take anything for granted and always go with your first feel when you encounter a problem vehicle.
