Durango in Disguise

by John Anello

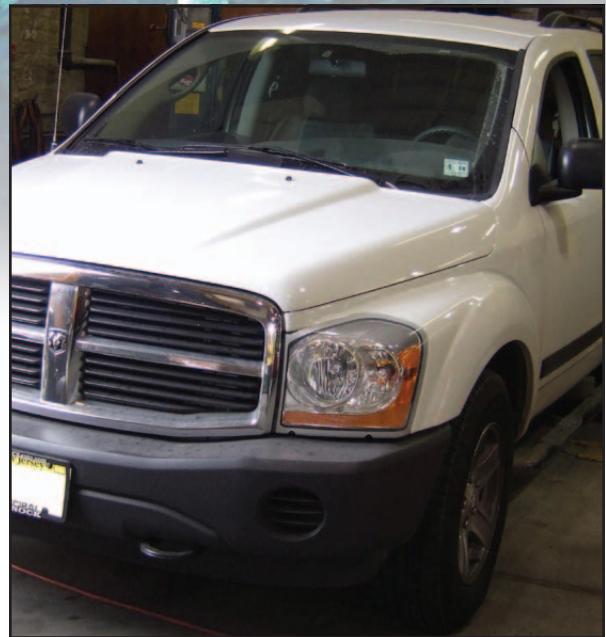
I was called in to a body shop for a complaint on a Dodge Durango that was in a front end collision (**Figure #1**). The truck suffered only minor damage, but the ABS warning light was on. The body shop inspected all the wheel speed sensors for visual damage and made sure the ABS module was properly latched. They also checked all the fuse panels for blown fuses. The shop did not have a scan tool to retrieve any onboard service codes, so I was called in.

Figure 1: Dodge Durango involved in front end collision effected the ABS warning light.

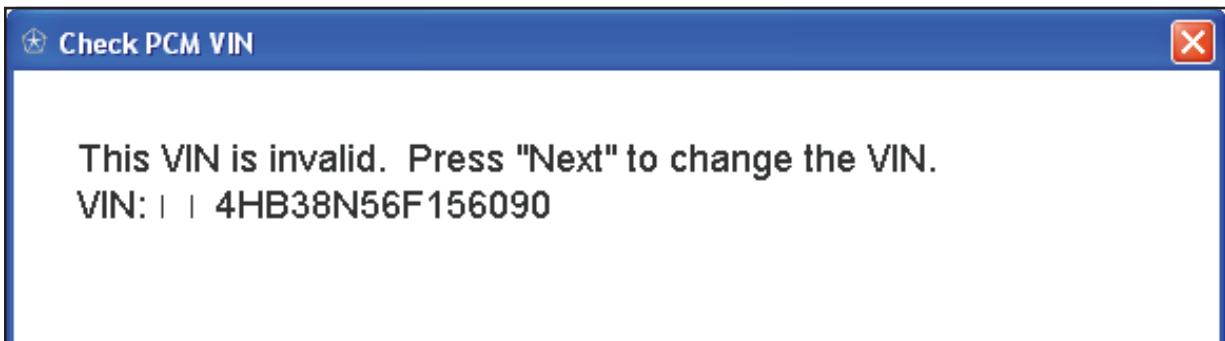
I wanted to view the entire network to see what the other controllers on board were seeing and to get more clues so I could dot the "I's" and cross the "T's." I selected the "All DTC's" menu (**Figure #3**) and discovered that the ABS controller was not the only one pointing a finger. The CCN, FCM and ORC also complained of a VIN mismatch as well as a configuration error. This now ruled out the ABS module as a possible suspect because too many other network fingers were pointing in the direction of the PCM. The body shop told me that they never replaced any controller on board. They also called the owner of the vehicle who stated that, "There never were any lights on before the accident." But you know how that goes. So, my next move was to go to the PCM "Miscellaneous Functions" menu to check the PCM VIN. When I did this, I was surprised to see the "This VIN is Invalid" (**Figure #4**).

Figure 4: Invalid VIN

This was not a case of a wrong VIN, but of one that was corrupted. The first two characters of the VIN were actually vertical space bars. There was no way someone could have typed these in to the PCM because the factory tool does not supply these characters as a selection and the scan tool would never validate such an entry. The only possibility that I could come up with is that maybe when the battery went completely dead, the VIN defaulted to a corrupt insertion of VIN characters. There is also a good possibility that the nonvolatile memory of the PCM could not hold its information properly after a loss of keep-alive

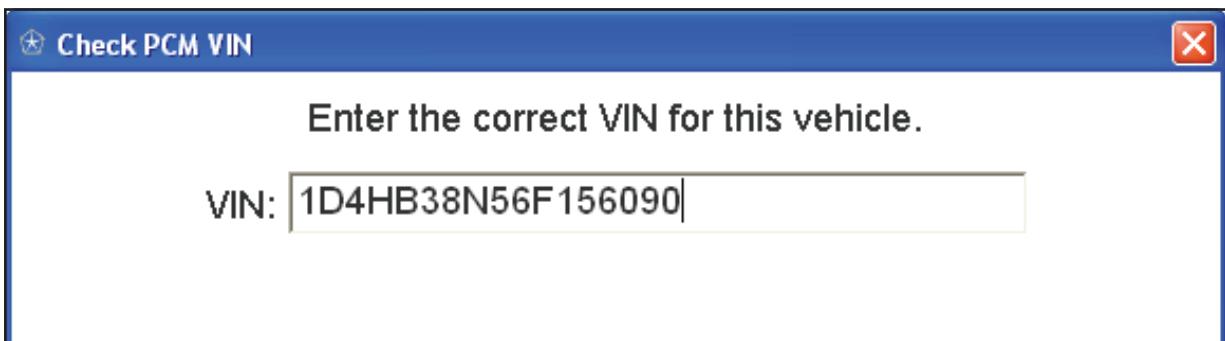
Figure 5: Correct VIN number entered.

power. I selected “Next” and entered the correct VIN characters (**Figure #5**). I proceeded to the following step and the Star Mobile validated the VIN as a good entry (**Figure #6**). I now went back into the “View All DTC’s” menu and cleared the entire network of error codes. I started the vehicle three times in a row with 10 seconds on and 10 seconds off to allow all controllers on board to perform a three-trip integrity check, and the ABS light was now extinguished. As a final check I went into the main ECU View menu (**Figure #7**) and there were no codes stored in any controllers.

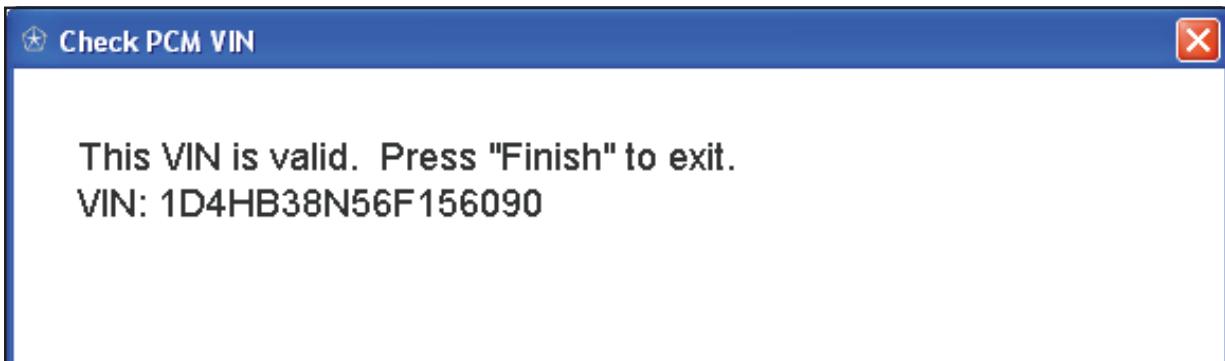
Figure 6: Star Mobile validated the entered VIN.

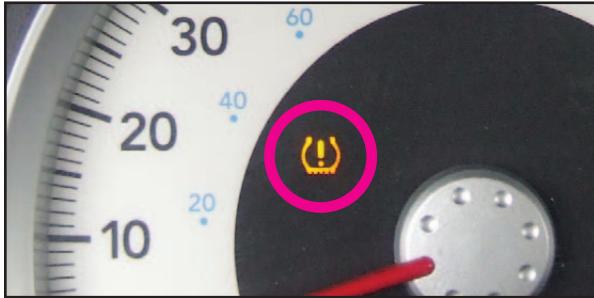
Figure 8: Dodge Durango with complaint of Tire Pressure Monitor light on.

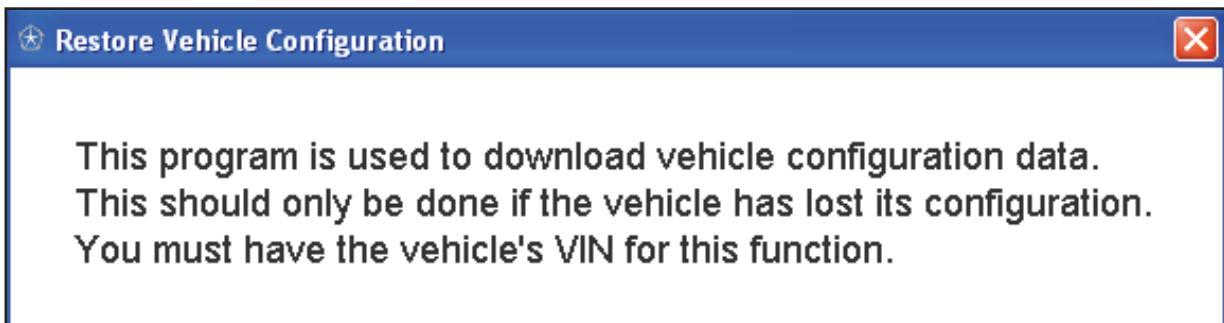
Figure 10: A vehicle restoration using the Vehicle Preparation menu found in the scan tool.

scan tool. Configuration and coding information is usually held in the nonvolatile memory of a controller and should not be lost in battery power loss situations. I have seen many cases of controllers defaulting to factory options, but have never come across one with a corrupted VIN. While I was writing this story, I came across a 2004 Dodge Durango with a complaint of a Tire Pressure Monitor light on (Figure #8) after a battery was disconnected. This vehicle was not equipped with a TPM system. There were also six codes stored in the Cabin Compartment Node pertaining to heated seats that the vehicle also did not have (Figure #9). The only fix was to connect the Star Mobile to Chrysler's server and perform a vehicle restoration using the Vehicle Preparation menu found in the scan tool (Figure #10). I hope this story will shed some light to help you through a similar adventure.
