# On The Outside Looking In

by John Anello

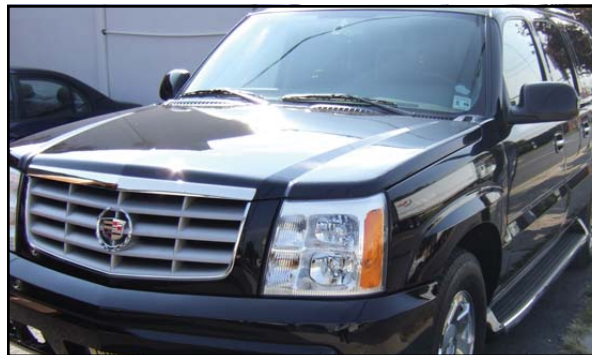
I was called in to a shop that had a complaint of an illuminated check engine light (MIL) on a 2005 Cadillac Escalade with a 6.0L V8 (Figure 1). The shop was wrestling with an IAT temp code, but was hesitant about changing the MAF sensor due to the low mileage (18,000) on the vehicle. The IAT sensor wiring at the sensor checked out fine, but the shop was still seeing a negative value on the IAT sensor reading on the scan tool. The Intake Air Temp sensor on this vehicle is incorporated within the MAF sensor assembly. Hanging one of these sensors on the engine without any results could prove to be a costly mistake. If you purchase a part and it doesn't resolve the problem, the wedding ring goes on and you're now married to the vehicle. It becomes a love/hate relationship with no turning back because you have now committed yourself to fixing the car. You could, however, choose divorce, but that would only lead to you having to eat the unwanted parts and losing the trust of your customer, who may label you as a parts changer.

Figure 1: 2005 Cadillac Escalade with a 6.0L V8 and illuminated check engine light (MIL).

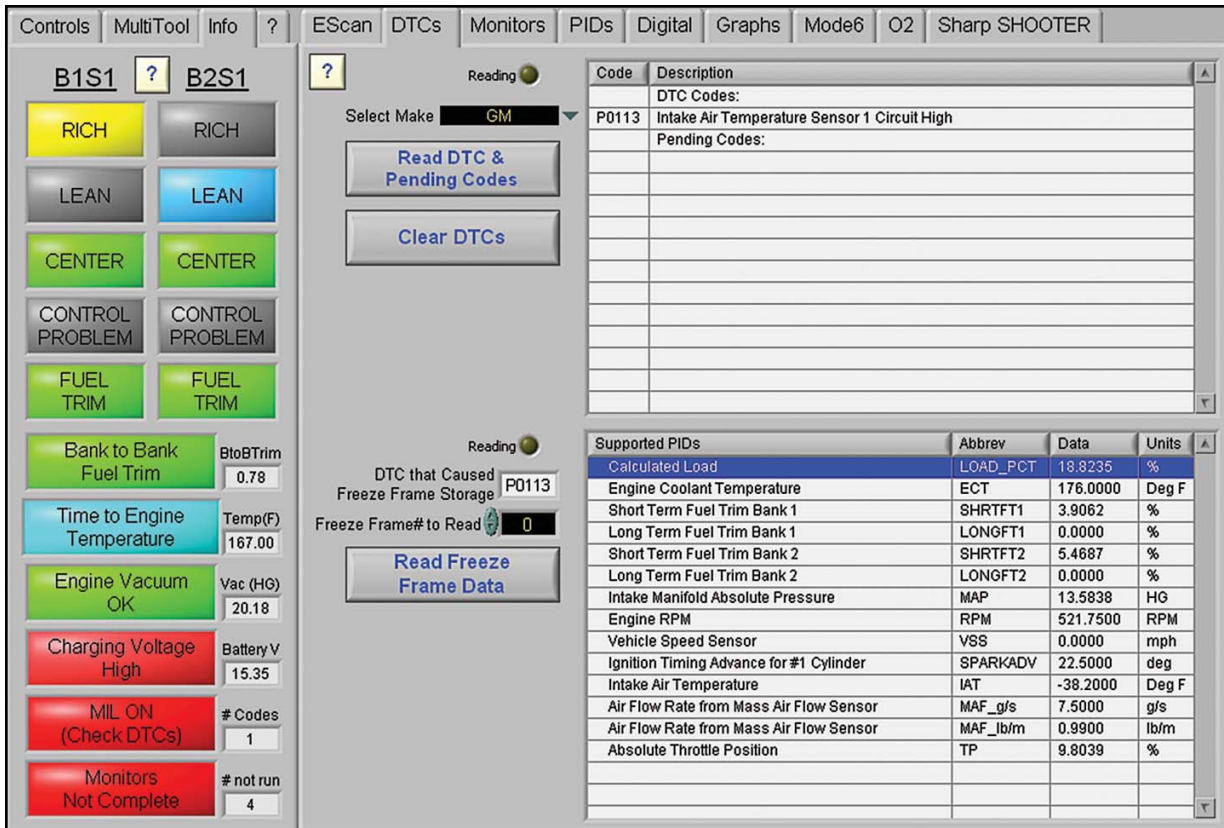
I first scanned the vehicle (Figure 2) and pulled a code P0113. This indicated that the circuit was high above the threshold allowed for the sensor's range

Figure 2: First vehicle scan pulls up a code P0113.

of operation. By also looking at the freeze-frame (Figure 2), you can see that the engine was at an operating temperature of 176 deg. F. when the IAT sensor failed with a reading of -38 deg. F. The freeze frame information holds a lot of value for a technician by allowing him or her to actually see what events took place at the time of the failure. It's important for a technician to have a set of parameters to view, such as rpm, coolant temperature, throttle position, air flow rate, fuel trim information, and even vehicle speed. This can provide criteria that may be needed in order to duplicate the problem, especially if it's not present at the time the vehicle is driven to the shop. There are a lot more freeze frame PIDs available on newer OBD II systems, and this list will only get bigger in the future.

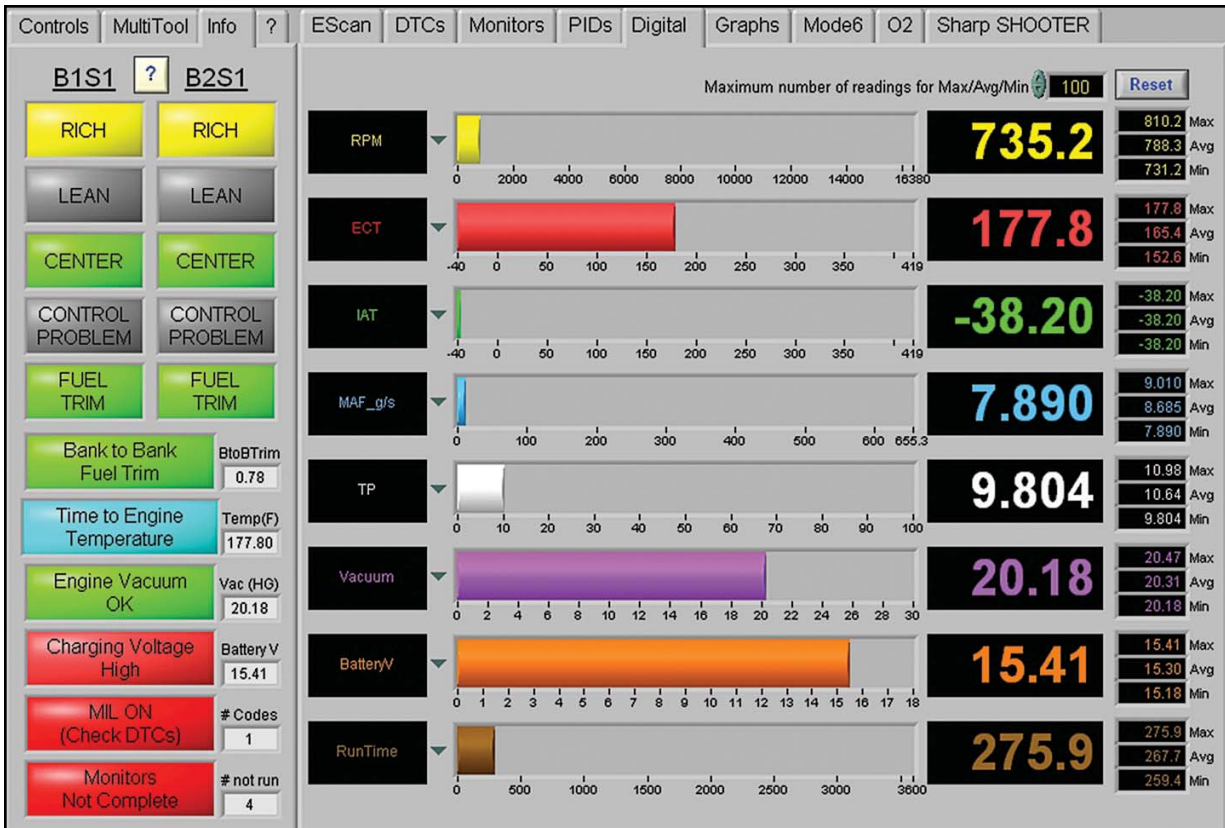
To verify the IAT failure, I selected the IAT parameter in digital format (Figure 3) and I could see the -38 deg. F. value on the scan tool. What was also interesting was that the scanner pointed out that the vehicle was over-charging at 15.3 volts. This can be seen in the left side bar of the screen shot

Figure 3: To verify the IAT failure, I selected the IAT parameter in digital format and I could see the -38 deg. F.

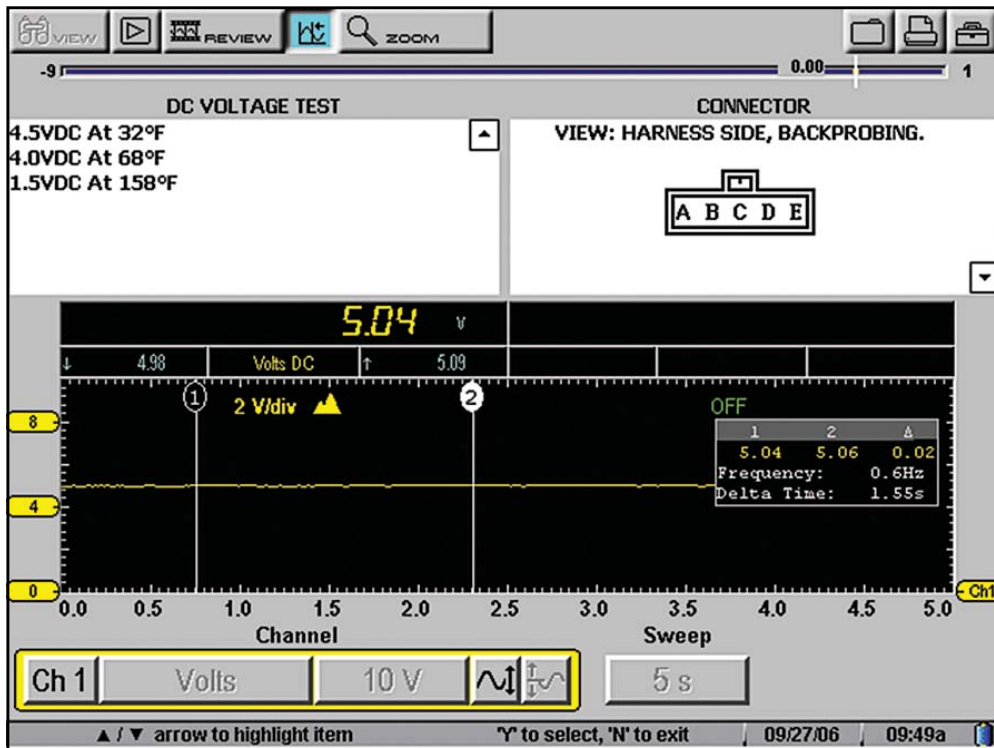
I went back to the IAT sensor connector to take a reading with my component tester and found the IAT sensor line to be at 5V (Figure 4). According to the component tester screen and taking into account the high temperatures within the engine compartment, the IAT value should have been well below 4.0 V. The only way the reference voltage could be at 5V is if the reference ground was bad, or the sensor was on an open circuit. I checked the reference ground at the sensor connector and found it to be well below 100mV, so my next move was to unplug the sensor to check

Figure 4: The IAT sensor line to be at 5V

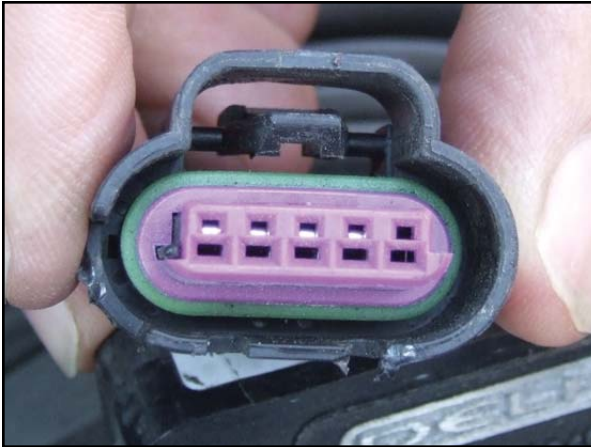
Figure 5: After pulling the connector, only four pins show at the end of the connector.

the integrity of the connector. It is not uncommon for a connector to have a collapsed pin, or even a broken stranded wire so it's only being held together by the insulation. When I pulled the connector (Figure 5) I was surprised to see only four pins showing at the end of the connector. The IAT reference ground had backed out of the connector (Figure 6).

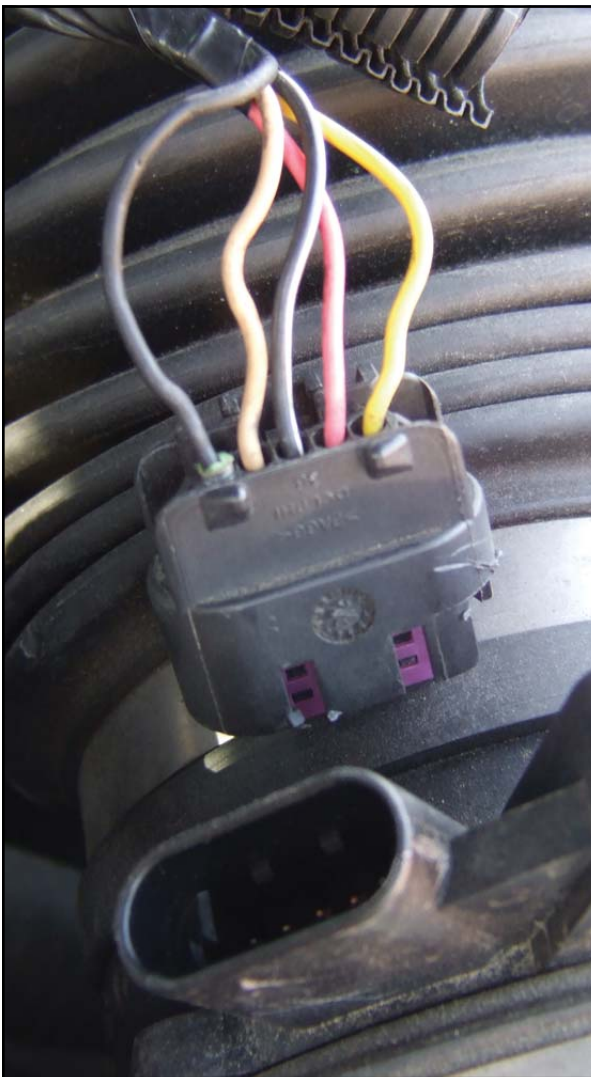
Figure 6: The IAT reference ground had backed out of the connector.

The connector pin could have been pulled out when someone was replacing the air filter and inadvertently tugged on the MAF harness connector. It was an unforeseen problem that could be mistaken for a component failure. But let's get back to the high charging volts of the alternator, and why it was now okay. I gave this one a lot of thought and just applied some logic to the voltage readings I saw on the scan tool. The PCM saw the ambient temperature of -38 deg. F. and decided to up the charging rate of the alternator to keep the electrons within a very cold battery moving. This was a normal reaction of the PCM to counteract the frigid ambient conditions it believed the vehicle was exposed to. Once I repaired the problem, the PCM saw the correct ambient temperature and lowered the charging voltage back to a normal state. If you'll remember, Chrysler also used the IAT sensor to control charging voltage according to ambient temperature. This is why the company renamed its IAT sensor a "battery temp sensor" and relocated it much closer to the battery.

At this point I simply pushed the pin back in place and reinstalled the connector. I took another reading with my component tester (Figure 7) and I could see the IAT sensor value came back down to the proper level of about 2.5V. I erased the codes and started the vehicle up again to view the IAT sensor value, which was now reading about 86 deg. F. (Figure 8). To my surprise, the charging voltage also came back to a normal reading of about 14.66V (Figure 8).

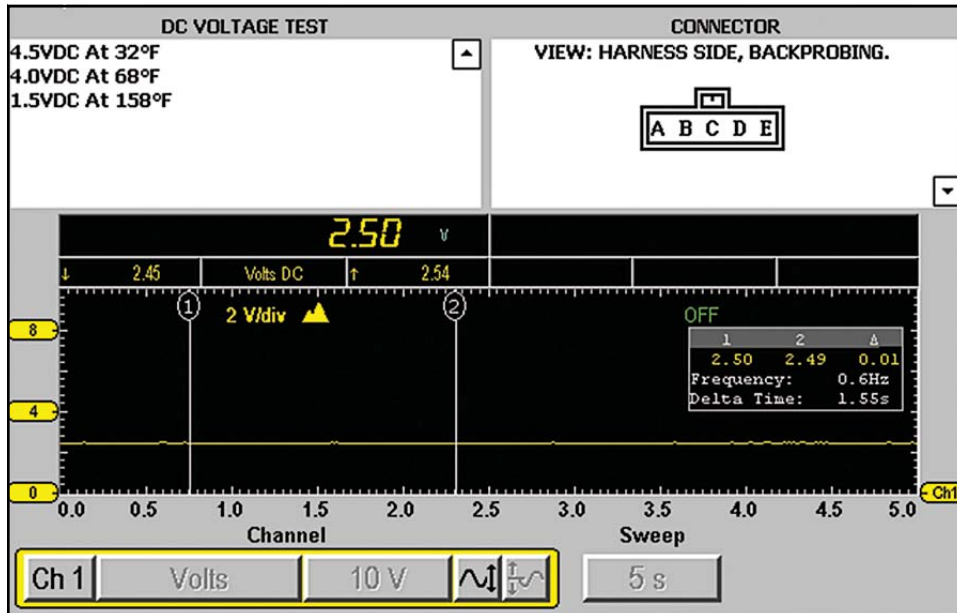
Figure 7: Another reading with the component tester and the IAT sensor value came back down to the proper level (~2.5V).

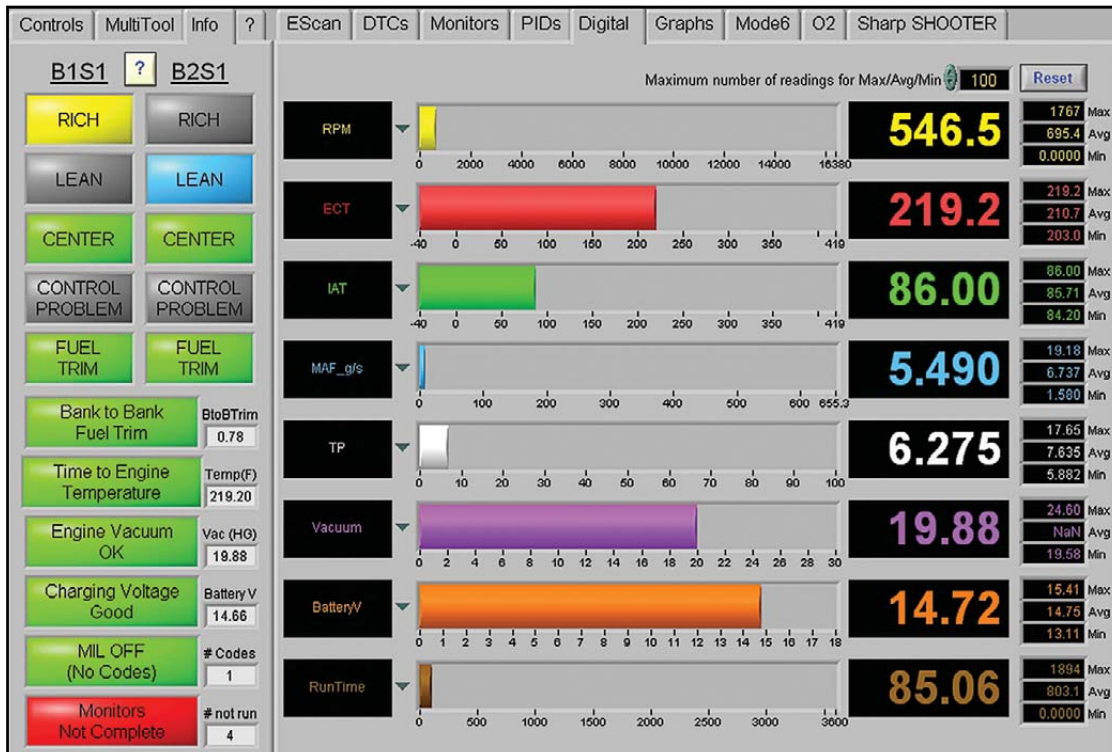
Figure 8: Both the IAT sensor value and charging voltage return to normal readings.
