# The Cadillac Story

These days, when we see a wheel speed sensor code can we really afford to just throw a new sensor at it? For most GM vehicles, that means a whole wheel bearing assembly. With parts and labor being what they are, we'd better make sure.

by Kerry Jonsson  
Image courtesy GM.  
© GM Corp.

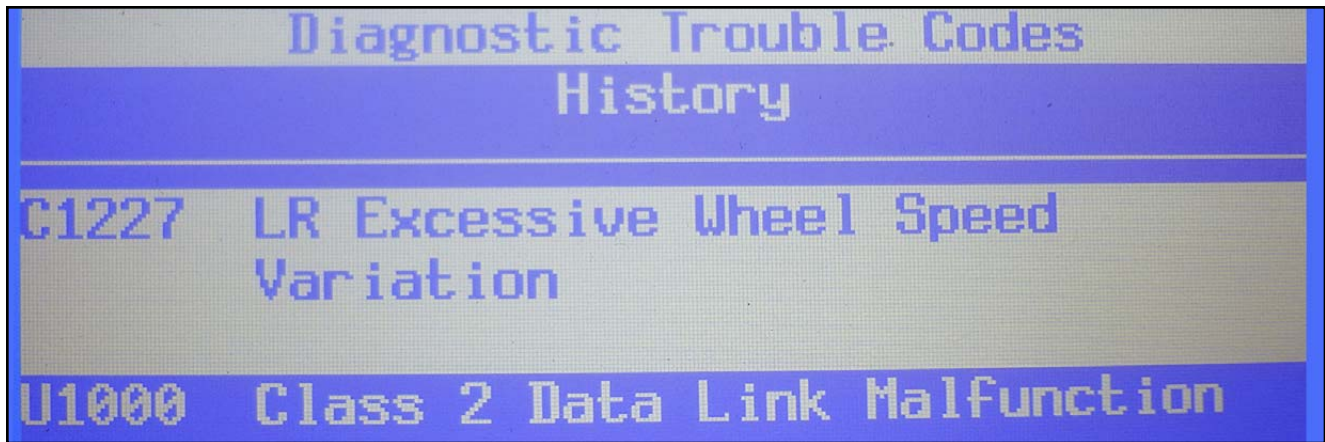
This 2002 Cadillac Seville SLS had come in with the ABS and TCS warning lights on and this code C1227. The U1000 code never returned, but the C1227 did. Our first inclination was to change the bearing/sensor assembly.

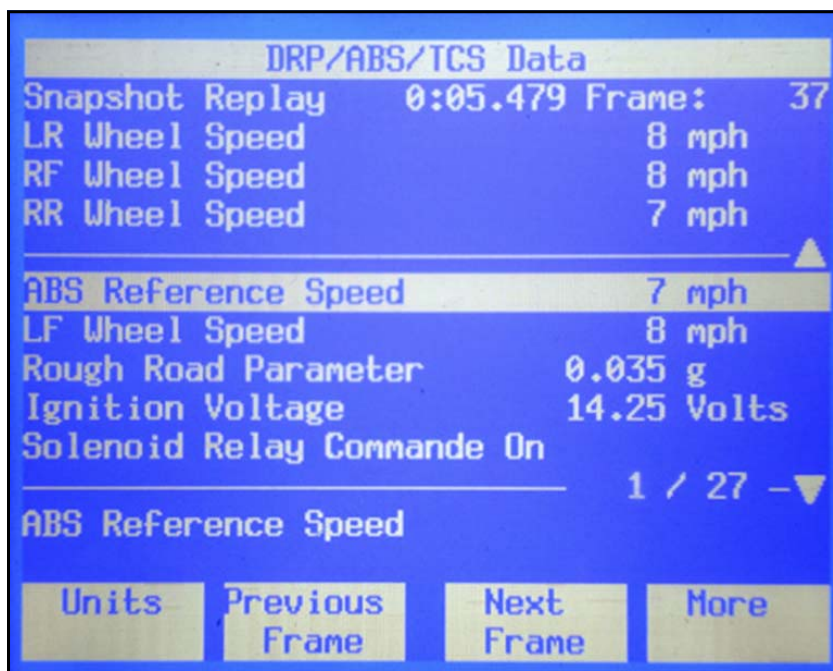
*After road testing and scanning out data, we saw the wheel speeds were very close together and did not think that this would set a code. The problem was deeper, so we put down the scan tool and started checking with our DMM.*

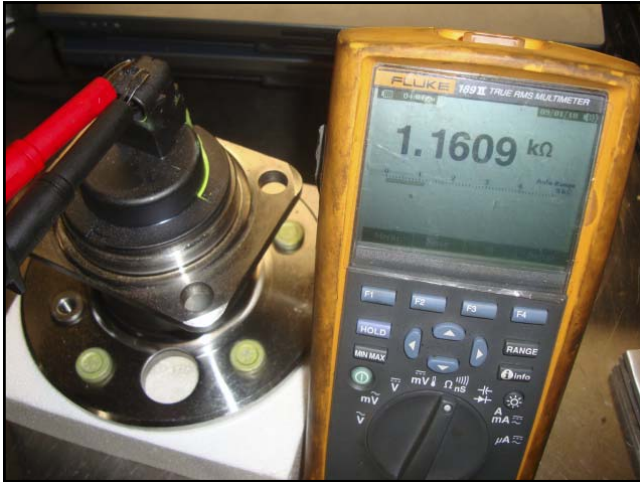
*We checked resistance at the sensor for both the left and right wheels. There was a 200 ohm difference between the OEM bearing and its aftermarket replacement. We had to ask if this was enough of a difference to flag a code.*

Maybe we had a bad replacement part. It was not OEM and we hear there are a lot of cheap parts being made in developing countries that make their way to our parts shelves. We were going to have to diagnose this problem all over again. We went back and checked the resistance of both sensors. The new replacement sensor read 1,300 ohms, whereas the old sensor on the other side measured 1,100 ohms. Was this enough to generate a difference in the AC voltage pattern? We decided to check the AC voltage coming off the wheel speed sensors while spinning the wheels by hand. With each wheel, we were able to generate .5 of a volt and both were pretty even. These measurements were taken at the sensor itself, so the wiring leading to the control unit wasn't taken into account. What were we going to have to do to check that?

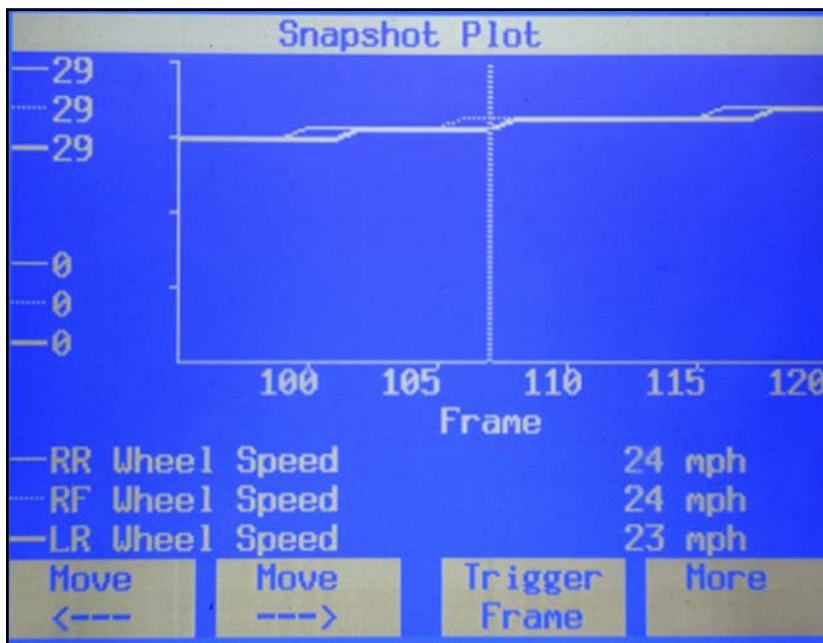
*The graphing function is a great help in diagnosing wheel speed sensors is. Here we have sensors that are pretty close together, but little did we know the problem was only at very low speeds.*

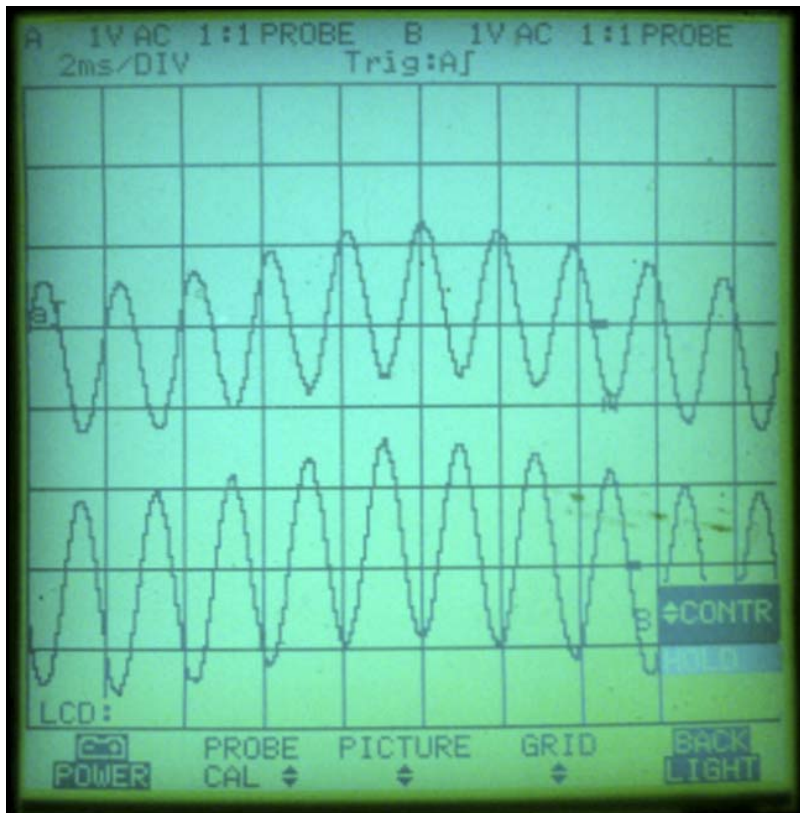
*We also scoped the two rear wheel speed sensors together and even though there was a slight voltage difference the code did not return and the scan data reflected the correct speed even when at low speed.*

While looking at the scope signals during the drive (with someone else driving, of course -- this is for the lawyers), we noticed a slight difference in the amplitude of the voltage signal. The right rear was putting out just under one full volt, but the left rear was putting out just over one volt, maybe 1.25 volts. Remember that the resistance values were slightly different and therefore the AC voltage signals could be slightly different. We were stumped at this point, so we started thinking outside the box.

Cleaning the connector at the EBCM and adding the Stabilant-22 corrected the electrical connection of the left rear wheel speed sensor. If we hadn't followed our habit of cleaning pins and applying electrical contact enhancer whenever we unplug a connector, the problem would still not have been fixed. Now, we may have actually had a bad bearing. The problem did take a few days to come back. It had seemed like a straight-forward repair at the time.
