Driver's Seat Diagnostics

by John Anello,
"The Auto Tech on Wheels"

I was called to a shop on a 2006 Lincoln Navigator (Figure #1) 5.4L with a complaint of a rough-running engine. The techs pulled some O2 sensor lean and rich codes along with some variable valve timing codes. They were not too familiar with the operation of the variable valve timing system on this vehicle, so they decided to get a more in-depth diagnosis before making any major decisions on where to go.

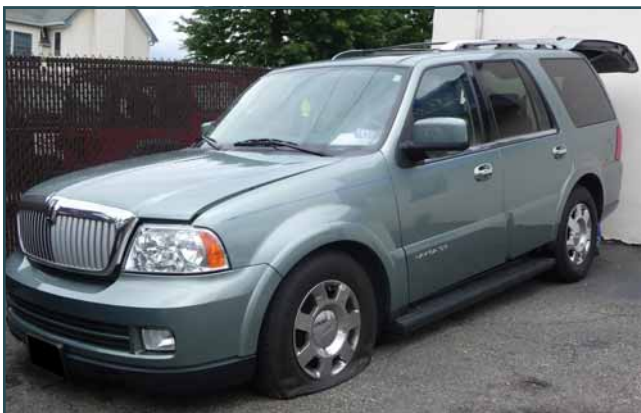
Figure 1: 2006 Lincoln Navigator with a complaint of a rough-running engine.

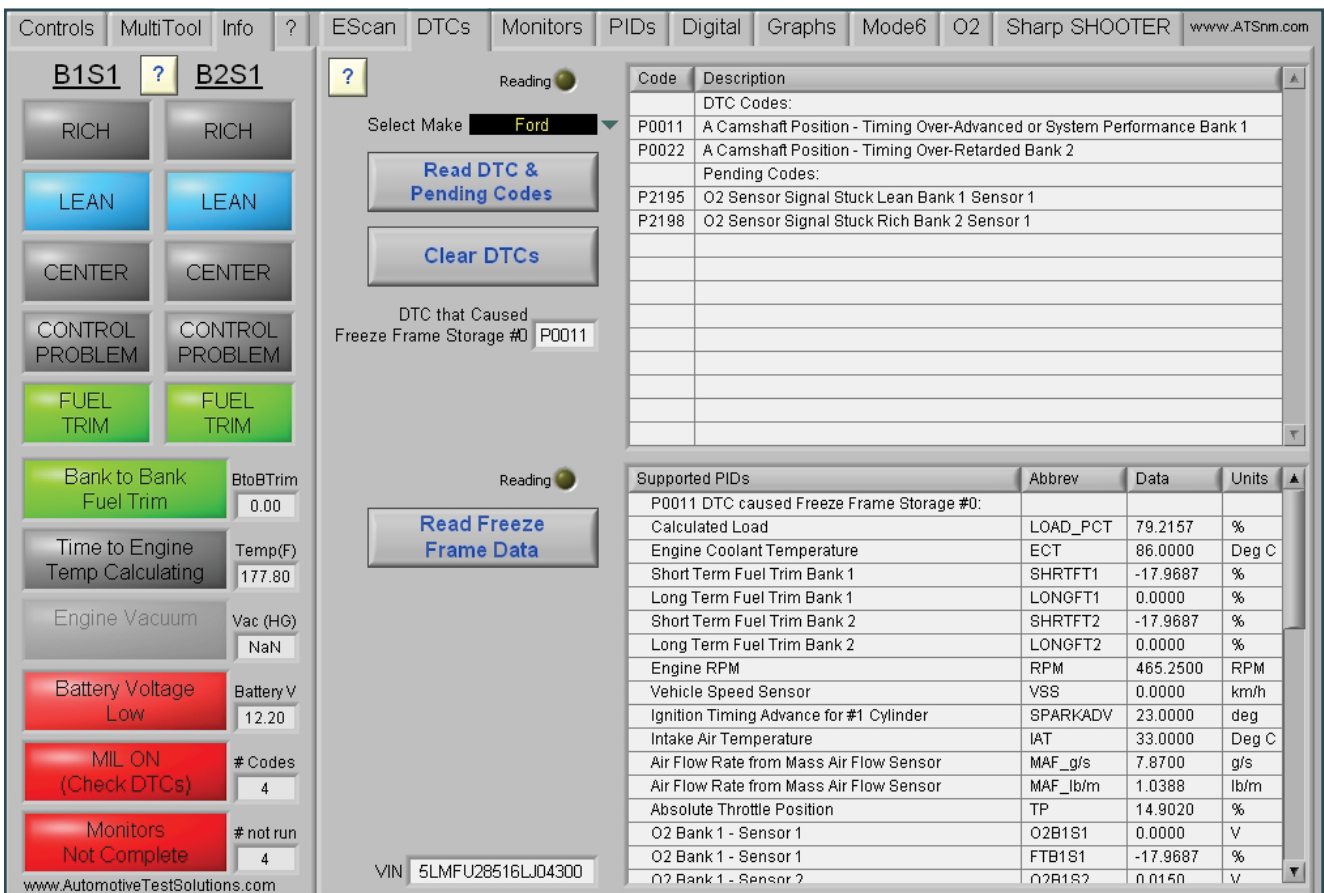
When I arrived at the shop I hooked up my generic Escan tool just to pull and verify the codes that had already been retrieved (Figure #2). There were P0011 and P0022, which related to the position of Bank #1's camshaft being over-advanced, and Bank #2's camshaft being over-retarded. The PCM in this vehicle was using two camshaft positioning sensors to perform a check and balance of the variable valve timing system. The command was given to each camshaft to move to a certain position while the PCM had the ability to validate if the camshaft sprockets were actually in the correct commanded positions. There were also O2 codes P2195 and P2198 stored in memory stating that Bank #1 was running lean while Bank #2 was running rich. These O2 codes were in the mi,x but you need to keep in mind that an engine with mechanical or hydraulic problems can easily mess up the fuel trims and create a lean or rich condition. So, I decided to home in on VVT.

Figure 2: Generic EScan tool readings for verification.

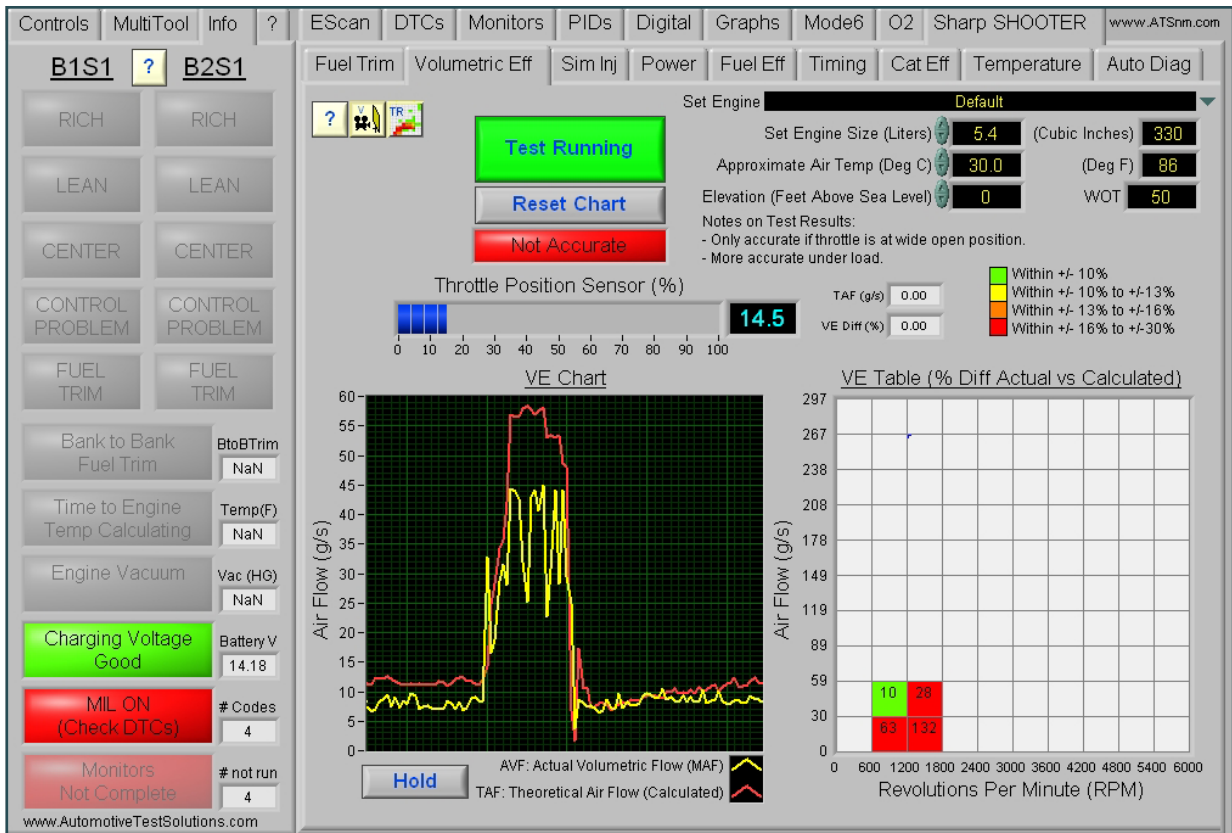
test the volumetric efficiency. I set the engine size to 5.4L, ambient air temp to 86 deg. F., and my elevation at sea level. I next power braked the engine to wide open throttle and graphed my readings within the program (**Figure #3**). The red graph represents the theoretical air flow as calculated by the program, while the yellow graph represents the actual volumetric flow. By looking at the yellow graph you can see that not only was the volumetric efficiency of this engine low, but the air volume was moving in and out of the MAF sensor. I have seen this erratic air flow many times before using this VE graph and it is usually a clear indication that the engine either has a clogged exhaust or a valve timing problem where the intake valves are not properly closing as the piston is reaching top dead center of the compression stroke.

Figure 3 (Above): The engine, power braked, wide open throttle and graphed the readings.

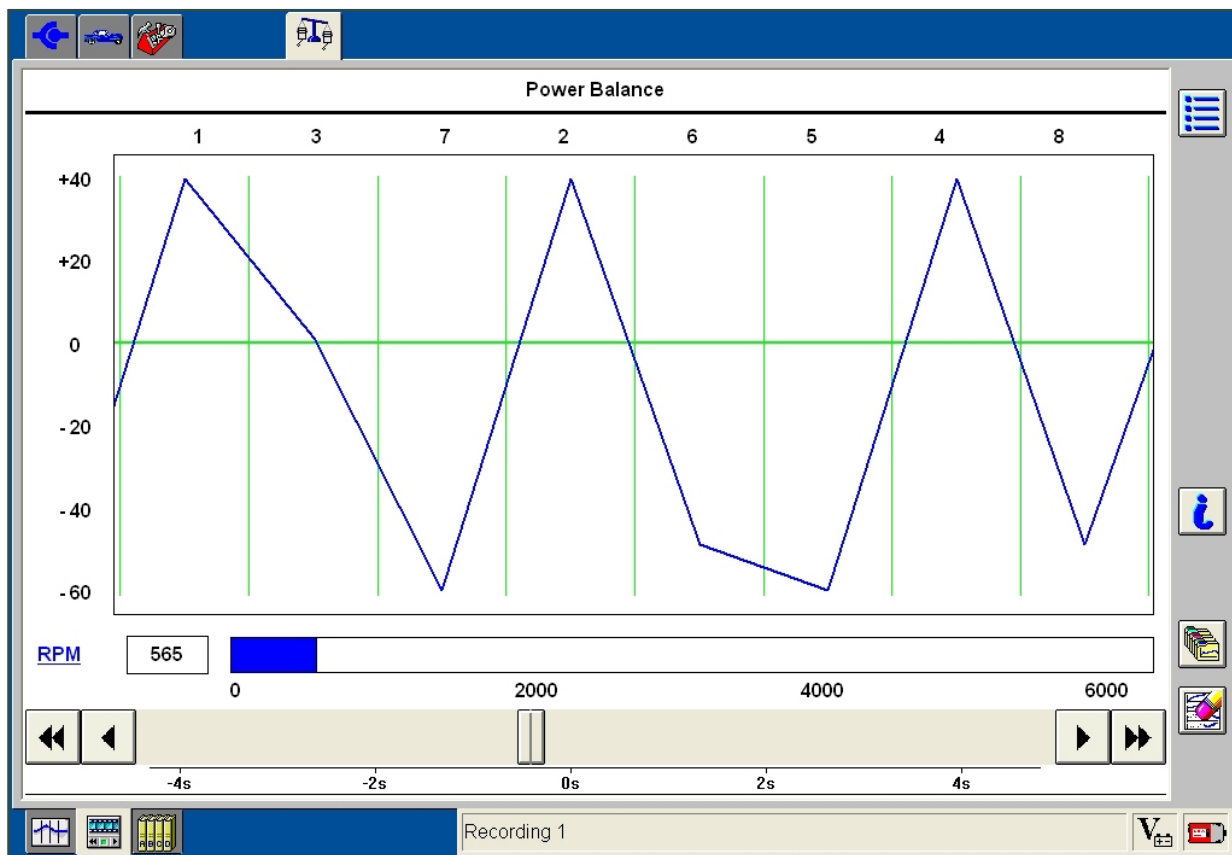
To stay in the driver's seat of diagnostics and still not being too intrusive, I decided to hook up my Ford IDS scan tool for some enhanced engine diagnostics that the tool claimed to perform. My first step was to verify which cylinders were creating the roughness in the engine. This I did by using the power-balance mode (**Figure #4**). In this mode I was able to see the PCM monitor the speed of each individual cylinder's crank throw by means of the crank

sensor. You can see that cylinders #5, 6, 7 and 8 were all below the zero line. Normally this pattern would run close to the zero line with slight deviations of plus or minus 5% and any large "V" spike below the zero line would indicate a misfire. Taking into consideration that cylinders #5, 6, 7 and 8 all share the same Bank #2 cylinder head, I was leaning toward a valve train problem with that bank.

Figure 4 (Below): Verify which cylinders were creating the roughness in the engine, by using the power-balance mode.

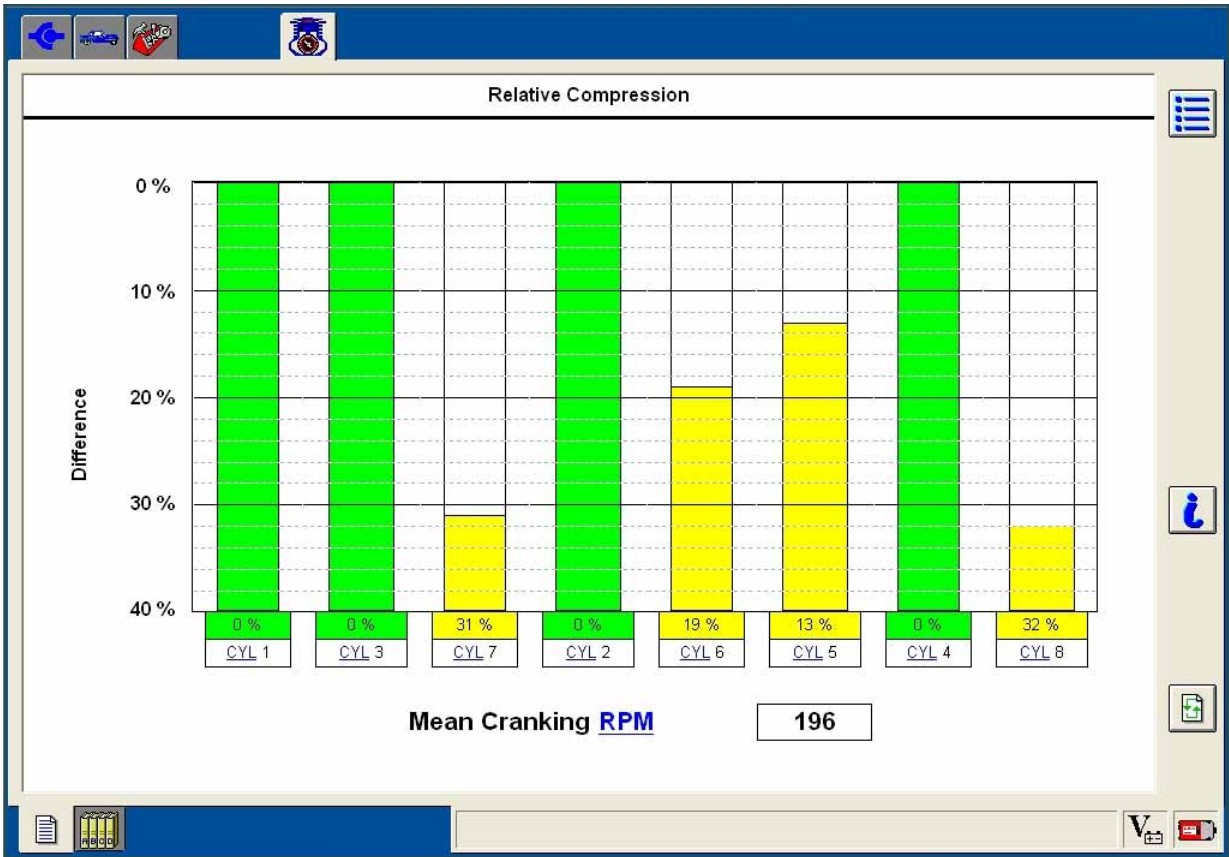
I moved on to the cranking compression test that I have found to be a solid Ford IDS procedure that has yet to let me down. Again, this uses the crank sensor to determine the speed of each cylinder as it monitors the slow-down of crankshaft speed as each piston comes up on the compression stroke. A weak cylinder doesn't slow the crankshaft as much as a stronger one does, thus showing up as a low-compression cylinder. As I cranked the engine at wide open throttle to prevent the injectors from firing, I captured a cranking compression chart (**Figure #5**). You can see by the chart that cylinders #5, 6, 7 and 8 all had low compression as compared to Bank #1's cylinders. It's convenient that this can be done without ever having to pull the spark plugs and measure the compression of each cylinder with a mechanical gauge. This is technology at its best!

Figure 5 (Above): A captured cranking compression chart.

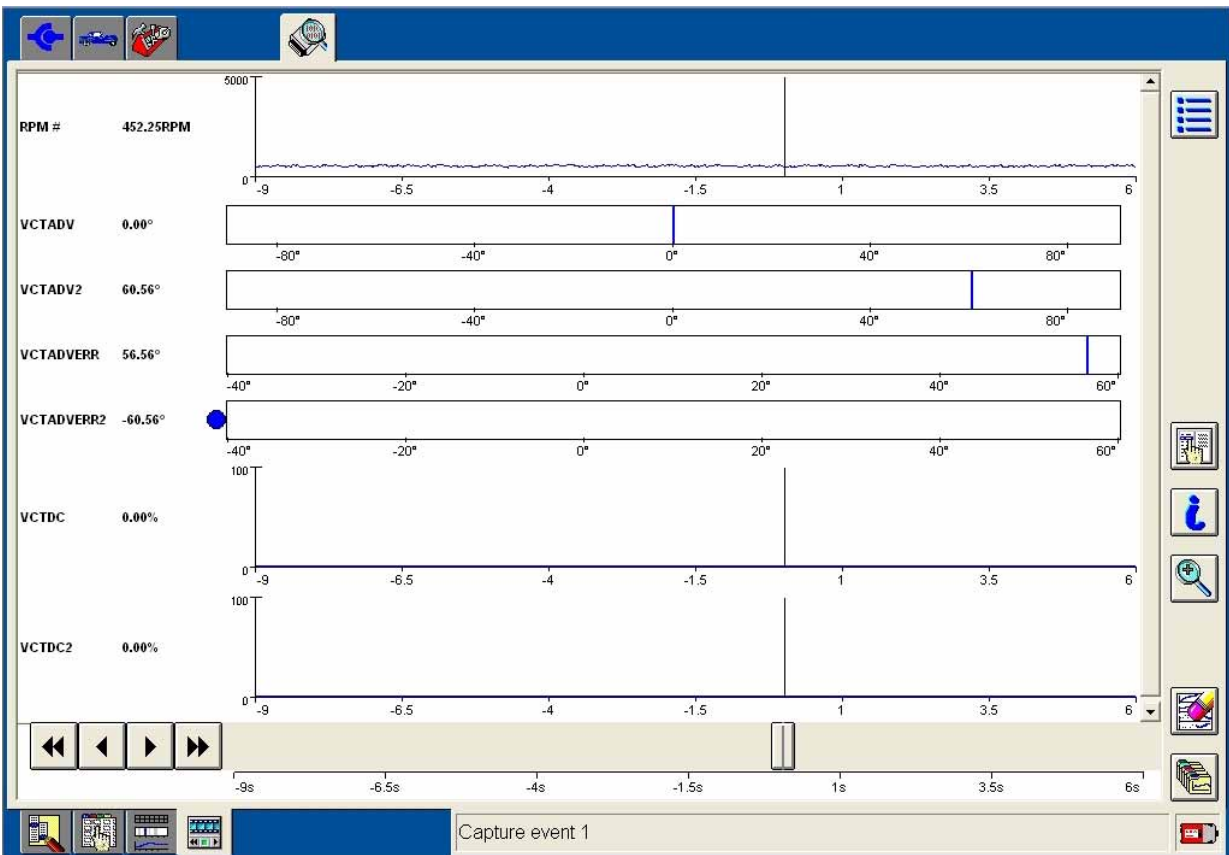
Figure 6 (Below): The camshaft timing parameters for each bank on the scan tool.

The validation process was all pointing toward a possible jumped timing chain on Bank #2. It was just unlikely that one head would have four bad cylinders with leaky valves. The common cause of low compression in four cylinders in the same head would most probably be a valve timing issue. I now wanted to do one more check to find out what the PCM was seeing when it set the variable valve timing codes, so I decided to look at the camshaft timing parameters for each bank on the scan tool (Figure #6). By looking at the data with the engine idling in its rough mode, I could plainly see VCTADV for Bank #1 was at 0 degrees at idle, but the VCTADV for Bank #2 was close to 60%, indicating that the cam sprocket on Bank #2 was out of correlation to the crankshaft. At this point I had gathered enough information to validate the removal of the front timing cover.

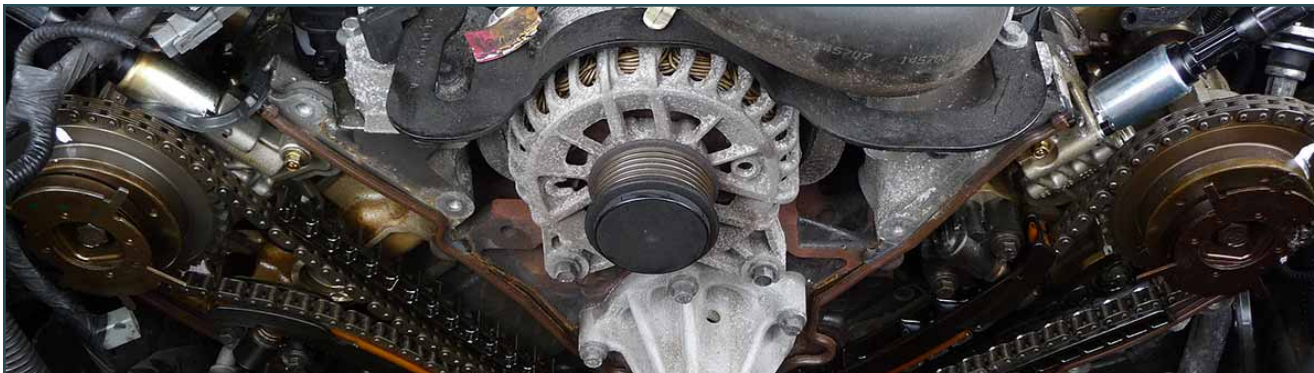
Figure 7: The crank lined up so the keyway was up at the 12 o'clock position.

I went back to the shop the next day and the tech had pulled the timing cover and lined up the crank so the keyway was up at the 12 o'clock position (Figure #7). I placed whiteout on both cam sprocket marks and I could see the driver cam sprocket timing mark was properly lined up with the center of the camshaft hold-down cap (Figure #8). When looking at the Bank #2 cam sprocket (Figure #9), I could easily see that it was off by a few teeth. The timing chain had jumped, which caused the engine to run very poorly and the PCM to set timing position error faults. I felt good about my findings because I did not want the shop to go through all the work of ripping down the front of the engine just because it "felt" like a timing chain issue. I had to be sure on this one.

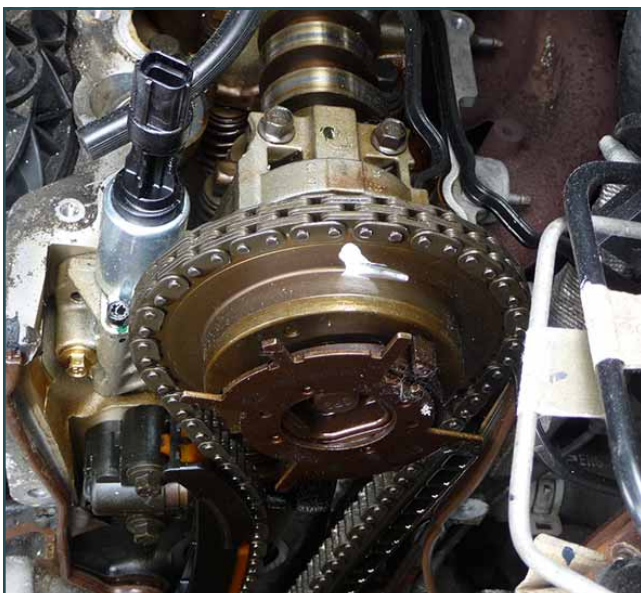
Figure 8: Driver cam sprocket timing mark, properly lined up.
