MISSING MINI

No, this is not a mystery about a Mini that has gone missing. This car had been off the road for a year's storage in a body shop. When it came time to return the vehicle to the customer, it had an illuminated MIL and a misfiring cylinder.

by Kerry Jonsson

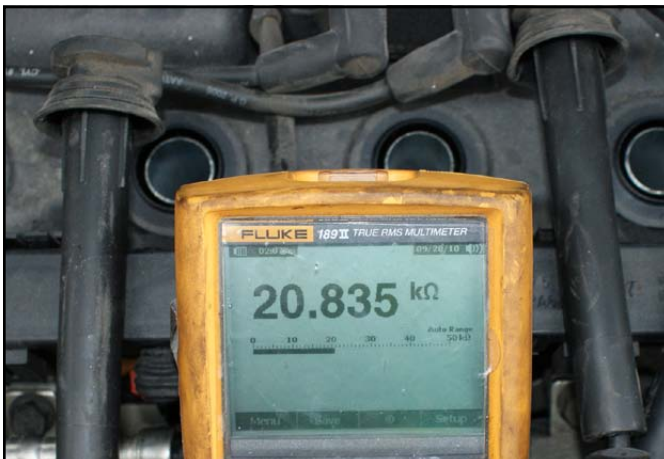
We checked to see if improper ignition was causing the misfire. Checking secondary resistance is one part of doing that. You can also use a HEI spark tester to put a load on the coil. You can also try swapping the spark plug wires and see if the miss moves.

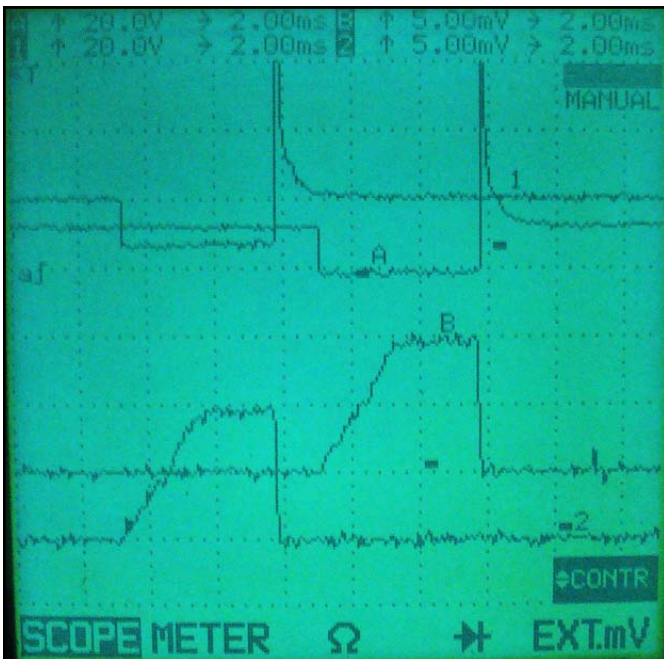
With our lab scope and a low-current probe, we compared the #1 injector to the #3 injector. The upper trace is the voltage pattern and the lower trace is the current ramp. There was little difference between the two.

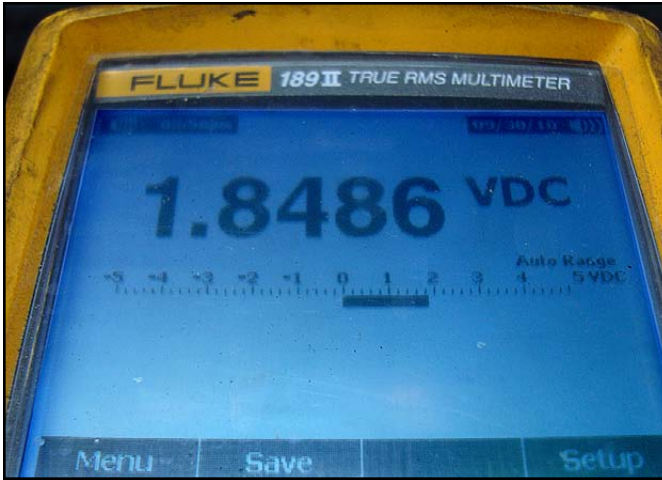
After letting the vehicle idle, the MAP voltage signal was 1.8V. Our Bentley Mini manual told us we should have 1.25V at 18 in. Hg. That meant low manifold vacuum. We needed to find the cause.

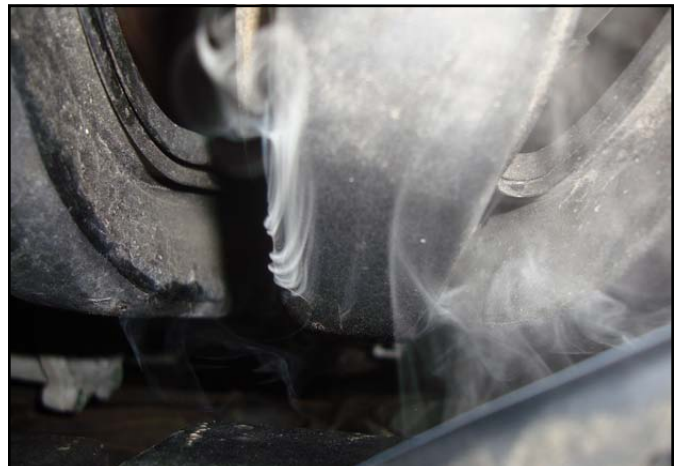
manifold vacuum is slightly low. A few things can cause low manifold vacuum: a vacuum leak, late valve timing, a restricted exhaust, etc. Since we had a code for the air leak, we decided to start there. Smoking the intake manifold directly through the canister purge solenoid feed line helped us find the problem. The plastic intake manifold had cracks in it. These cracks showed up particularly on 3rd cylinder. This could definitely cause a lean misfire on only one cylinder and apparently drop manifold vacuum, increasing the MAP sensor signal voltage. Once we temporarily sealed the leaks (since this is vacuum and not pressure, you can use tape, RTV, etc. for testing purposes), MAP sensor signal voltage read 1.3 volts and the 1498 code disappeared.

We added smoke through the canister purge line and it started coming out of the #3 intake runner. This could have been cracked from the accident that happened over a year before, but hindsight is 20/20.
