Switching It Up

*No power window switches on
a 2003 Pontiac Bonneville SSEI*

by John Anello,
"The Auto Tech on Wheels"

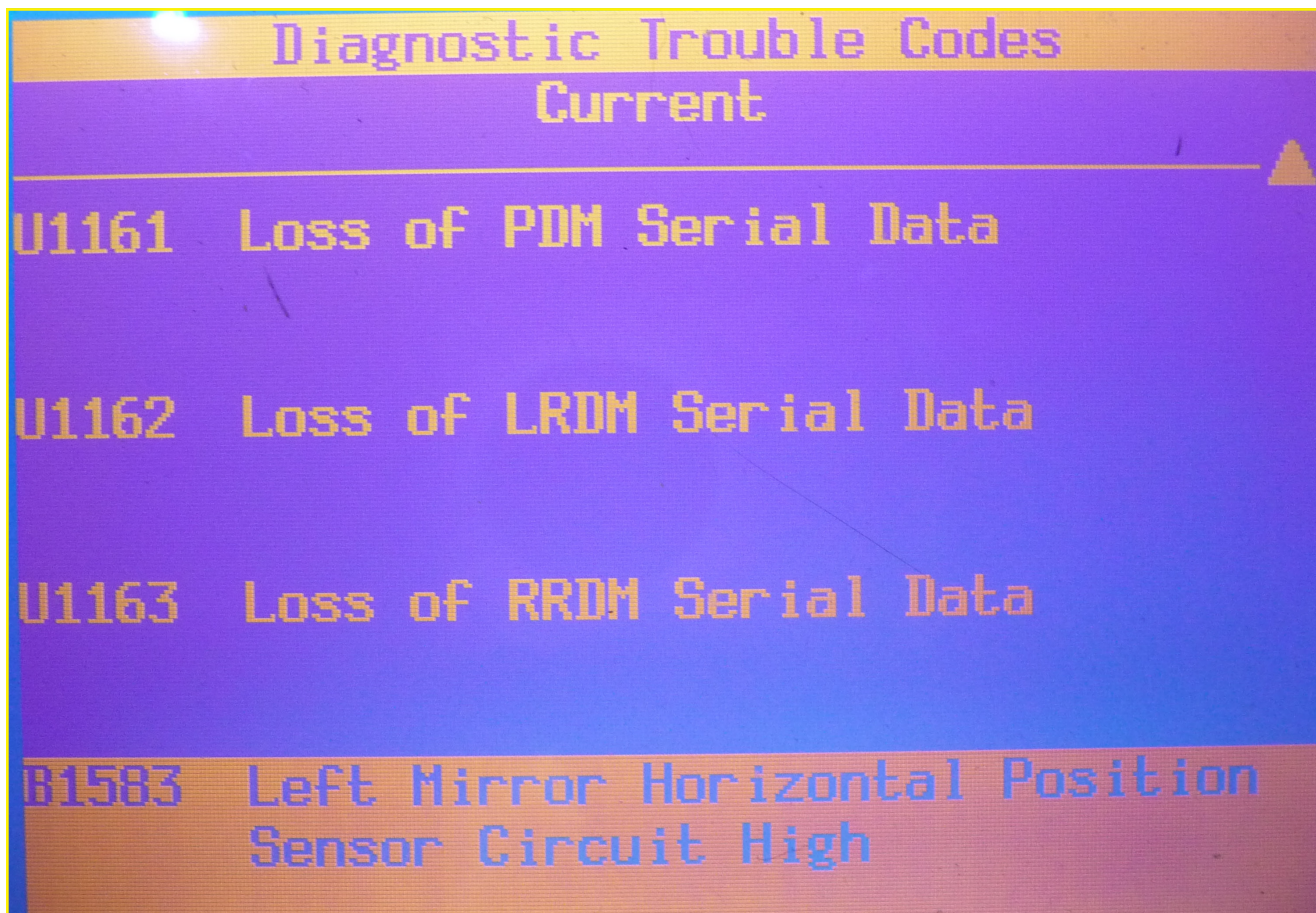
I discovered that the driver door module had the ability to communicate with a scan tool by looking at a data communication wiring diagram (Figure 3), which showed all the onboard controllers on the serial data network linked to the ALDL connector. So, I hooked up my GM Tech II scan tool to see if there were any trouble codes stored in memory that could lead me in the right direction. Looking at the scan tool, I pulled some "U" codes of interest (Figure 4). The codes U1161, U1162 and U1163 all pertained to the driver's door module's inability to talk to the other three door modules. There was no access for my scan tool to talk to the other three modules because it was only able to access the

Figure 4: "U" codes.

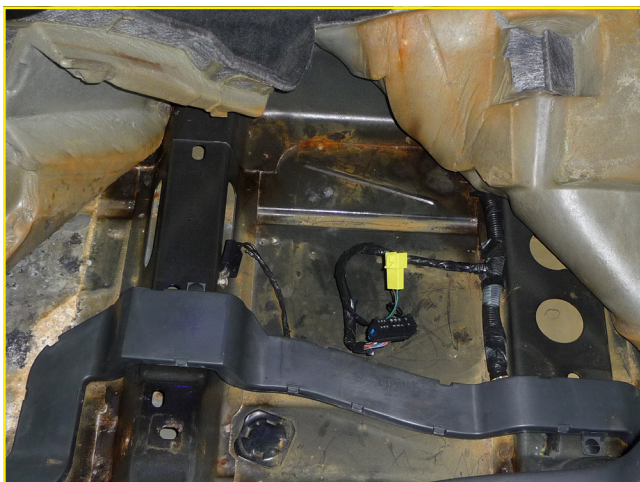
Figure 5: Lifting the rug, noticing a lot of rust build-up on the floor from a prior water leak.

According to the diagram, there was a splice for this private UART network located under the rug about 14cm from the left power seat breakout. I had the shop remove the front driver's seat, and as I lifted the rug I noticed a lot of rust build-up on the floor from a prior water leak (Figure 5). I next located a conduit that held the splice internally wrapped with black electrical tape (Figure 6). I slowly removed the tape and was surprised to see a Scotch Lock connector joining all four UART lines going to the door modules (Figure 7). This connector was badly corroded and was barely making a connection for all the wires to share. I removed all of the wires and repaired the splice. Suddenly, all the windows were working fine.

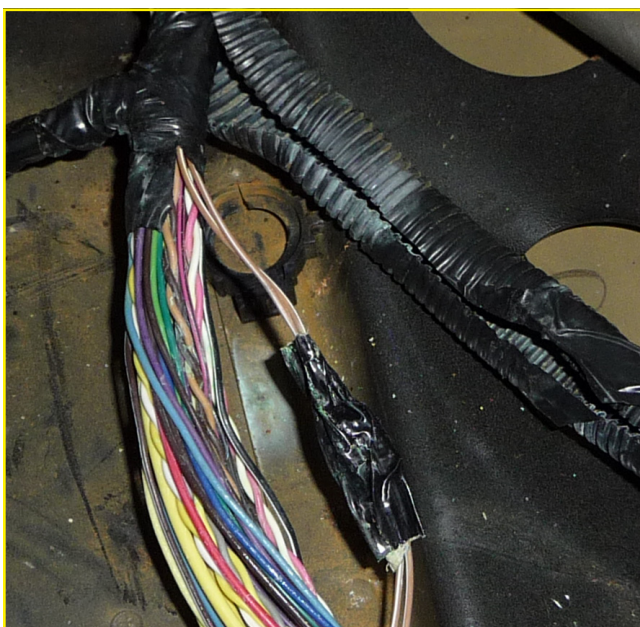
Figure 6: Located a conduit that held the splice internally wrapped with black electrical tape.

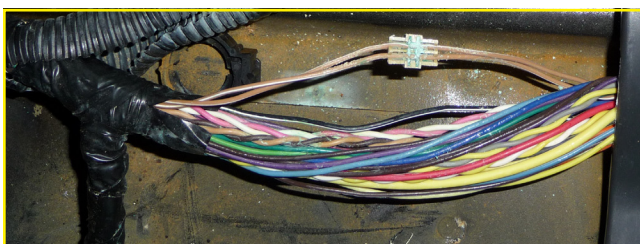
Figure 7: Removing the tape, a Scotch Lock connector joined all four UART lines going to the door modules.

So, now the recap on this whole scenario. I discovered that the door modules were on a private network with each other and even though they had their own power and ground feeds and switch signals, they all refused to operate when they were unable to communicate with one another. It was a default built into the system. What was amazing to me was why any manufacturer would use a Scotch Lock to connect these wires inside a harness running along a floorboard. Wouldn't it have been better to use a solder joint located in a higher area not so susceptible to water damage? But, then again, who am I to second-guess the engineers? There's always the possibility that this was a field repair done by another shop.
