# “This Seat Is Occupied”

*In the quest for ever-increasing safety, seat occupancy detection systems help by giving the electronics the info needed to determine how to fire the airbags. That system is malfunctioning in this 2005 Chrysler Town & Country. It's our job to diagnose and repair what's wrong.*

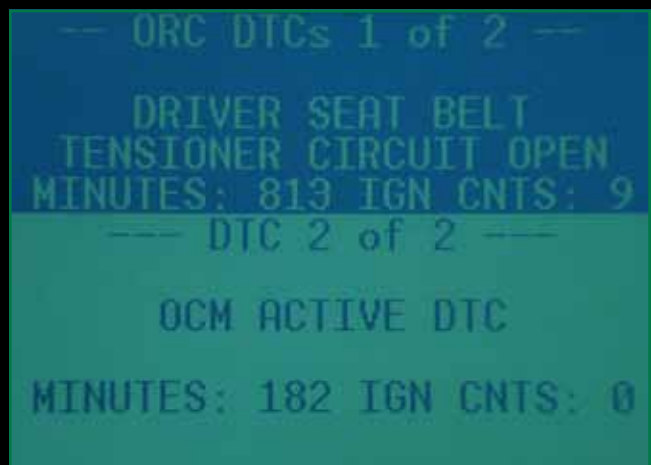
*The primary code led us to diagnose a bad seat belt tensioner, but the second code directed us to a relatively new item added in 2005, the Occupancy Classification Module.*

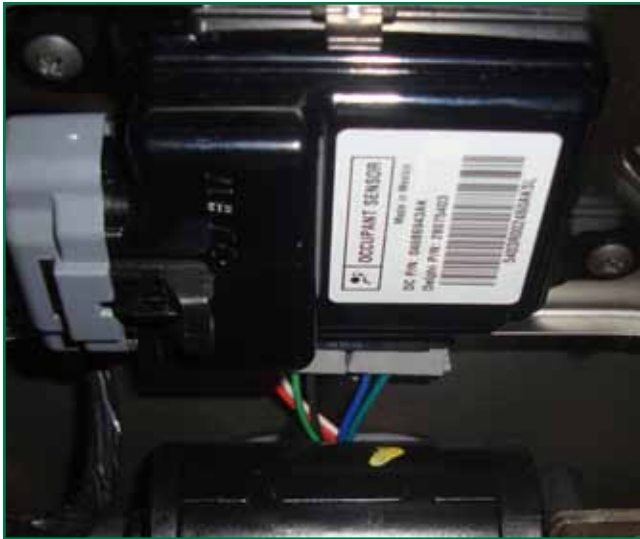
*The OCM module is located under the front passenger seat cushion. It gets voltage from the Front Control Module, and relies on both a weight sensor and a seat belt tension sensor to determine how the passenger's side airbags should be fired.*

Since the sensors were functioning properly, our repair was going to be the installation of a new OCM. It's mounted on the underside of the passenger seat cushion, and is fairly easy to get to. Even though it's a control unit, it doesn't need to be programmed or coded when installed. However, it is not just plug-and-play, either. You will have to calibrate the weight sensor after installing a new OCM. With your DRB III/Star Scan, or equivalent, you can calibrate the weight sensor, but you are going to have to throw some weight around. It is a three-stage process. You start with an empty seat. You then put 37.5 lbs. on the seat. In the next step you add an additional 10.6 lbs., and, finally, 52.5 lbs.

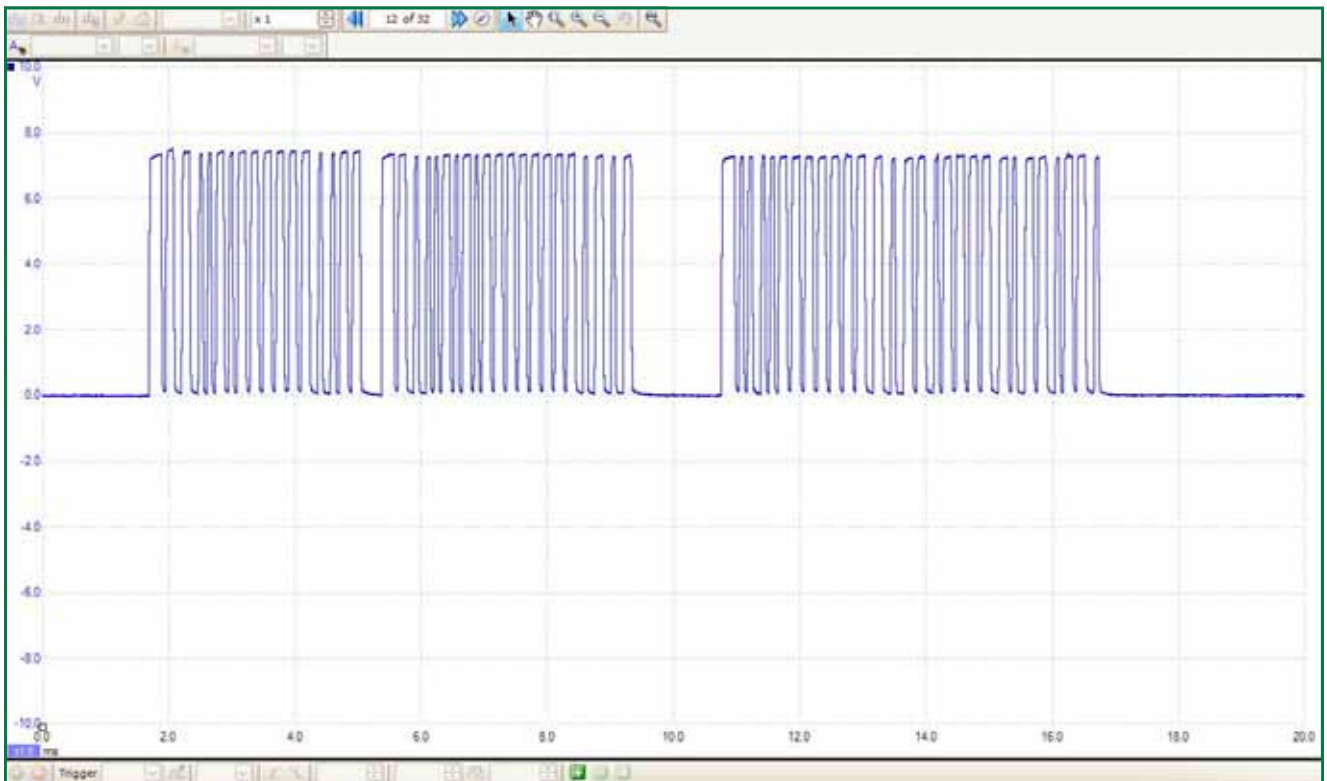
*By watching the oscilloscope pattern of the PCI bus we could easily determine that there was communication among control units. The bus links many modules, so it was possible that some other unit was interfering with communications. That should have flagged some other communication code, however.*

interference from other voltage or ground sources. We did see a 7.1 to 7.5V square wave with the ignition key on. This meant the wires were not shorted and the control units could communicate with each other. If there was a communication problem between these two units, it could be because one of the units was malfunctioning, or some other control unit was putting out erroneous data and confusing the others. We decided to check codes in the other control units on the PCI bus, but didn't find any that dealt with a loss of communication. So, we concluded that the communication problem was isolated between the ORC and the OCM units.

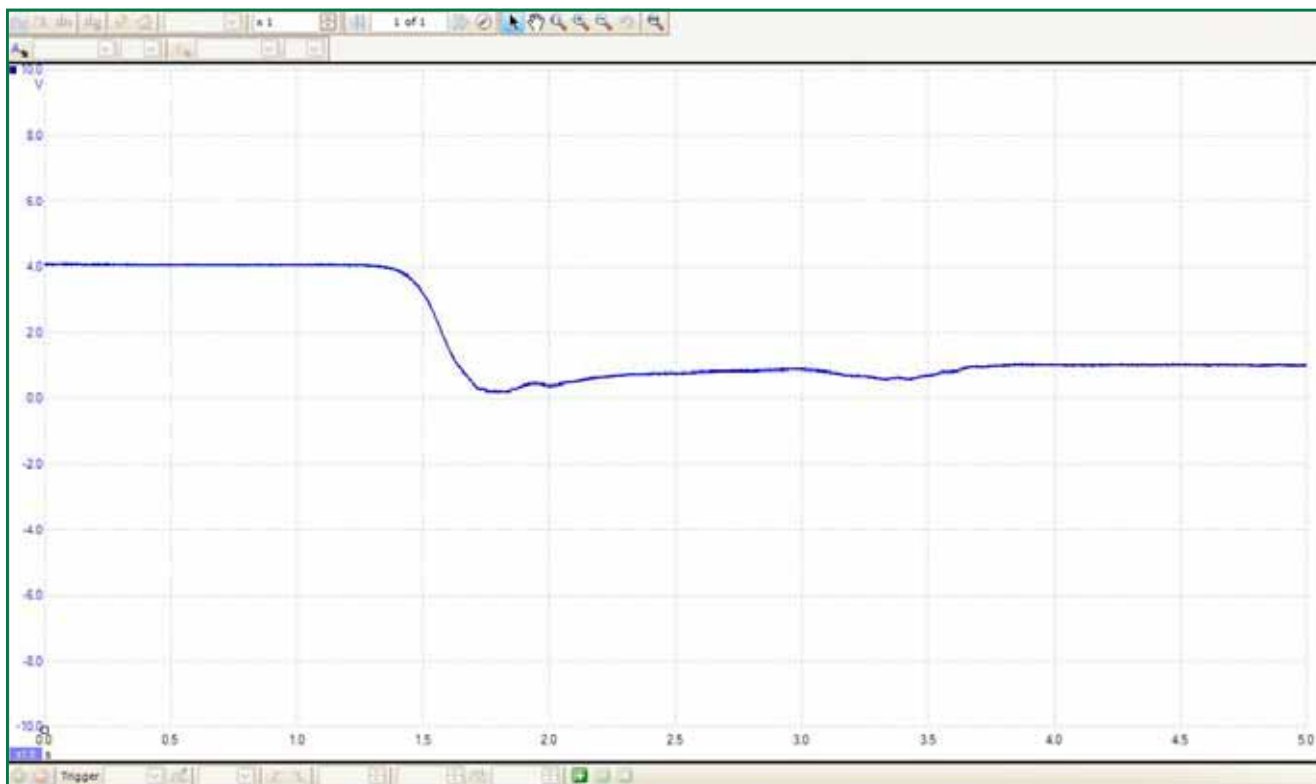
Looking at this weight sensor signal, we see about 4V volts with the ignition key on. The voltage dropped to about 1V with 185lbs in the seat. You can watch this signal voltage with a DMM as well.

in on pin #6 and changes with the weight applied to the seat. With no weight, you should see about 4V, and with a 185 lb. man in the seat the signal drops to just about 1V. In other words, the greater the weight, the lower the signal voltage. If you have codes for this sensor, refer to TSB #08-001-04 on passenger side airbag safety issues and aftermarket parts, such as an add-on cushion, that can interfere with proper sensor operation.

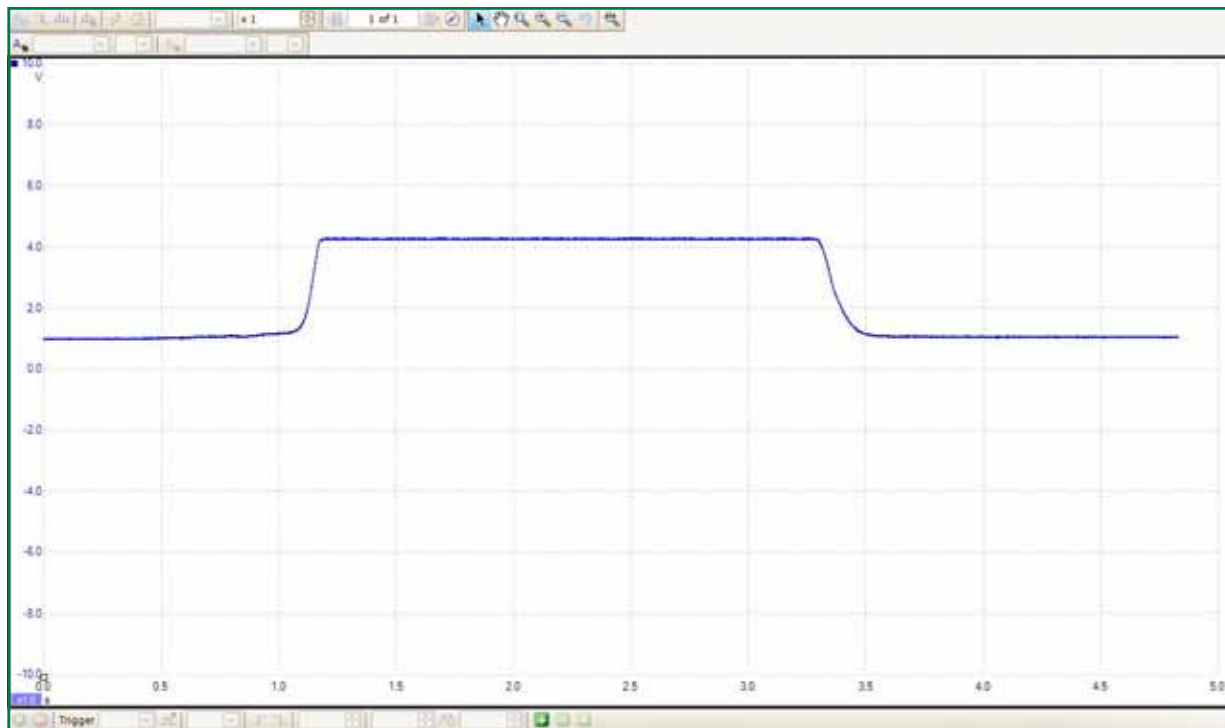
*The seat belt tension sensor is mounted in the lower mount of the belt, so moving the reel will not change the signal voltage. You can check the voltage and pull up on the belt. You should see the signal voltage change from about 1V to 4.3V while pulling.*

The second is the Belt Tension Sensor. This component also uses a three-wire design. The 5V reference comes from pin #16 of the OCM, and isn't shared with that of the weight sensor. The ground is also separate and comes through pin #14. The belt tension signal comes in on pin #4. With no tension on the belt, you should see just under 1V on the signal line. Pulling the belt out of the B-pillar mount will not cause the signal to change. The sensor reads the tension on the mount side at the base of the B-pillar. Grab the belt near the base and pull up. You should see the signal rise to about 4.3V.
