Anatomy Of A Collision Repair

During collision repair, you must remain focused on the goal: Return the vehicle to its original structural integrity and appearance in a cost-effective manner. Here is the plan.

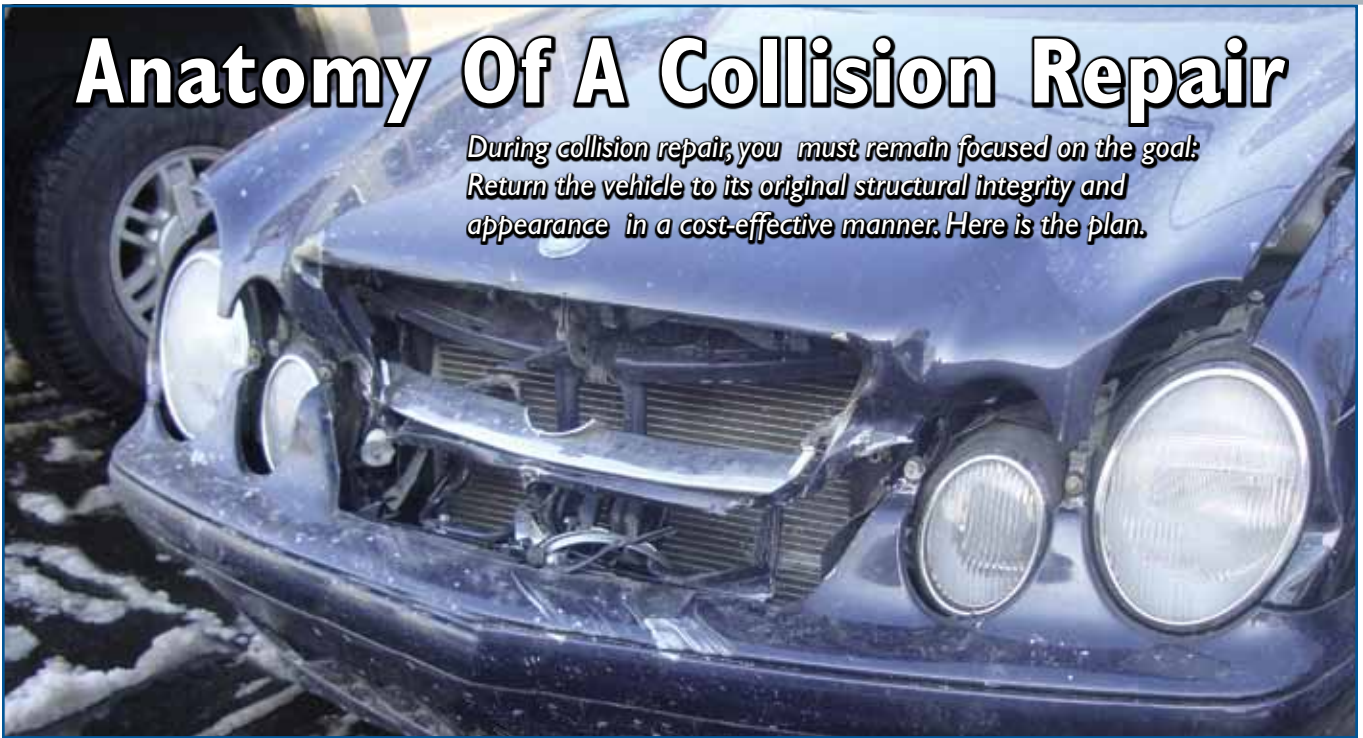
Opposite Page: Here we have a front-end hit on a 2002 208 chassis CLK. There is the obvious damage to the hood, center support, and front crashbox, but what about underlying damage? The headlight frame mounting was damaged on the passenger's side and may not have been put on the estimate.

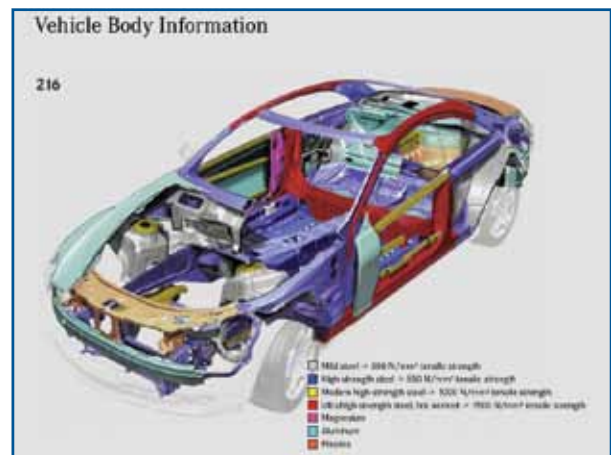
The first step before performing any repair work is a visit to www.mbcollisioncenters.com for a look at the vehicle's construction materials. This is an essential safety step and will let you know when magnesium or ultra-high-strength steel is used. Repair procedures will be different as a result.

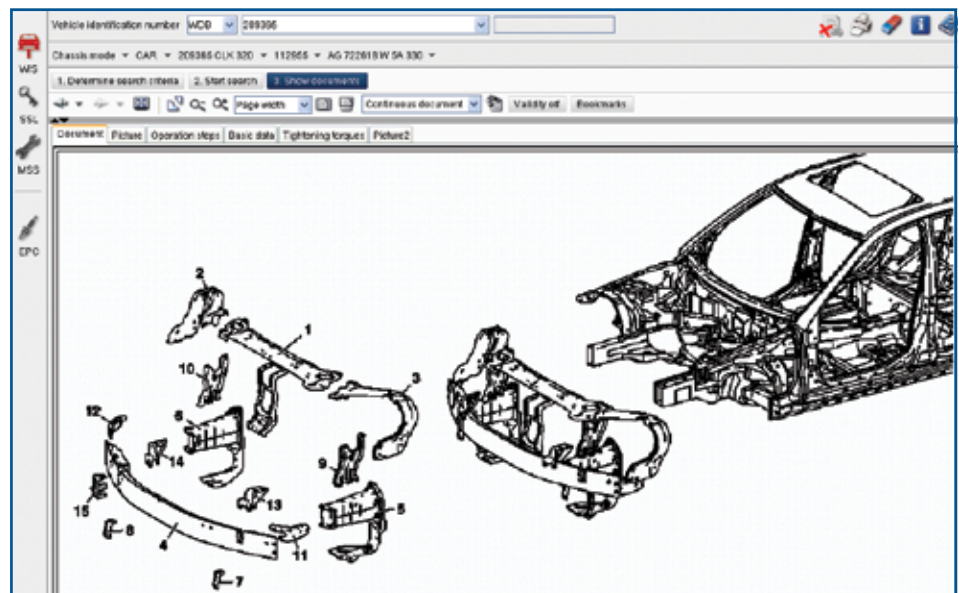
Before you start to take the damaged section apart, look at the repair instructions at www.startekinfo.com, and the parts information on EPCnet (<http://epc.startekinfo.com>). This will help you generate an accurate estimate. Also, by quickly removing panels, you can look for further damage to the structure.

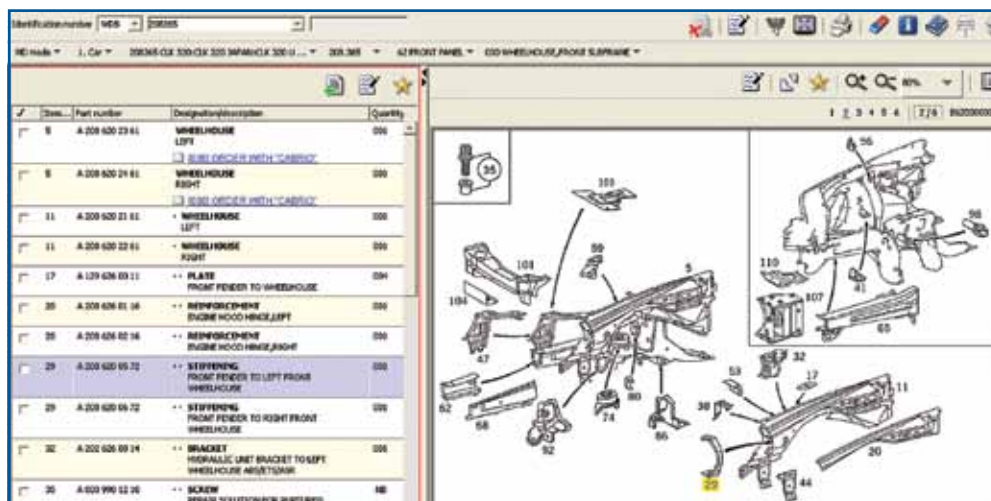
Looking at EPC, you can see the many stiffening support brackets in the front crashbox that can be replaced instead of worked straight. It may be cheaper and faster to replace components instead of straightening them, and you get O.E. crashworthiness, too.

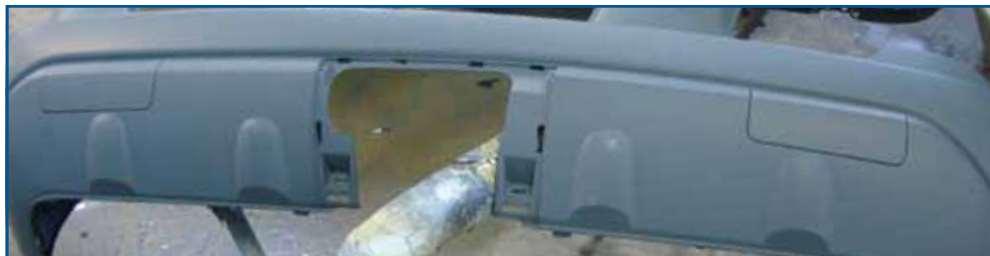
Even with light hits, using OEM parts like this ML rear bumper cover will reduce labor time. You will not have to modify the part to make it fit. It comes already primed so all you have to do is prep it for painting.
