AUTOMOTIVE POLYGAMY

by John Anello, "The Auto Tech on Wheels"

Why it's a good idea to look the whole vehicle over before going crazy with high-tech diagnosis

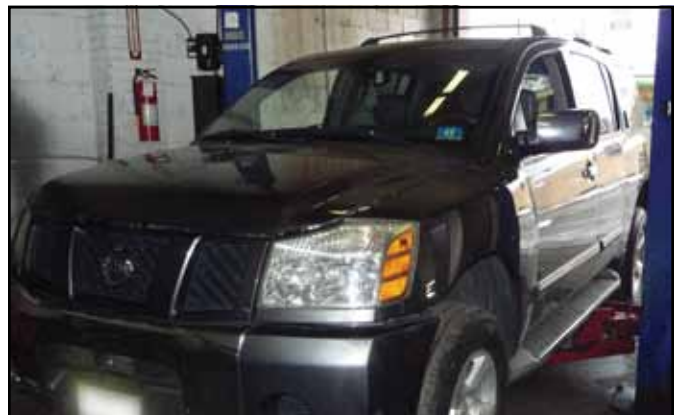
Figure 1: 2004 Nissan Pathfinder.

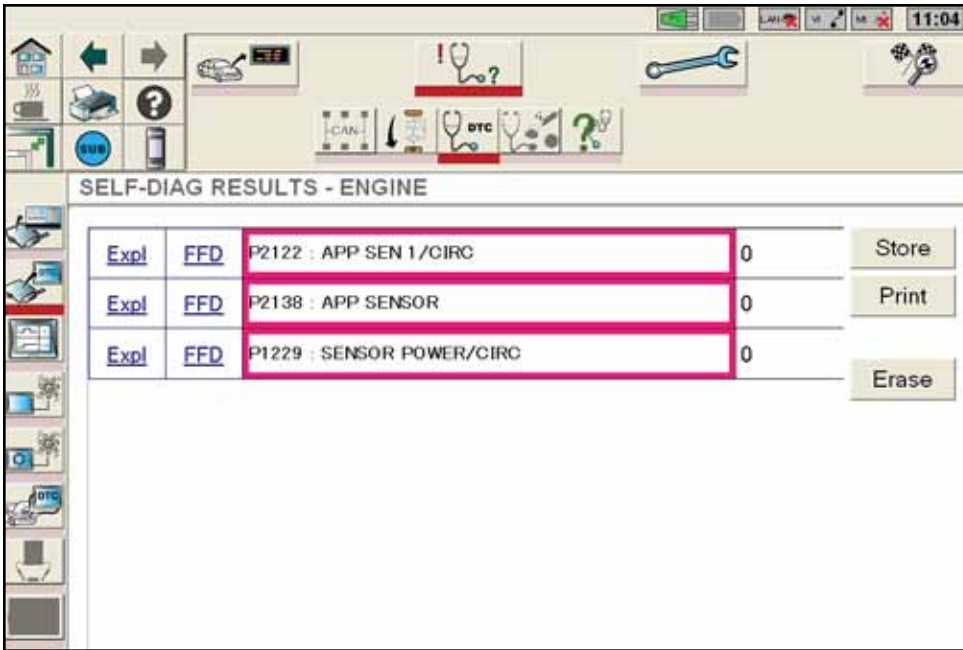
When I arrived, I attached my Nissan Consult III to the truck and pulled codes P2122, P2129 and P2138 (Figure 2), which were current. These codes

Figure 2: Current ECM codes in memory.

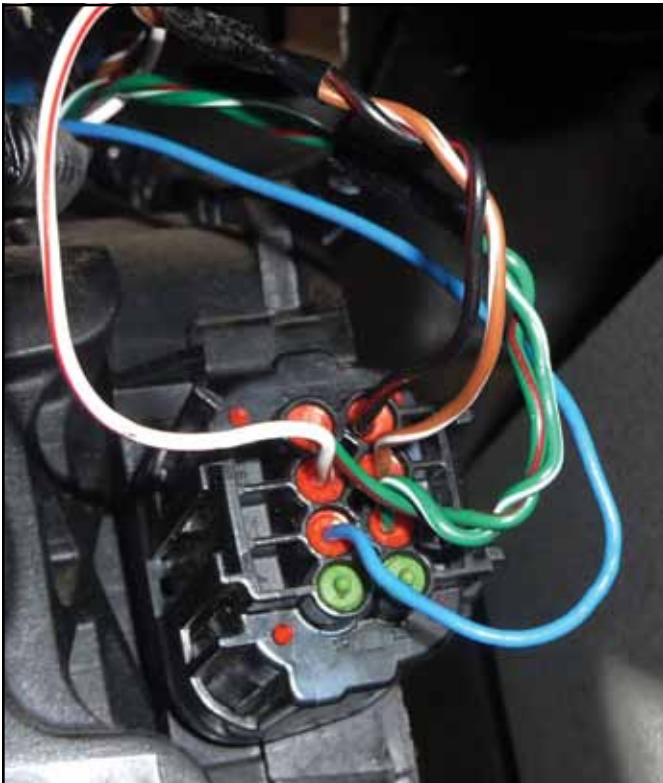
Figure 3: APP Sensor located at gas pedal.

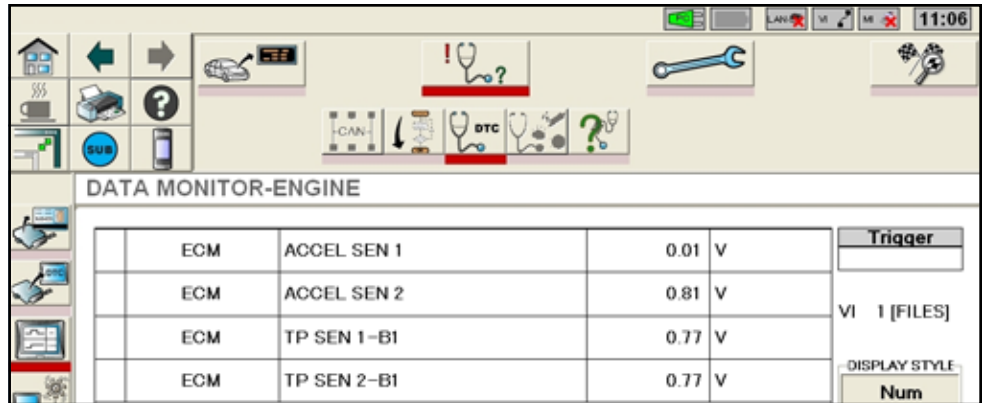
at 0.01 volts while accelerator sensor #2 was at 0.81 volts. Then I moved the accelerator pedal to the floor and accelerator sensor #2 displayed 4.40 volts while accelerator sensor #1 never changed (Figure 5).

Figure 4: APP Sensor readings at closed throttle.

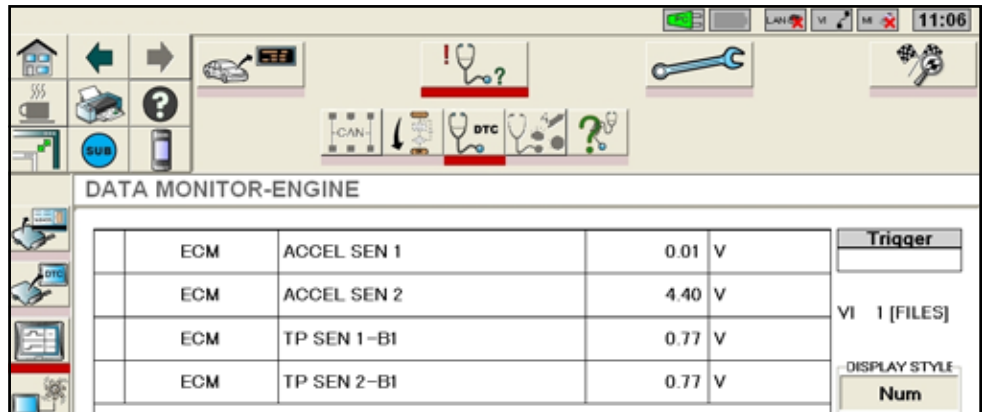
Figure 5: APP Sensor readings at wide open throttle.

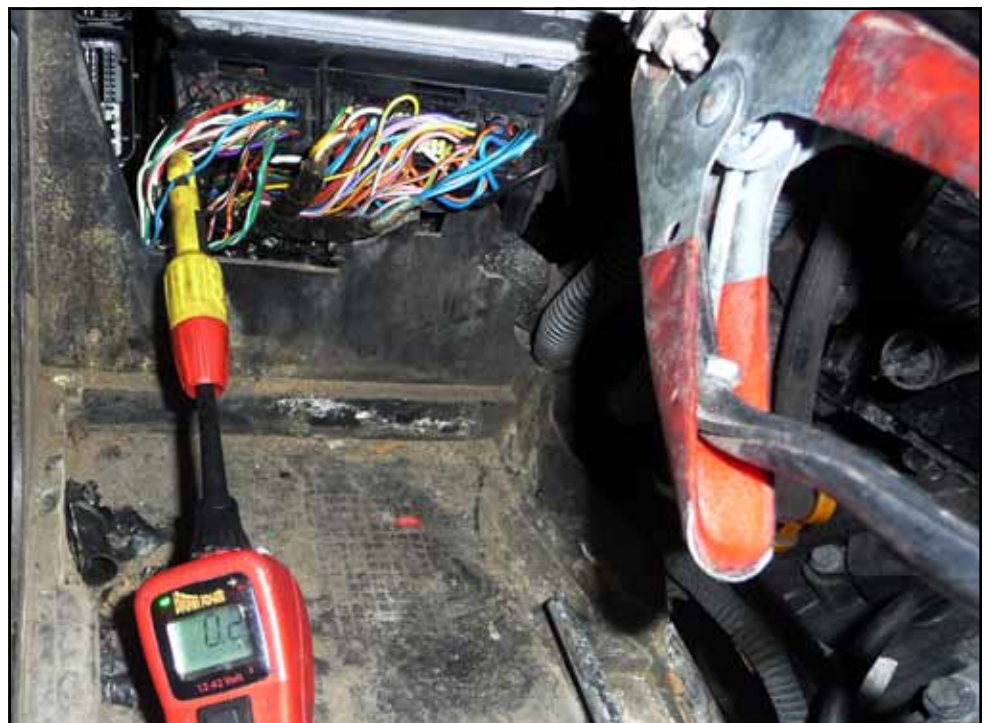
went directly to the PCM connector. The reading at there was also 0.2 volts (Figure 6), but I wasn't sure if this was a shorted circuit to ground, or a lack of five volts coming out of the PCM. To be certain, I placed my test light on sensor #1's feed circuit while it was connected to the positive side of the battery and the test light lit up (Figure 7). Keep in mind never to use a test light on a good working reference voltage feed line because the high current draw of the test light bulb could damage the internal circuitry of the PCM. The line was already low, so there was no chance of creating any damage if it were shorted to ground or open within the PCM.

Figure 6: APP Sensor #1 Ref Voltage reading at ECM.

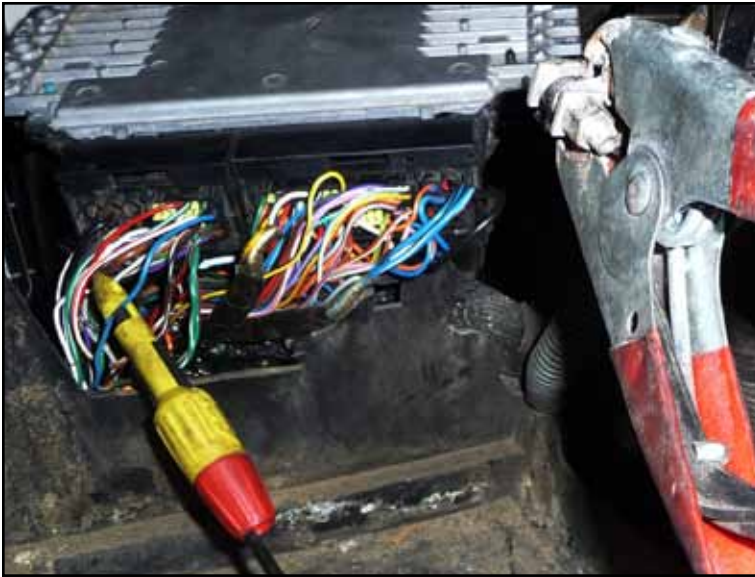
Figure 7: APP Sensor #1 Ref Voltage circuit shorted to ground.

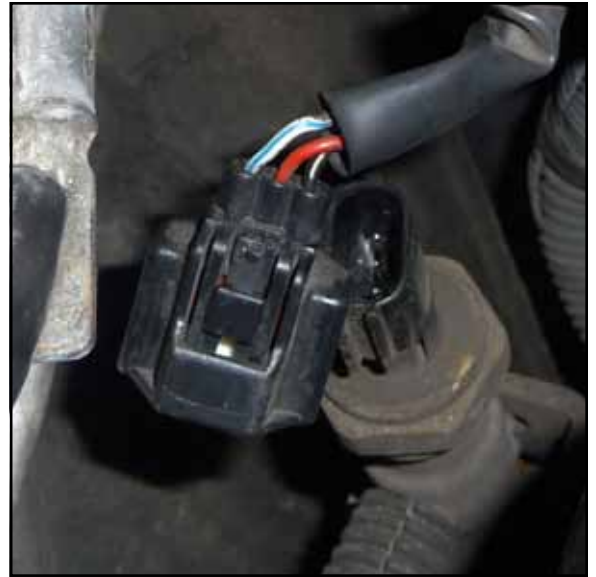
Figure 10: P/S Pressure Switch unplugged.

wrong. I next decided to do an isolation procedure by unplugging all four sensors one at a time. If the short did not go away, I was dealing with a shorted circuit to ground leading to any one of these sensors. I first unplugged the accelerator sensor with no results, then I unplugged the P/S pressure sensor (Figure 10) and the short was still there. I next unplugged the A/C pressure sensor -- no change (Figure 11).

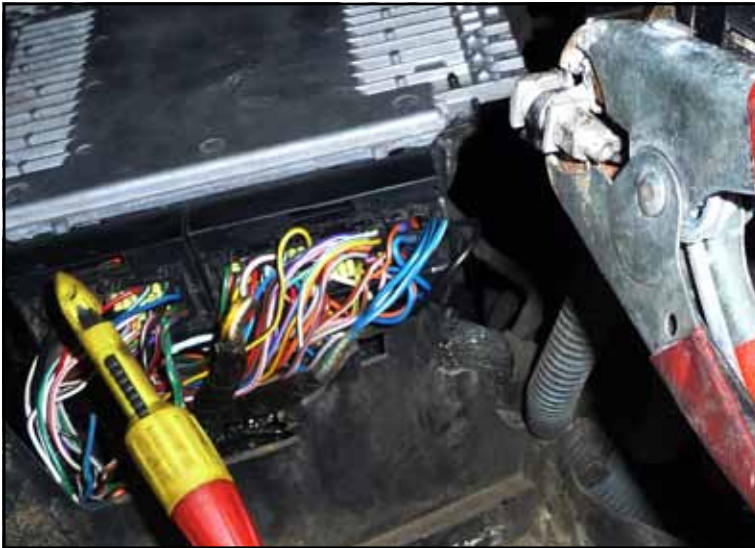
Now that I'd determined that the circuit was shorted to ground, I had to validate whether the short was internal or external to the PCM. So, I cut the wire at the PCM leading back to sensor #1 and found that the short circuit remained (Figure 8). This had to be a bad PCM because the short was now found to be on the PCM side. I advised the shop to get a used PCM just to keep costs low, and that I would be back to program it once they were able to locate one. I left feeling pretty good with my final diagnostic decision, so I moved on to the next shop.

Figure 8: APP Sensor #1 Ref Voltage circuit cut-Short remains.

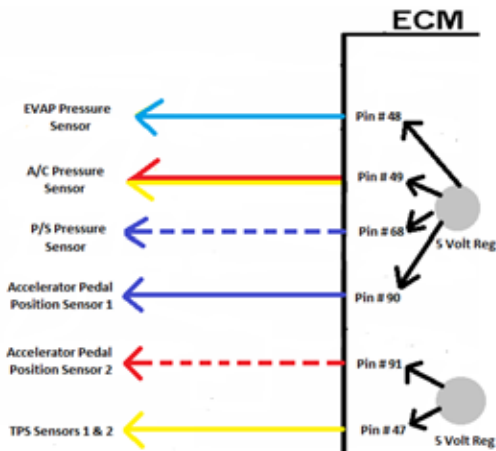
Figure 9: Diagram of 5 Volt Ref Voltage feeds from ECM.

By testing the harness at the PCM, I discovered that accelerator sensor #2 and the TPS #1 and #2 reference voltage feeds were okay. The EVAP sensor, A/C pressure sensor, P/S pressure sensor, and accelerator sensor #1 circuits were all shorted with no five-volt reference feed. I now drew a new diagram to reflect my findings (Figure 9) so that it would help me better understand where I went

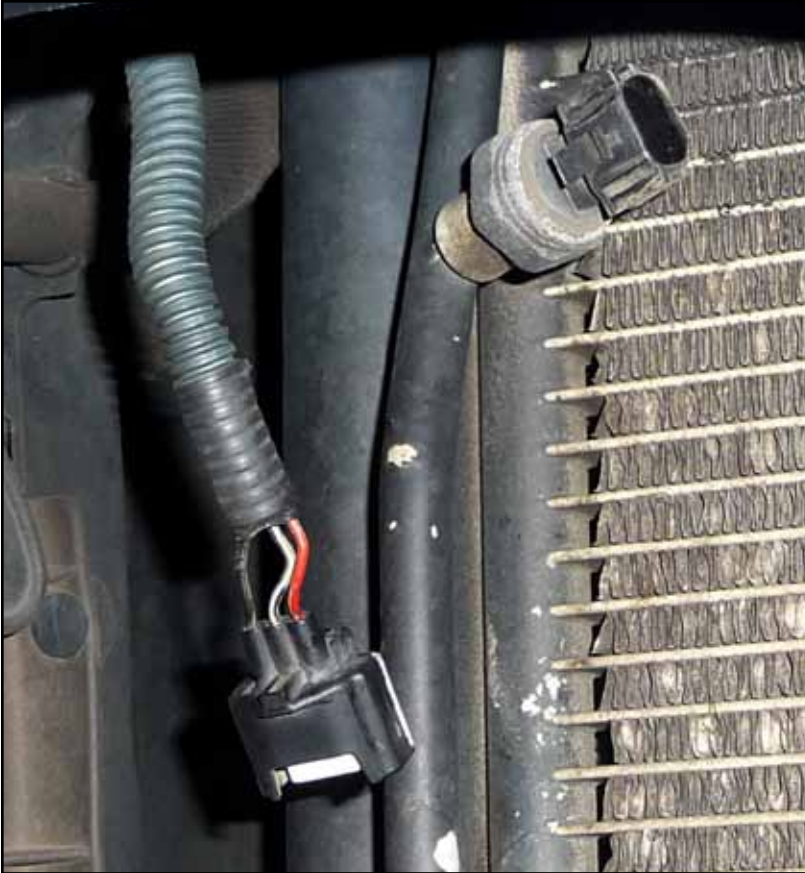
Figure 11: A/C Pressure Switch unplugged.

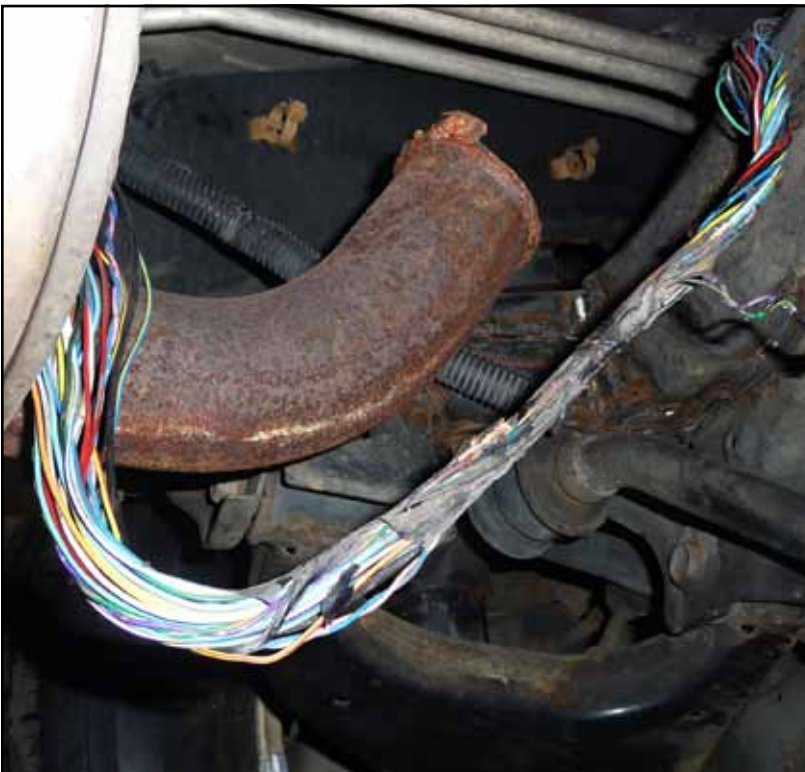
Figure 12: Melted ECM harness at R/R suspension from broken tailpipe.

I now needed to get the vehicle up on the lift to access the EVAP sensor. As I was trying to locate the EVAP sensor in the right rear of the vehicle, I was suddenly taken aback by what I saw. The tail pipe had broken and the customer must have ripped it off the truck. This allowed hot exhaust gases to directly contact the main wiring harness that runs along the right side frame rail (Figure 12), melting it in such a fashion that the EVAP pressure sensor five-volt reference line was shorting to a ground wire.
