# I'm Stuck in Neutral

*As with any diagnosis, the first step is the most critical. In this case, we needed to find out if the problem was in the transmission itself, or in the electronics that control it. The facts led us to something we didn't expect.*

by Kerry Jonsson

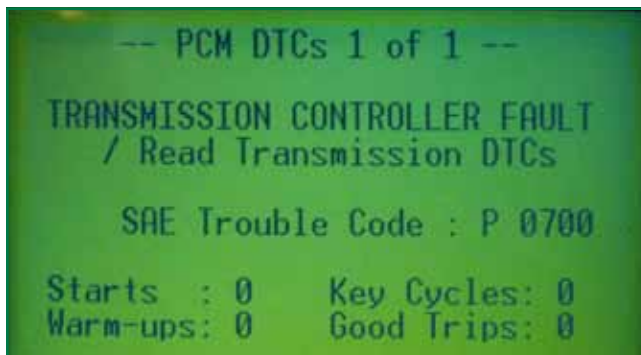
*We started by pulling codes with our DRB III. We were only able to access the PCM, and found a P0700. This gave us some hope. A DTC in the transmission may give us some concrete evidence that may lead us to the cause of the problem.*

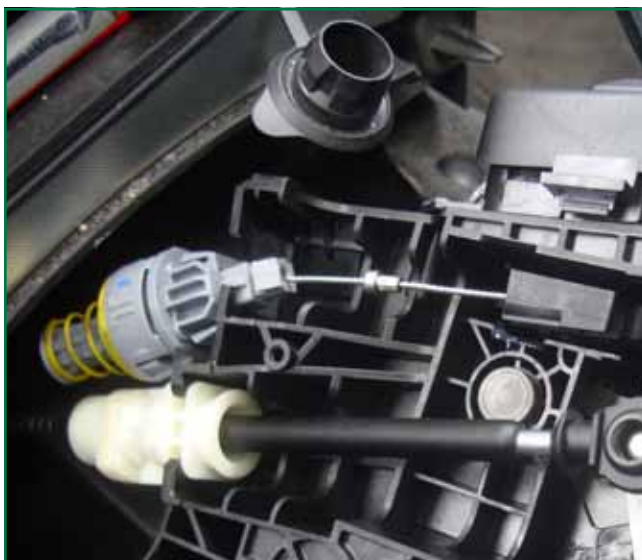
*To remove the shifter, you have to remove the key interlock cable. There is no adjustment on this cable. Simply unclip the housing mount and thread the cable through its holder.*

problem, the customer opted for the new ESM module. The job involves the removal of the center console; not too time consuming. There is a single electrical connection for the power, ground, illumination, brake switch, manual shift controls and CAN connections. The shifter has mechanical connections with two cables. The upper, smaller cable is for the key interlock so that you can't remove the key from the ignition unless the shifter is in park. The other cable is connected to the transmission mechanical shift input. This allows for failsafe operation of park, reverse, neutral, and drive, in the event of electrical failure. The key interlock cable has two clips that when squeezed together unlock the cable housing and allow it to be removed. Then unhook the ball end of the cable from the shifter assembly.

The shifter cable just slides out, and the ball socket has to be popped off before you can totally remove the shifter. When installing the new shifter, the lever in the assembly is not locked down. A 13mm nut must be tightened when both the shifter cable and shifter lever are in the correct position. To make sure of this, pull the cable all the way toward the back of the vehicle. This insures the transmission is in the park position. The

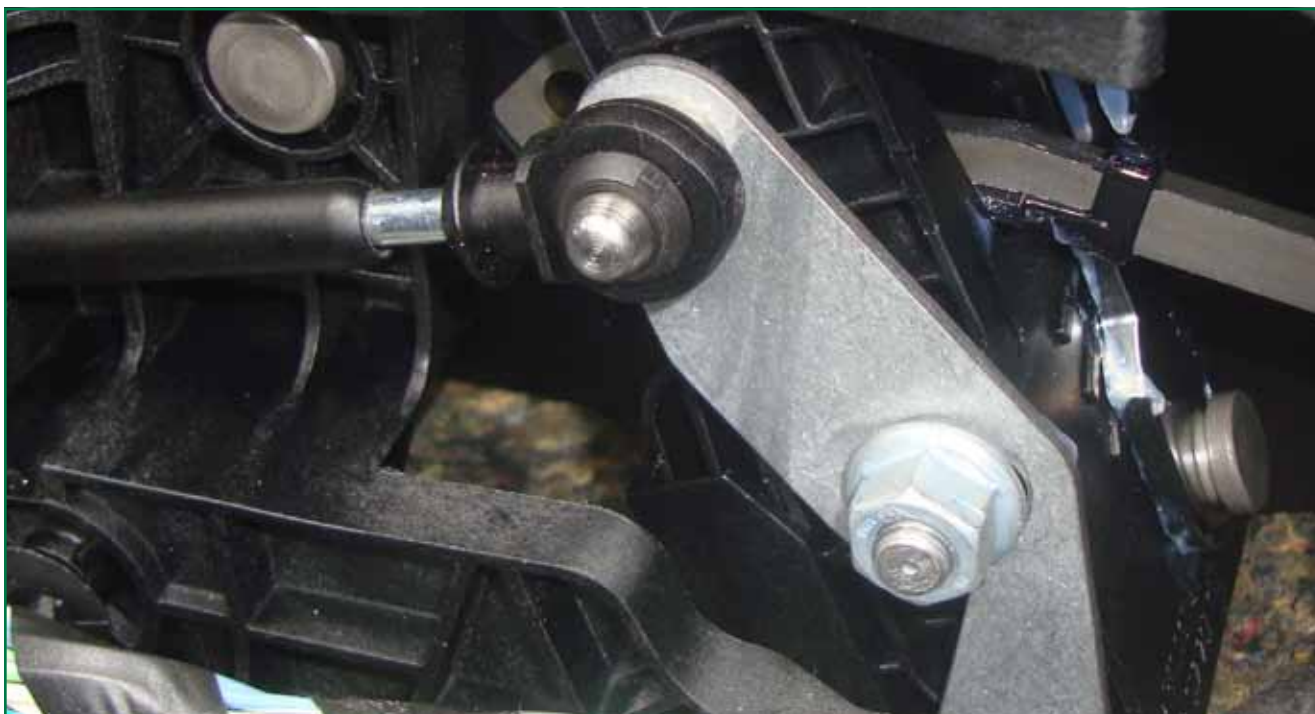
*When installing the shifter, put it in park. Pull on the shift cable all the way rearward, then position the lever so you can pop the ball socket on the lever. Then tighten the 13mm nut to secure the adjustment.*

driveshaft should not rotate when you try to turn it. With the shifter in Park, adjust the lever in the shifter until the ball on the lever can be attached to the ball socket of the cable. At this point tighten down the 13mm nut and the shifter and cable will be properly adjusted. Reassemble the center console and go for a test drive to verify that you can catch all the gear positions.
