AUTOMOTIVE FORENSICS

Our man John tracks down what that DTC was really trying to tell him.

by John Anello, "The Auto Tech on Wheels"

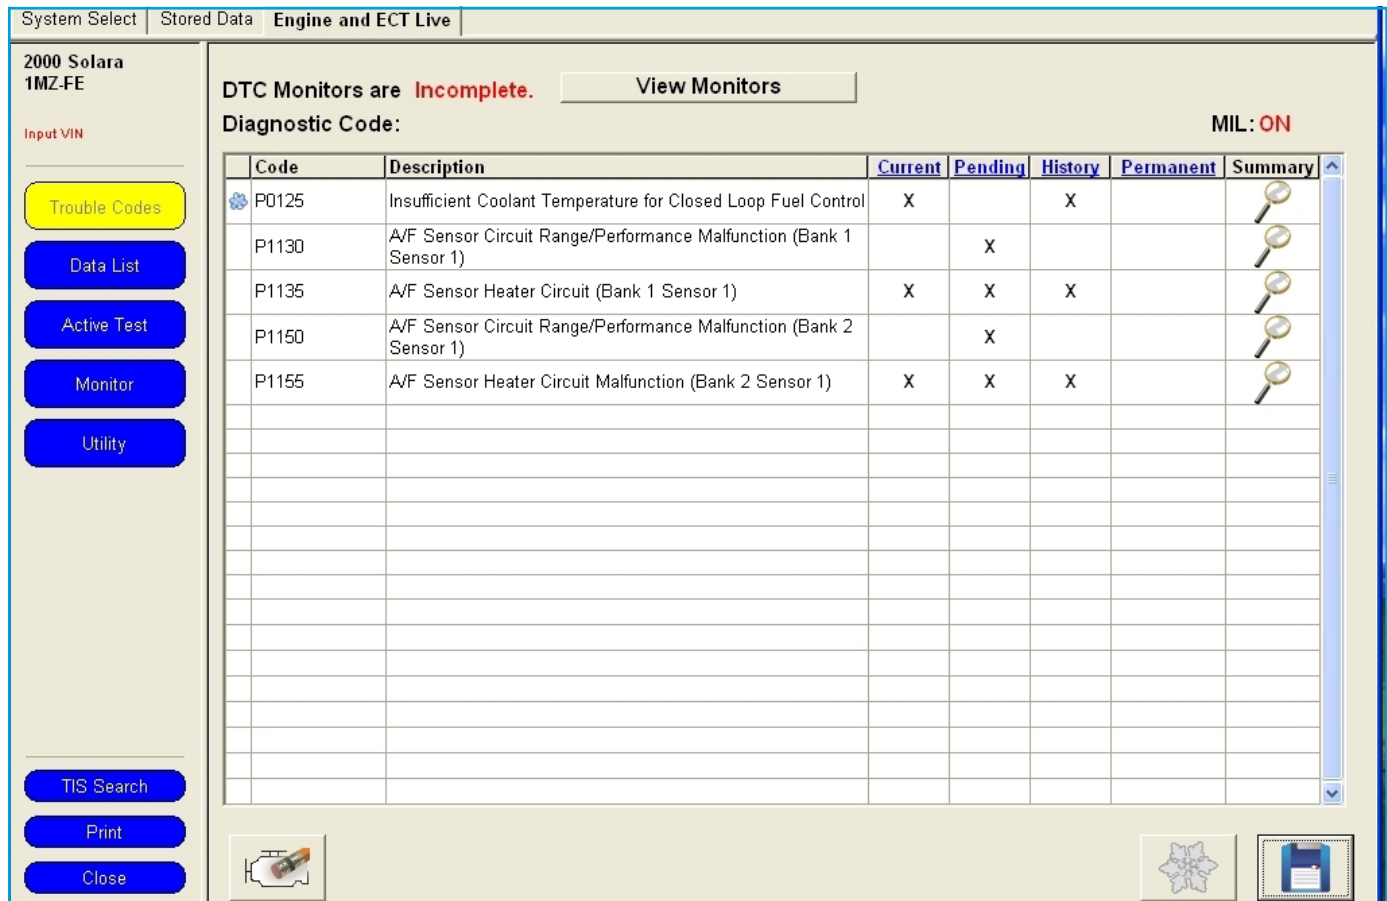
selected “Trouble Codes” from the menu and found five codes stored in memory (Figure 2). Two of the codes, P1130 and P1150, were related to a range/performance issue with both upstream air/fuel ratio sensors. The next two codes, P1135 and P1155, were related to a heater circuit malfunction in both of those sensors. The fifth code P0125 (Insufficient Coolant Temperature for Closed Loop Fuel Operation) is one that takes many scan tool gurus down the wrong diagnostic path. They often mistake this as an indication of a bad engine thermostat when in reality it is letting you know that the air/fuel ratio sensor can’t reach its proper operating temperature due to a heater circuit problem.

codes will always be set as a secondary fault. If you think about it for a moment, you’ll realize that it’s not very likely that two A/F sensors would go bad at the same time, or even two heater driver circuits. It’s much more likely that something common to both heater circuits is at fault, such as a power feed source. Streamlining diagnostics like this cuts your chances of taking the wrong diagnostic path, so it’s important to use some “street smarts” when you approach a problem. It becomes a matter of automotive forensics to sift through the information you’ve gathered from your tests to see what’s really pertinent to the problem, then to apply logic.

Figure 2: Codes retrieved in ECM using the Toyota Techstream scan tool.

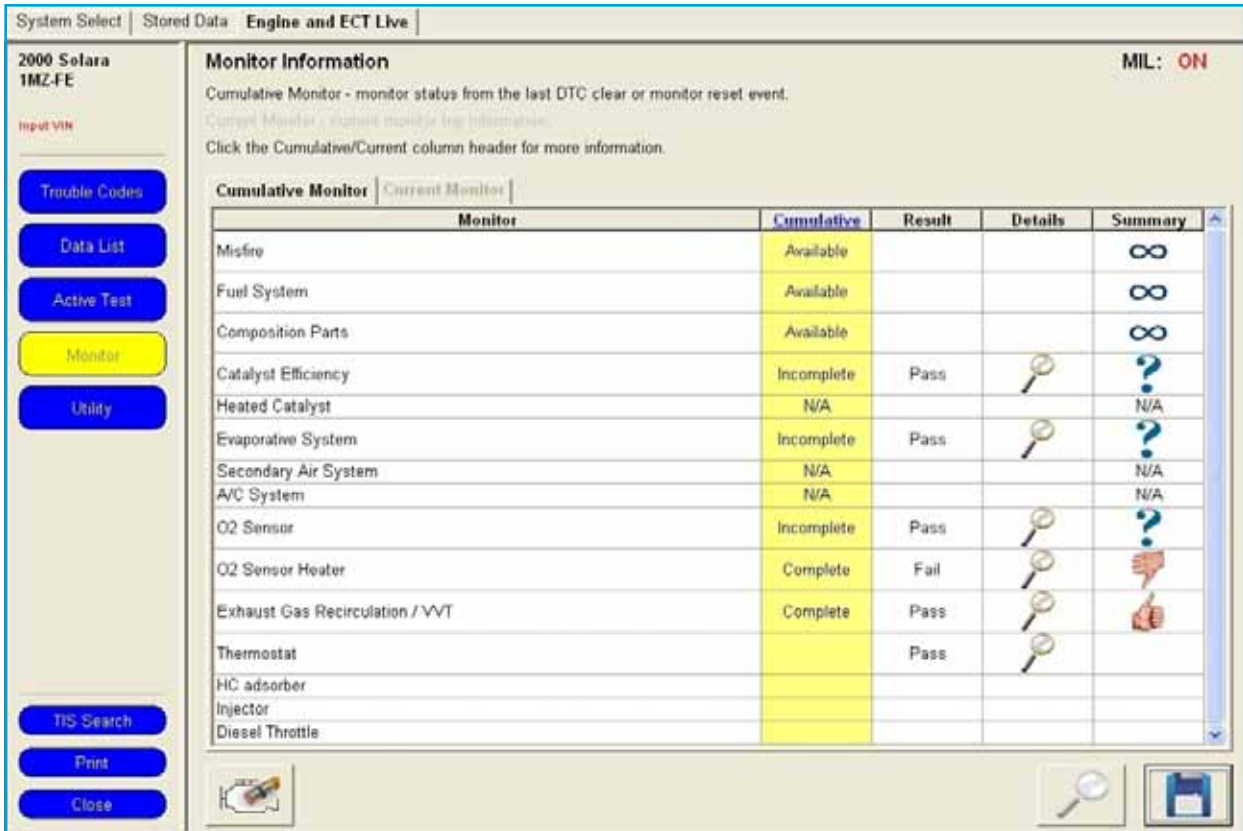
Figure 3: Viewing the OBDII Monitors using the Toyota Techstream scan tool.

Toyota, however, has done a phenomenal job making things easier through hyperlinking. You go to the “Monitor” selection menu and there you will view all the monitors with their pass or fail status (Figure 3). Notice how the thumbs-down sign for O2 heater failure instantly draws your attention with a universal language. Click on the thumb and it will hyperlink to Mode 6 test results that are easy to read (Figure 4). By looking at these readings you can see that both upstream A/F sensor heaters failed to achieve the minimum current threshold of 2.492 amps -- their test value was at 0.221 amps. By viewing the threshold information, you can conclude that both heater circuits pulled almost no current, which is an indication of an open circuit for both banks.

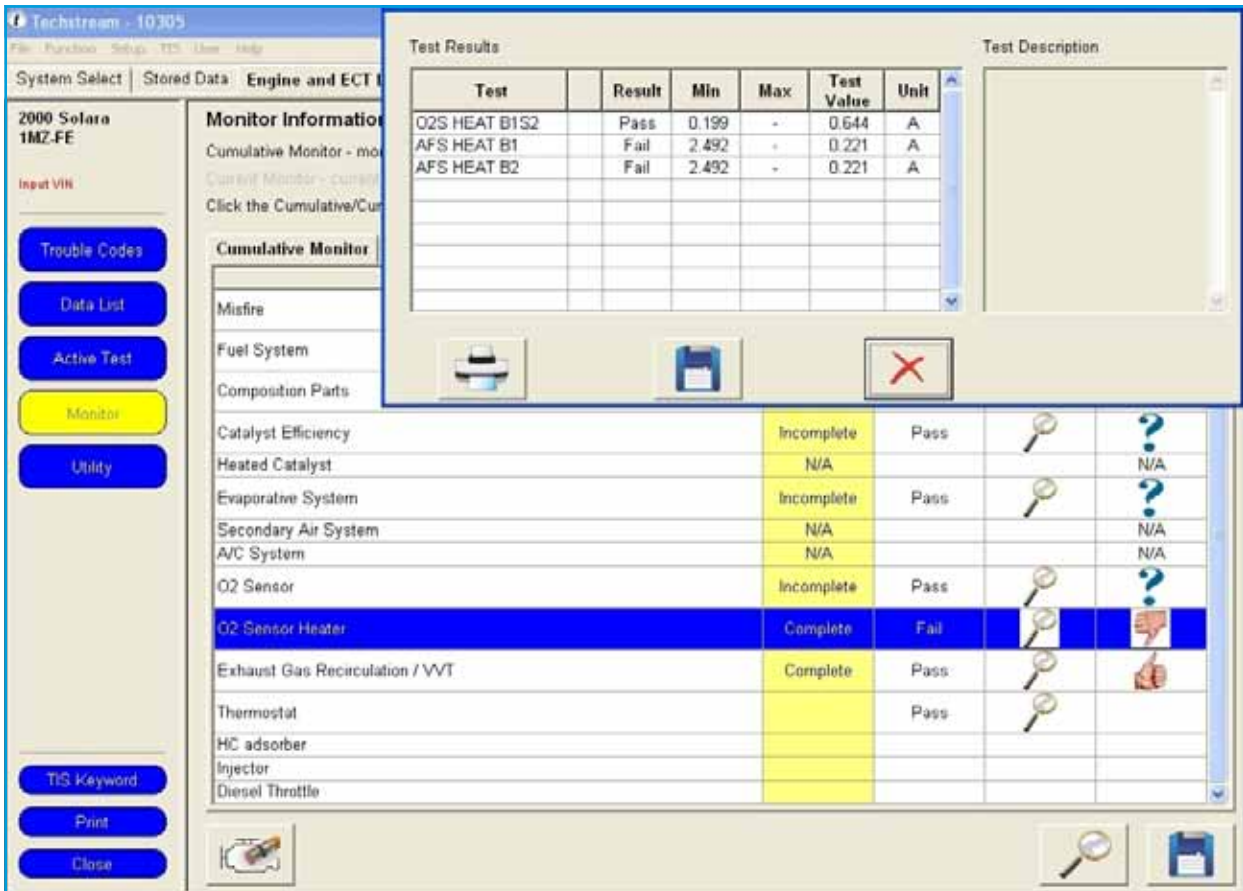
Figure 4: Viewing the Mode 6 results of the O2 sensor heater Using the Toyota Techstream scan tool.

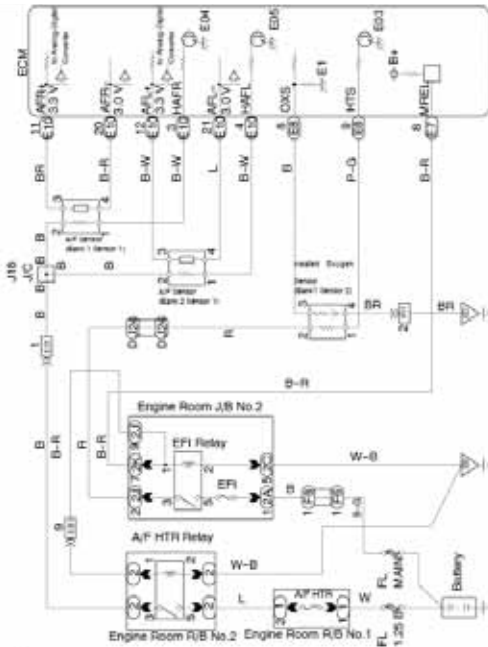
Figure 7: Hyperlinked wiring diagram of the O2 heater circuit.

I used the hyperlink DI-225 under "Wiring Diagram" and was linked to an isolated diagram of the heater circuit (Figure 7). By power-flow checking the diagram, you can see that power feed to the heating elements is supplied through the A/F heater relay contacts from an A/F heater fuse. I located the relay in the engine compartment relay box #2 and turned the box over to backprobe the relay contacts (Figure 8). The test light lit with the key on indicating that power was being supplied to wires leading to the sensors' heaters. I next unplugged the Bank #2 A/F sensor connector located at the back of the engine to test it for power and found nothing there (Figure 9). There was an open circuit between the relay panel and the A/F sensor connector.

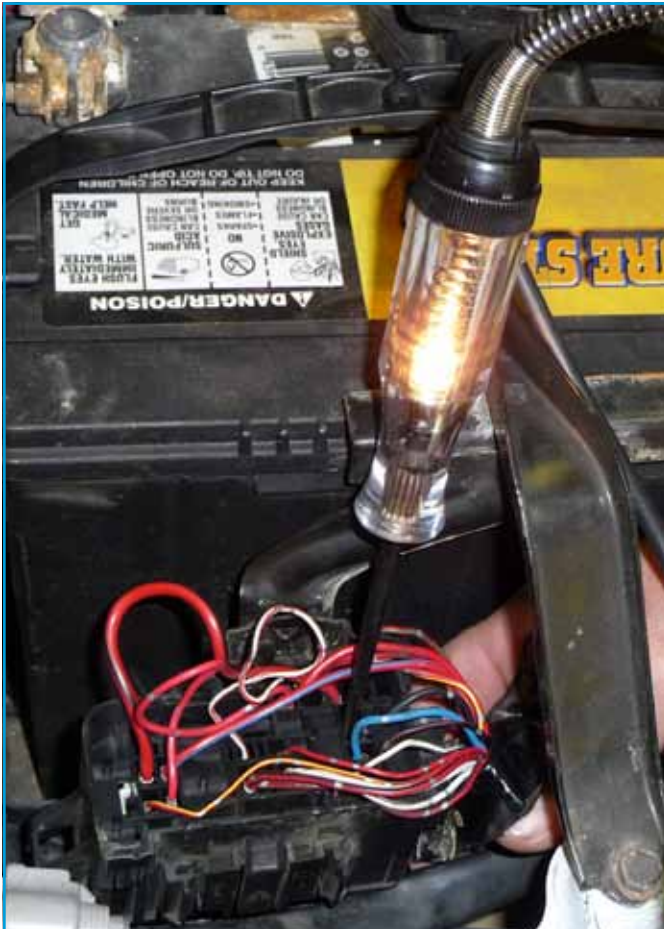
Figure 8: Back probing the O2 heater relay to check contact feed to O2 heaters.

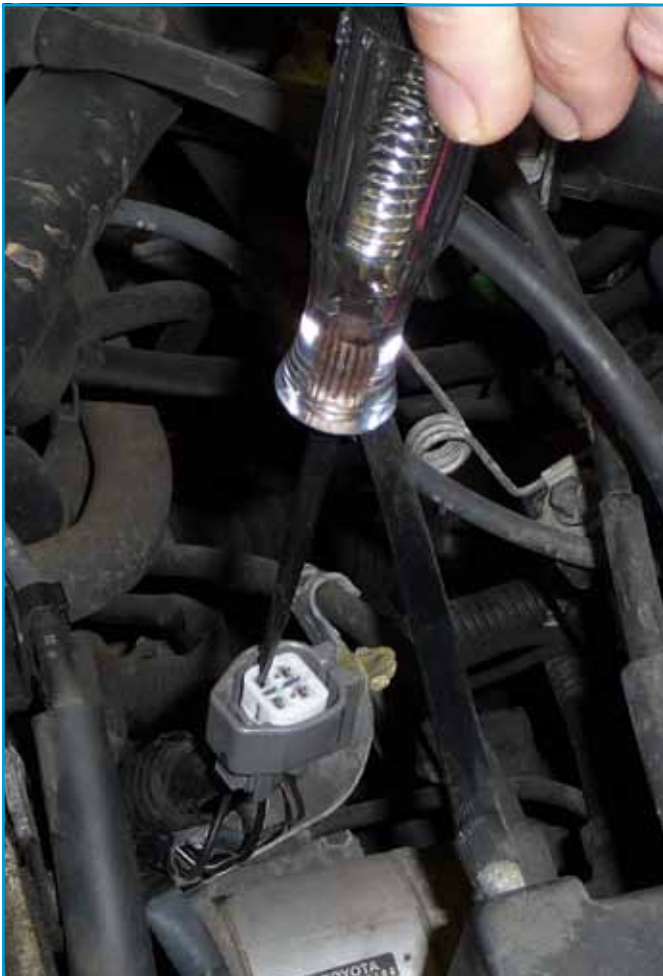
Figure 9: Testing the B2S1 O2 heater connector for power supply.

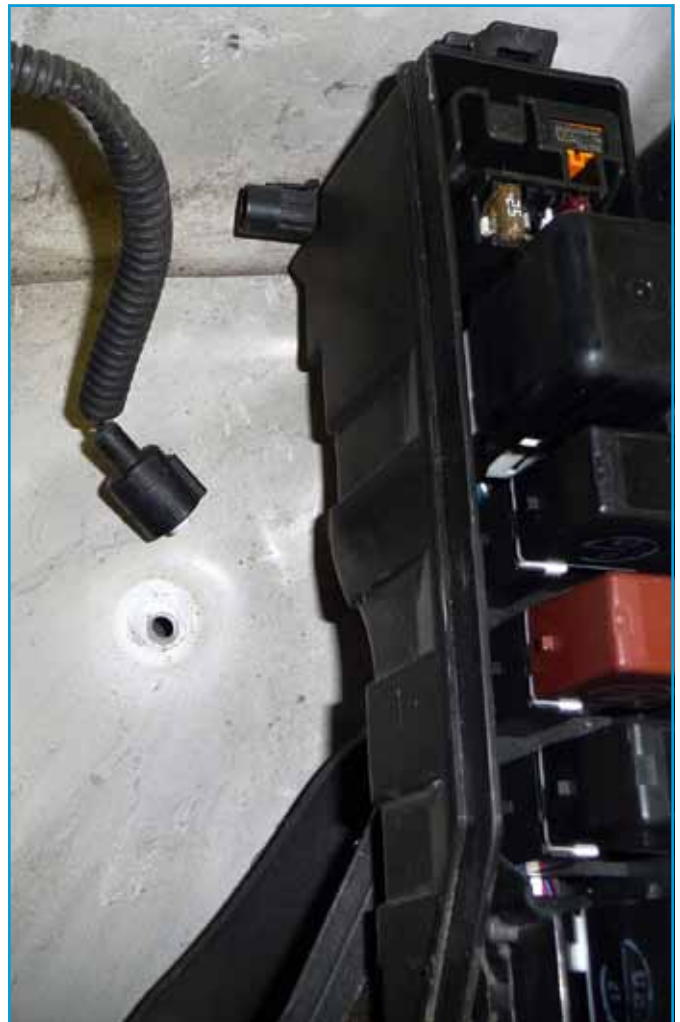
When I removed the battery and battery tray, I immediately noticed a crushed black wire housed in a conduit that was unplugged. It seemed to fit the description of a black wire that fed the sensor's heater circuit. I decided to plug it back into a mating connector located under the left front fuse/relay panel (Figure 10) and restored 12V to the vehicle by using a jumper box so I could recheck the circuit. Once I did this, power appeared in the sensors' heater circuits. It was like hitting the lottery. What are the chances of finding a connector that someone left unplugged, buried, and crushed under a battery tray?

Figure 10: Open O2 heater circuit under the battery tray.
