**HAVE YOU
MASTERED
P3006
DIAGNOSIS
ON THE
GEN1 PRIUS?**

by Paul Cortes

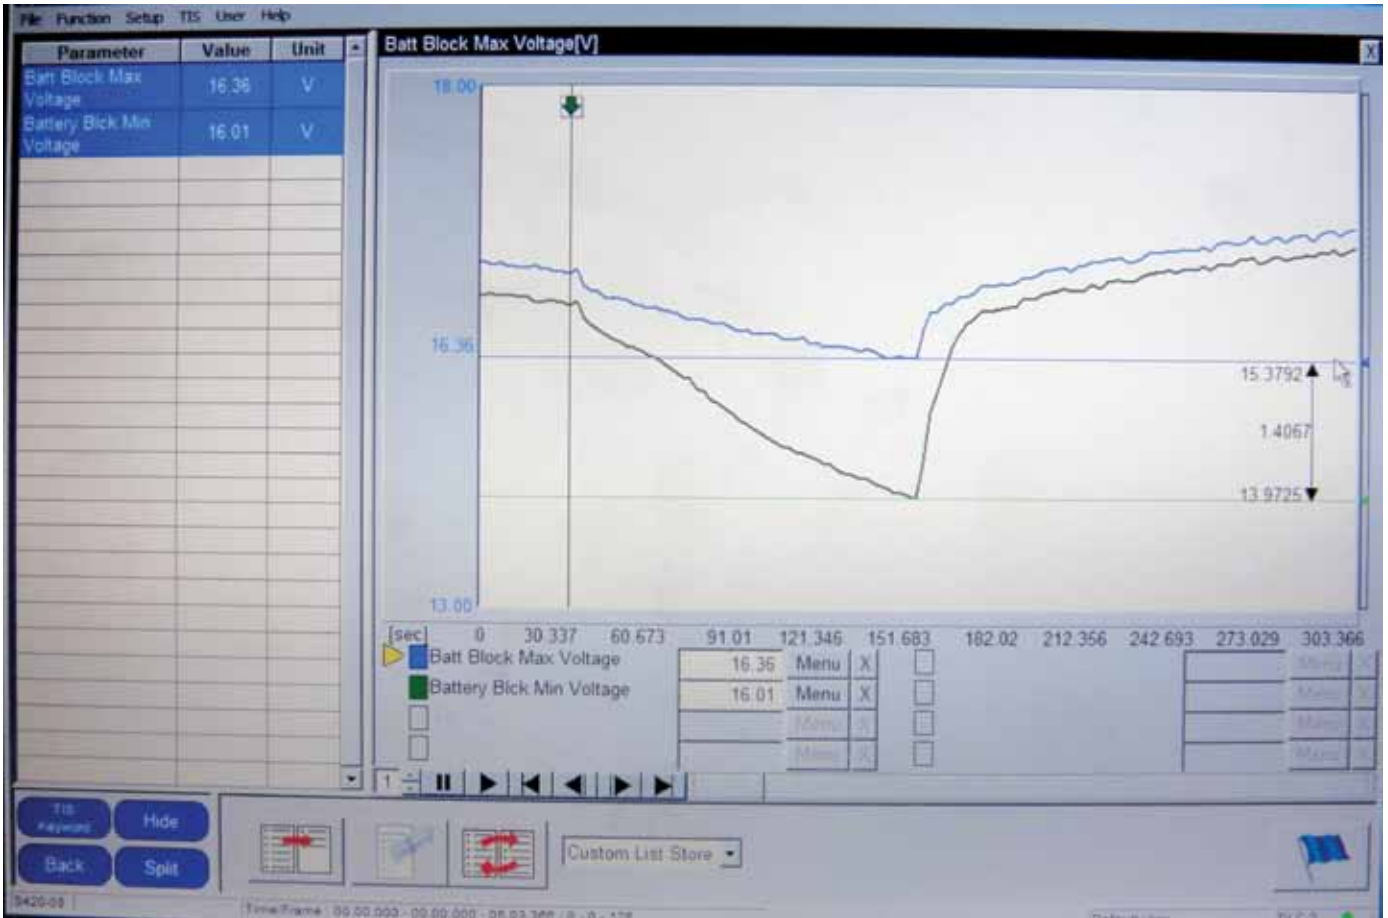
This graphed data is from a typical bad battery pack.

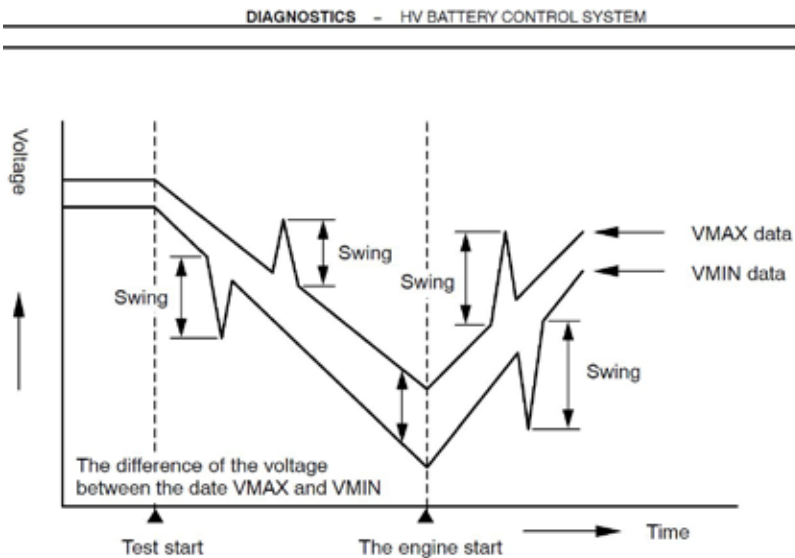
Toyota calls a sudden jump and recovery in battery voltage a swing. A voltage swing should not exceed 2V. If it does, Toyota says to replace the HV battery ECU.

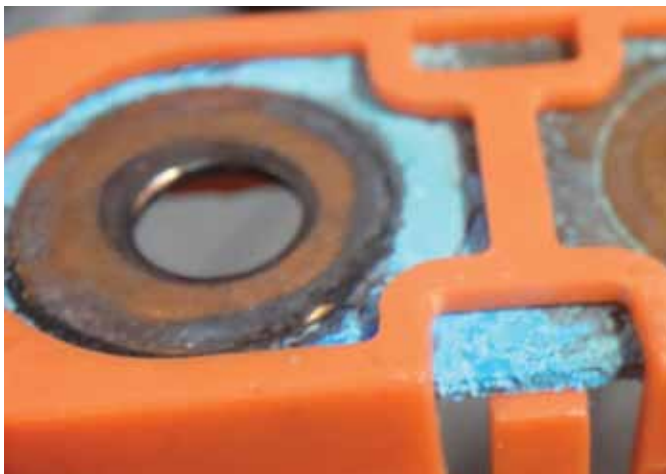
The Gen1 Priuses had trouble with leaking electrolyte around the terminals. The HV batteries were recalled, removed, disassembled, cleaned, and resealed with varying degrees of success -- I would call this effort unsuccessful. There is heavy corrosion on the bus bar that ties the batteries together in series, but more importantly in this case, there is heavy corrosion on the sense wire.

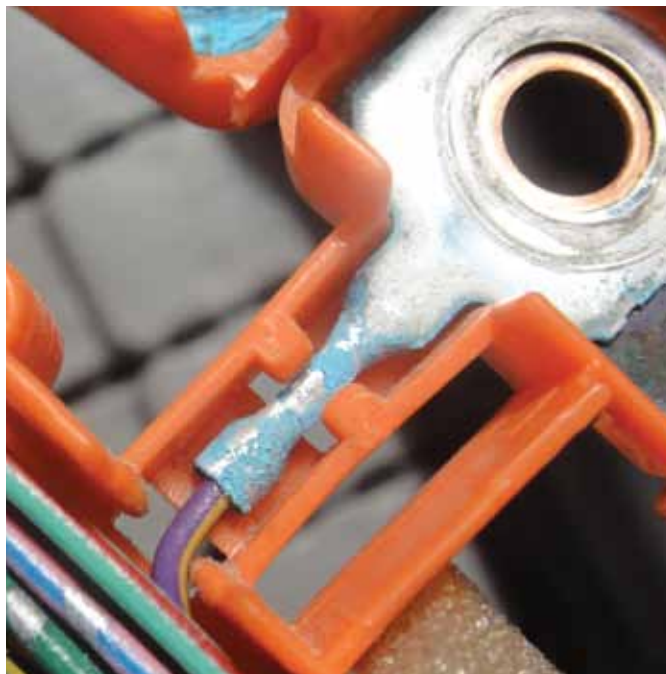
Sometimes the sense wires will erode to the point where the eyelet breaks. The eyelets on this car all remained intact. Was the corrosion alone enough to cause an inaccurate reading?

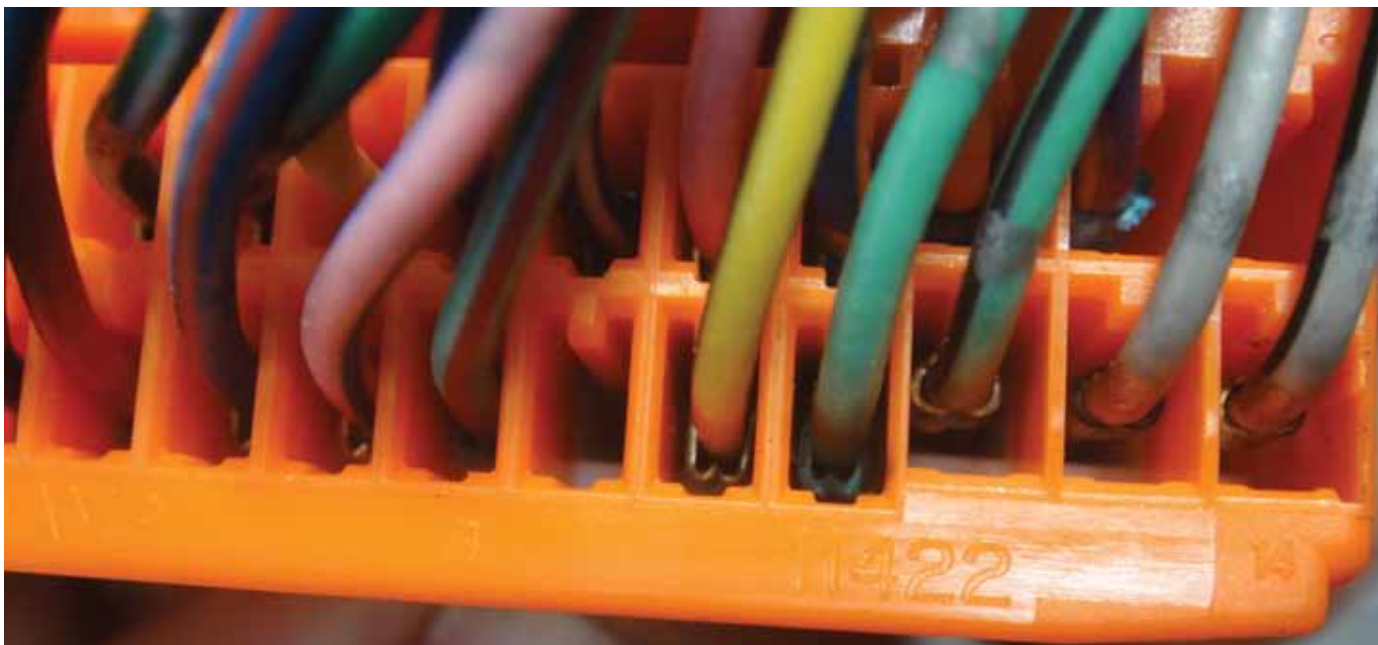
The electrolyte had traveled all the way down the sense wire through the insulation and caused the female blade connector on the other side to turn green. The bus bar and sense wires are available for purchase separately, but would that be enough to correct the problem?

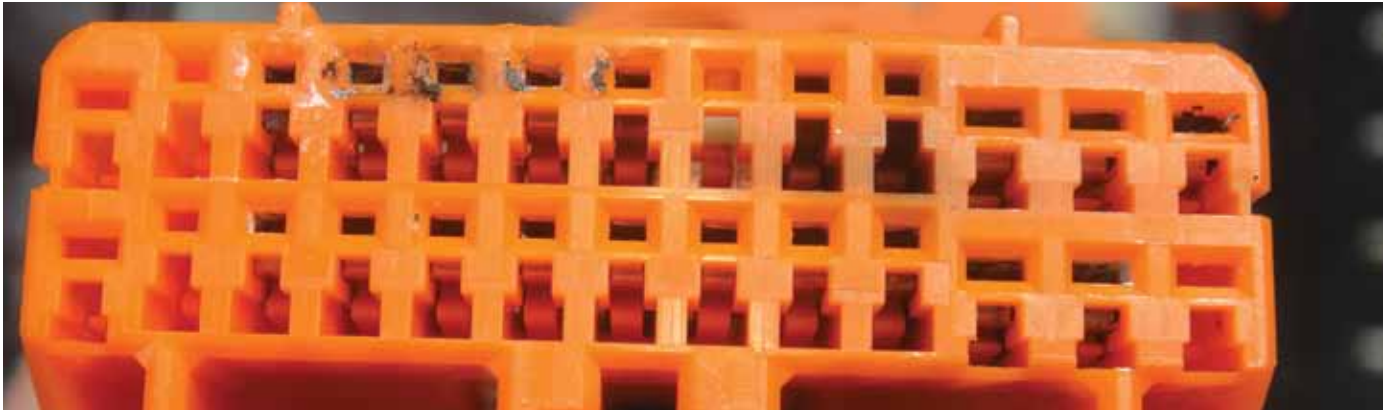
Uh oh. It looks like the electrolyte has traveled through the connector . . .

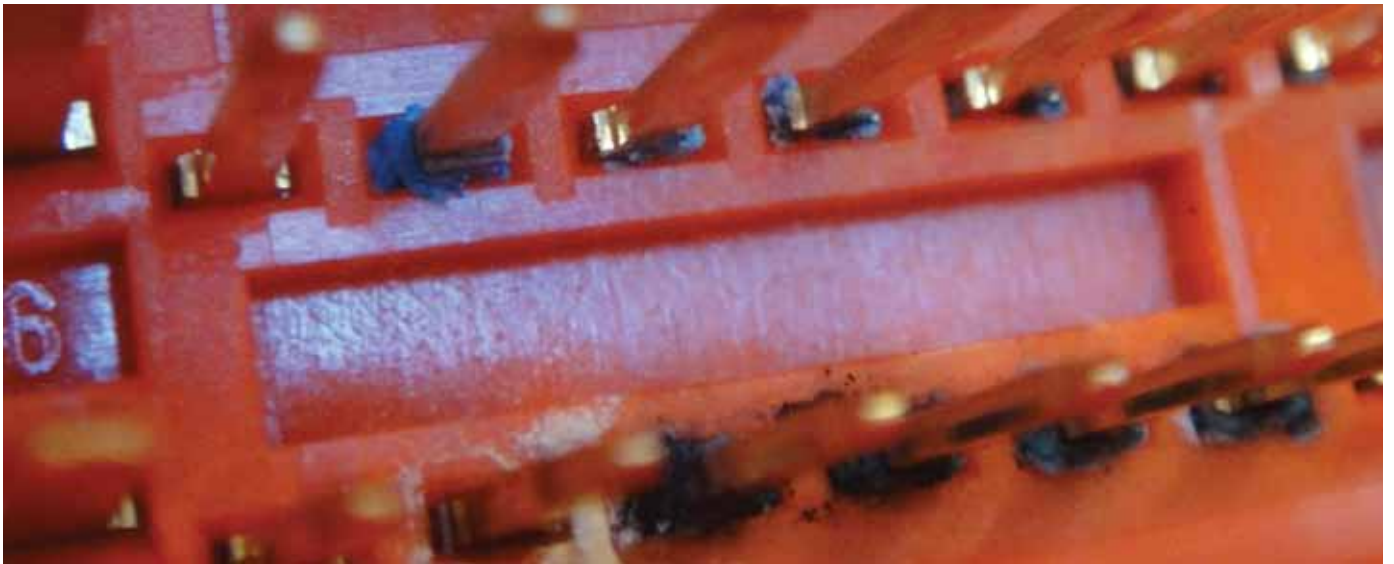
. . . and into the HV Battery ECU. It's worth noting how well the gold-plated terminals faired. Unfortunately, the gold plating only covers the contact area, and does not continue on into the ECU.

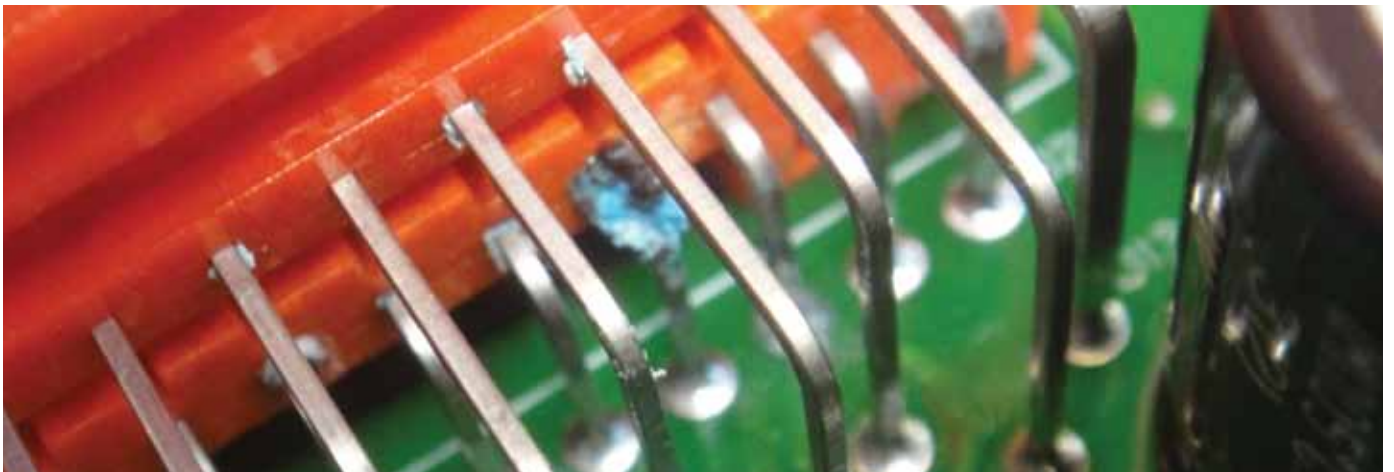
After removing the ECU cover, it was pretty clear that at least one of the pins is badly corroded. A little bit of scraping reveals that there is no metal left under the clump of corrosion. Time for a new ECU, or is it?
