A regular customer brought in his 2007 BMW 328XI E90 because the "lights" were illuminated. We asked which lights. He told us that the traction control, 4x4, and brake dashboard warning lamps were all on at the same time, but that they went out after the key was turned to the "Off" position. Obviously, some troubleshooting was in order.

Right turns only?

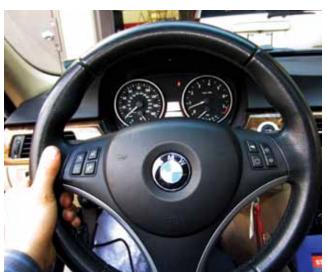
When checking the steering angle PID on your scan tool, make sure that the steering wheel is arrow-straight. You should see 0 degrees.

With the steering wheel of this 328XI E90 perfectly straight, we were not reading 0 degrees. Relearning produced 0, but it went out again on the test drive.

(out of 360) as possible. As you can see, the PID for the steering angle here was at -1.98 degrees.

Keep in mind that if you have a weak battery, or any previous repairs that involved disconnecting the battery were recently done, you will have to perform a "steering angle sensor recalibration or relearn." This is where we started our diagnosis. It is recommended that you re-learn the steering angle sensor with a factory or BMW OEM-enhanced scan tool, such as the Autologic. When you go through the steps of the steering angle relearn, make sure that the steering wheel is as straight as an arrow. When you do this, the steering angle PID should be as close to 0 degrees

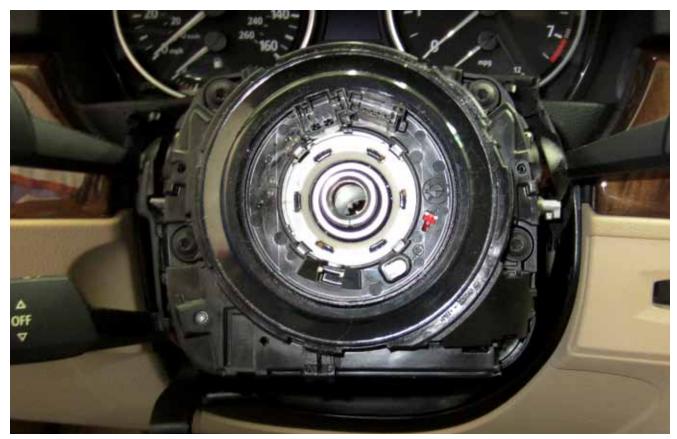
After removing the air bag and steering wheel, the multi-tasking SZL switch cluster is almost ready to come out -- just four more fasteners.

Special note to the techs out there who work under the tyranny of the clock: The removal and replacement of the steering column switch cluster is not tough. Simply disconnect the negative battery cable, remove the airbag, steering wheel, connections to the SZL, and then the four screws that hold the steering column switch cluster. No special tools needed to do this job.

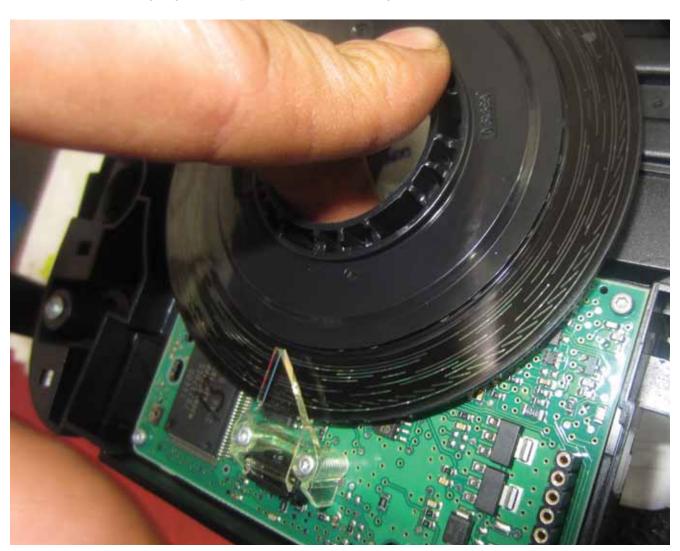
You might be surprised to find so much technology and so many functions in one component. The SZL switch cluster comprises LEDs, an encoded disc, a line camera, the clock spring assembly, and the turn signal, cruise control, and wiper switches. What we're interested in here is the condition of the encoded disc.

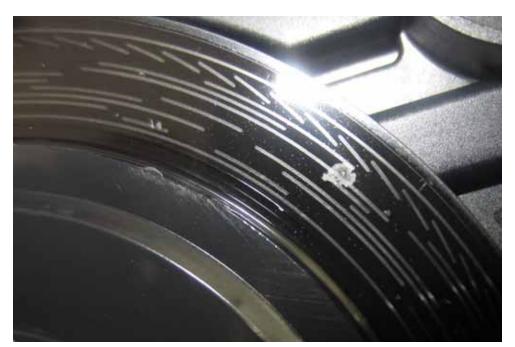
Rotating the encoded disc and examining it carefully revealed the surface damage that was disrupting the optical signal and confusing the system. The only remedy was replacement of the whole SZL switch cluster.

Now, do you remember how all the lights came back on when the car was turned to the right? From our understanding of the system, the optical conductor on this E90 is picking up a weak amount of LED light through the encoded disc when turning to the right, confusing the electronic

evaluation unit and setting all those codes. When we opened up the SZL, we found marks on the encoded disc, confirming our theory that this is where the signal was not being picked up by the line camera.

After installing the new steering column switch cluster, we coded the DSC module again. The steering column switch center is coded automatically when you code the DSC with your scan tool. Then, you re-learn the steering angle one more time and clear the codes. When we road tested the vehicle, being careful to take several sharp right turns, the lights did not come back on and the repair was good.
