The Stuff You See

by Greg McConiga

Our man Greg relates some egregious examples of the things that can be done wrong during the building of a high-performance engine. You'll learn a lot of interesting stuff here.

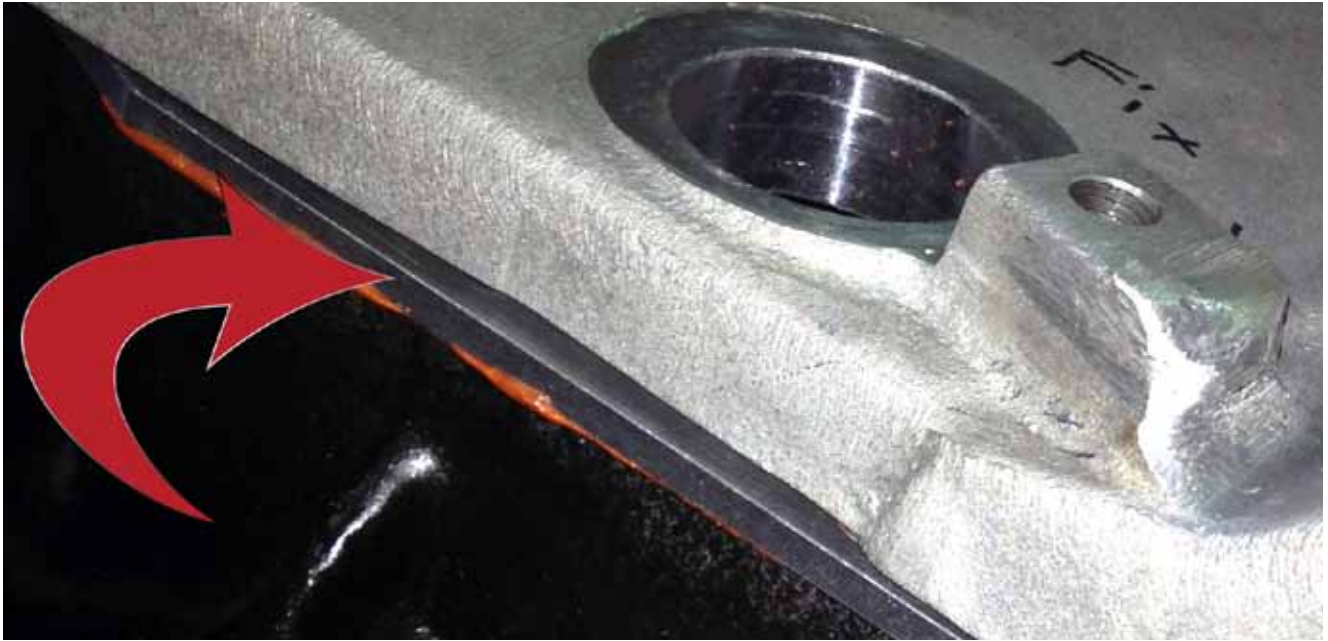
As you can see, a thin aluminum filler block is used to take up excess space between the china rail and the intake manifold. You can fill this gap with RTV, but why take the chance?

The first thing I spotted was that the intake wasn't entirely sealed at the china rails. The thick layer of RTV was just a little short and you could see daylight from one end of the intake to the other. It needed to have rail extenders installed.

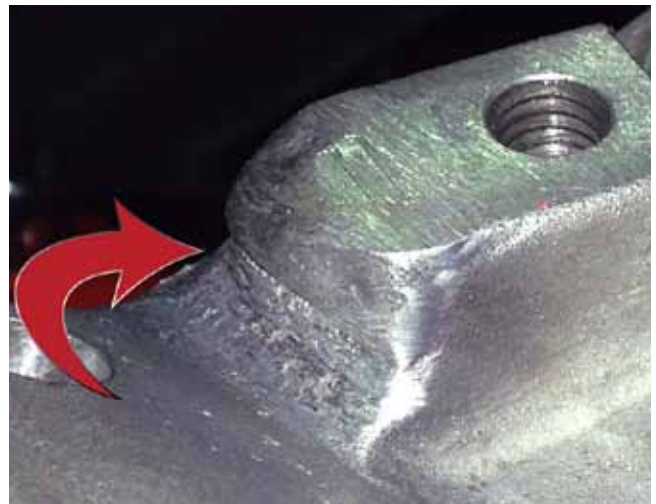
I also noted that the distributor could easily be turned by hand when the hold-down was fully tightened. While this was a

crank-trigger engine, the distributor body was the spark sorter, and if left this loose it would rotate against the torque of the high-volume oil pump in the wet sump and start cross-firing other cylinders resulting in catastrophe. The intake manifold distributor mounting pad was too short for the tang opposite the distributor to react against and hold the distributor from turning. So, I fired up the TIG, welded it up and shaped it so that it would lock the distributor in place against the resistance of the oil pump.

I added on about a half of an inch to the mounting boss so the distributor could be properly tightened.

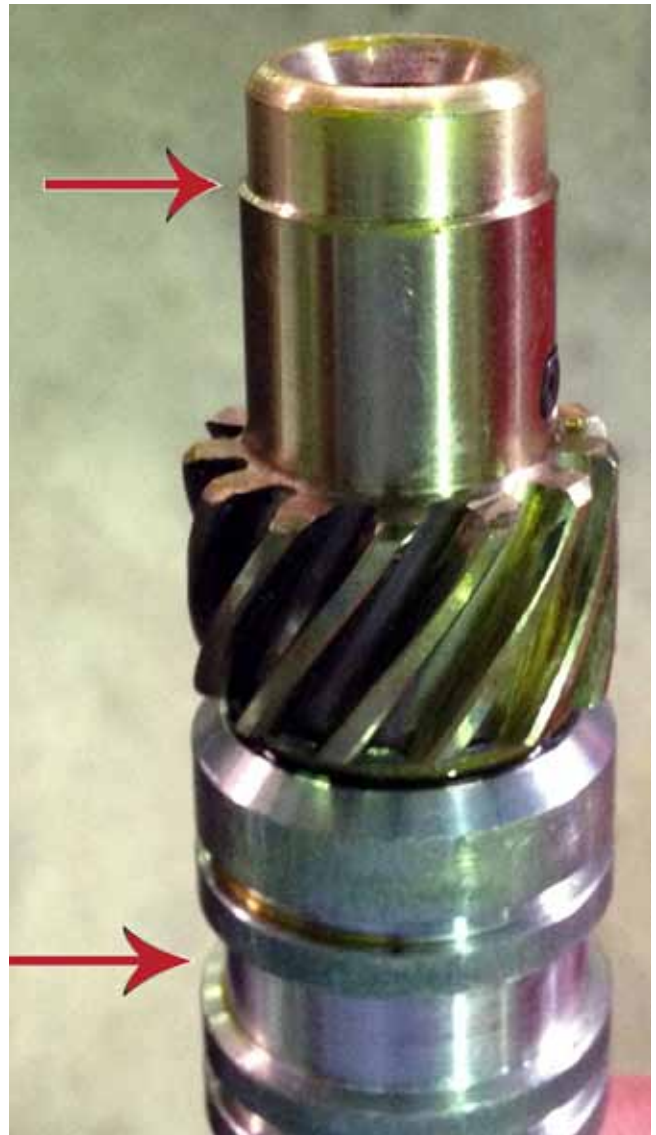
Further inspection revealed that the adjustable collar on the distributor body (an MSD billet piece) was not in the right spot, and the oil crossover channel at the back of the block sealed by the distributor body was nearly blocked off. Getting it in the right place (you have to remove the rear oil galley plug to visually center it) required that the distributor drive gear be machined a bit shorter and that the shoulder below the gear be reduced in diameter so it would drop deeper into the block. The block he was using was an aftermarket piece with a bulge that pushed over into the same place the distributor gear would normally occupy, and it was easier to modify the distributor gear than it was to modify the block.

The lower arrow points to the rear oil galley cross-over slot that you see on all big- and small-block Chevy engines. You should center that slot in the oil gallery to ensure full flow to both sides of the engine. The upper arrow shows where I machined off the end of the gear so that the distributor could drop deeper into the block.

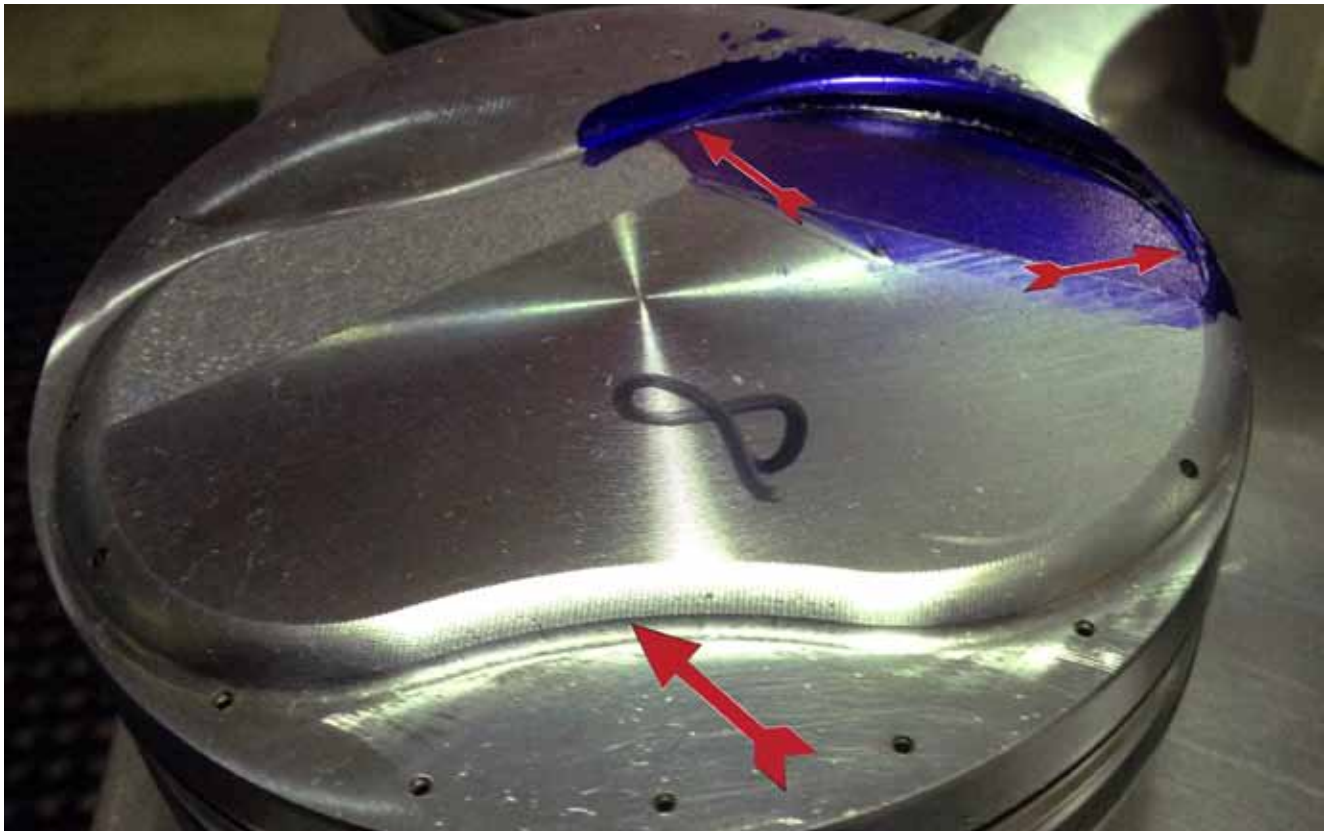
On the preliminary inspection, I noted a slight catch in the engine as I rolled it over. When I pulled the heads, I found that the intake valves were hitting the pistons -- there was insufficient valve drop clearance AND radial clearance. The new pistons also arrived with too much dome on them to be used as supplied with his 12-degree aftermarket racing heads. The static compression calculated out to over 17:1 (diesel territory), and that, combined with the new cam's early intake closing, resulted in a dynamic compression

The new piston arrived with way too much compression and not nearly enough valve clearance. The space between the arrows in the valve pocket show where the valve was making contact.

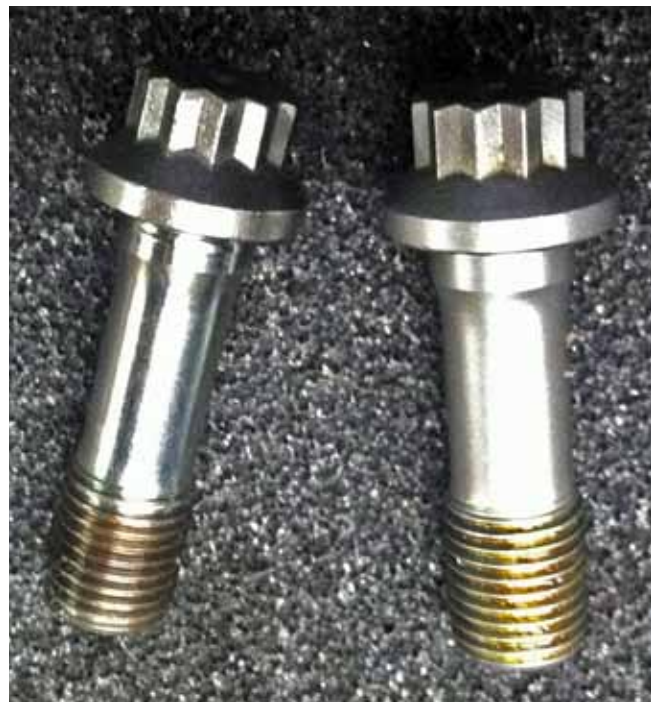
Rod bolts run \$15 to over \$50 each, but even at that they are cheap insurance. Never chase the stretch or you'll have to replace them all.

stunned to find several bolts that had relaxed by .007-.009 in! The spec for the bolts was .0054-.0058 in. Turns out the owner “chased the stretch” as he tightened the rod bolts... a fairly common error it seems because I’ve heard of others doing this as well.

When you stretch bolts, you must lube them, turn them one time all the way to the final reading, and measure. If they don’t reach stretch you must loosen them all the way, re-lube the area under the head, verify that they have not taken a permanent stretch and then stretch them again in one motion, and measure them again. You must NEVER tighten them, take a reading, then tighten them some more, and read them again and so on. All you’ll end up doing is “chasing the stretch” and ruining the bolts. Plus, once over 75 ft. lbs. or so the head of the bolt and the shank above the threads winds up ahead of any thread movement and you’ll introduce all kinds of stress into the bolt doing it that way. The best way I’ve found to tighten racing rod bolts is the “torque and turn” method used on a lot of late model car fasteners. I tossed the old bolts and bought new ones.

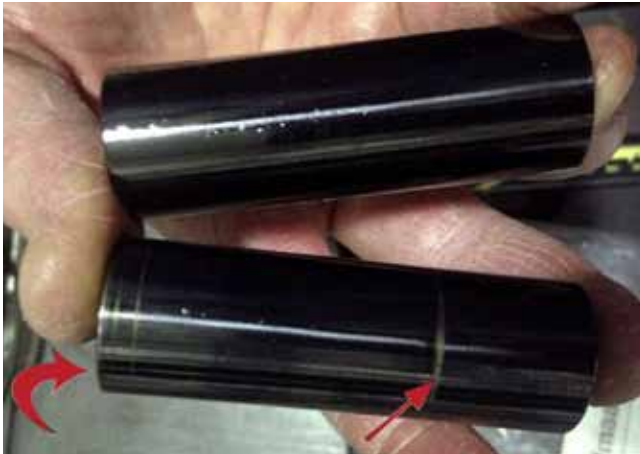
This engine uses a vacuum pump which tends to pull oil away from the wrist pins, so the owner specified pins coated with diamond-like coating (also known as Casidium or DLC). We were able to run these again, but they were too tight to start with. The arrows point to damage to the coating on the right and “faceting” on the left. Damage like this is a sure sign of too little clearance.

As I continued, I discovered that the DLC pins (Diamond-Like Coating -- the black finish you see in the picture) was marred. It turned out that the pin clearance was much too tight. If you look closely at the lower pin, you’ll see that it is “faceted” from being overly tight in the bore. Both the rods and the pistons were resized to correct the condition.

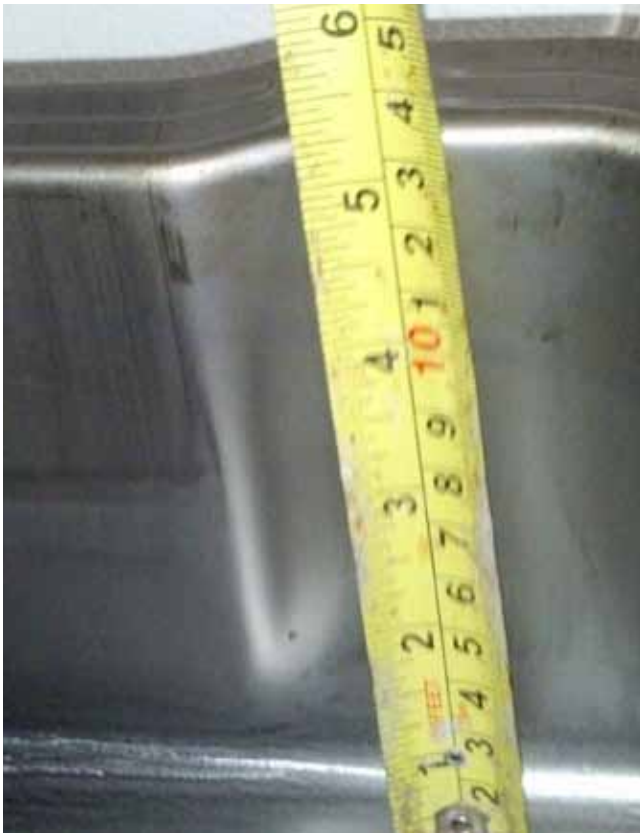
You must measure the pan depth from rail to sump bottom and pickup depth from rail to bottom of pickup. 3/8 in. is the preferred specification.

In my search for the low oil pressure problem, I discovered one thing early on: The oil pump pickup was damn near sitting on the floor of the oil pan. It was literally off the floor by just the thickness of the oil pan gasket, roughly .060 in. The oil pickup was modified to raise it up to just over 3/8 in.

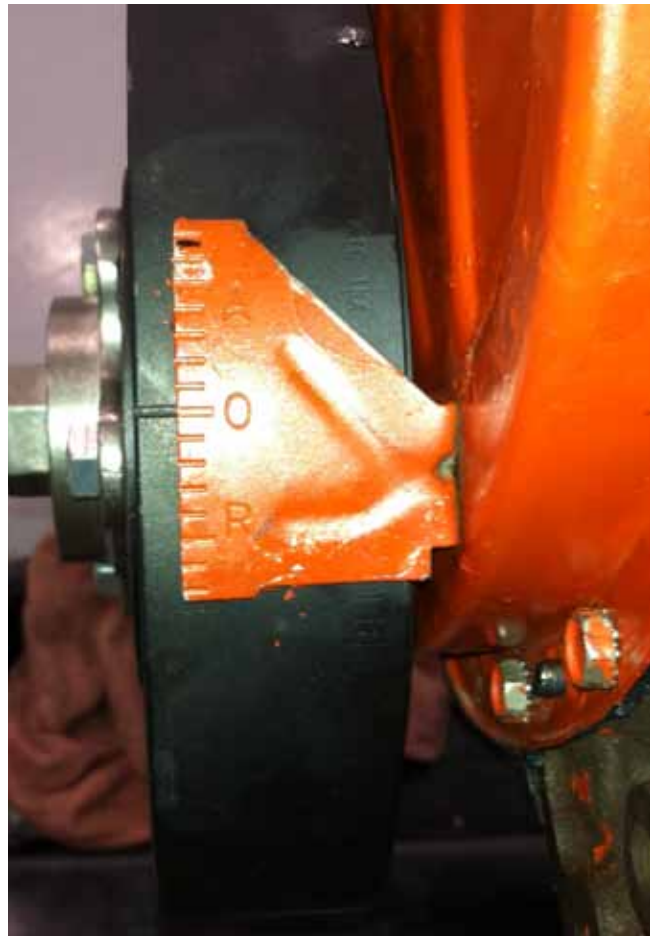
Always double check old rubber mounted dampers on older cars. A lot of them have slipped over the years. Remove your degree wheel without moving the crankshaft and verify TDC is correct.

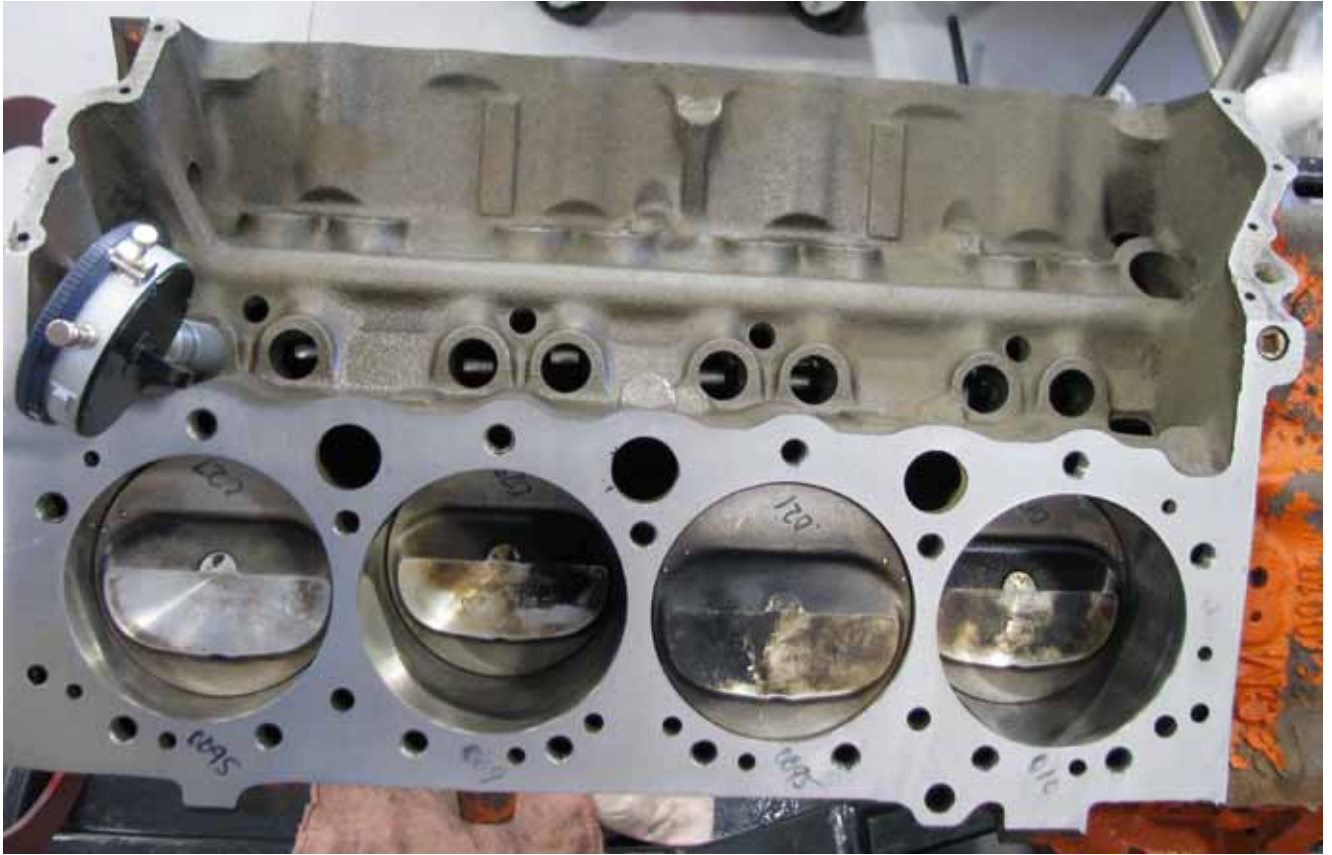
The numbers written on the pistons are how far down the bore the pistons were before we machined the deck. The numbers on the deck indicate where we ended up after machining... quite a difference! (Top: Driver's side; Bottom: Passenger's side.)

the deck of the block (after I had it decked to fix it). This thing went from .019 to .027 in. from back to front on the driver's side, and from .034 to .039 on the passenger side. The deck was tapered on one side, plus I had .020 in. difference in the piston-to-deck measurement. To make matters worse, the side with the sunken pistons had the cylinder head with the bigger combustion chambers -- something like three ccs bigger. I had one side of the engine at about 9.8:1, and the other side at about 10.4:1. Okay, combine that with a big old lumpy camshaft and I guess it might not run so well. The thing that struck me was that all of this mess had to come from the factory this way! The engine was original and had only been freshened up this one time. Good old days indeed...

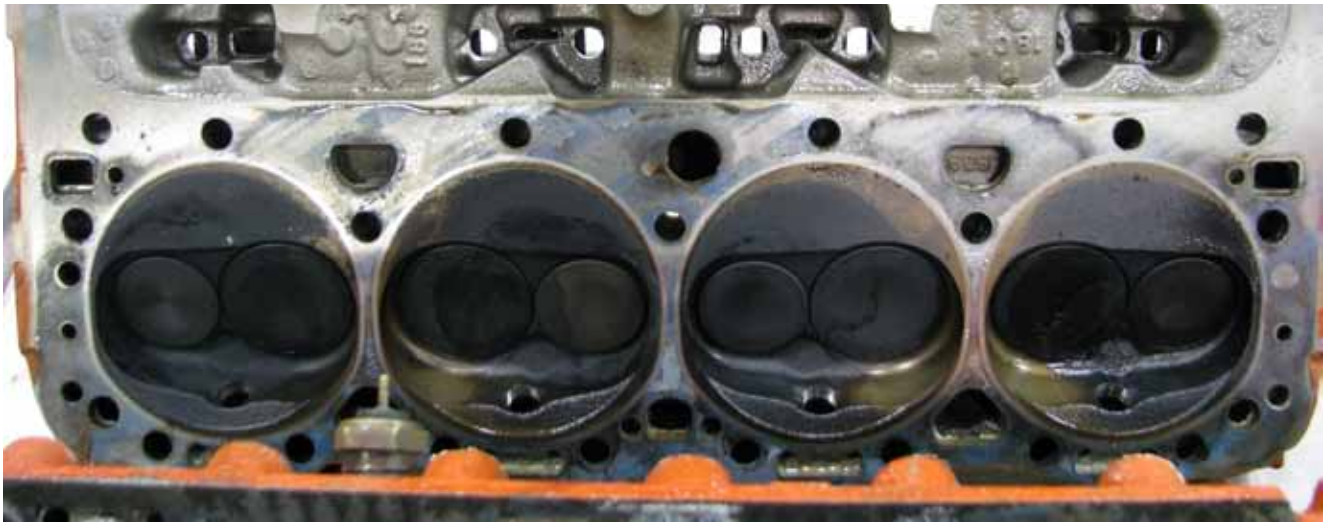
The valves were all sunk to about the same degree, so I just had the head with the larger combustion chambers machined to make both sides equal. It was the most elegant solution to the problem.

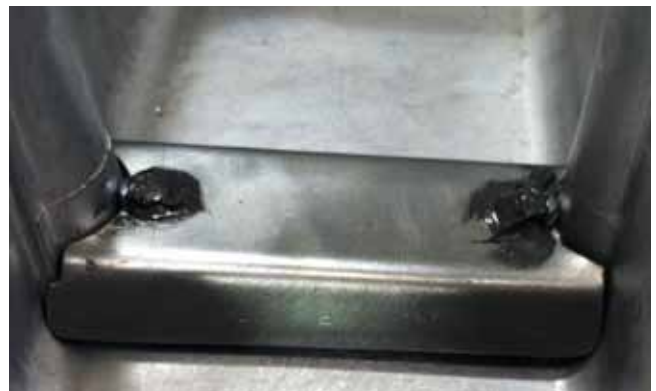
It's easy to forget that you must baffle the valve cover to keep oil mist from being sucked up into the PCV system.

It had a high-volume oil pump, which I replaced with the original high-pressure pump. I wanted to try to keep some oil out of the valve covers. I also fabricated baffles to divert the oil away from the PCV valve. I discovered that a couple of pushrods were trying to shove their way out of the pocket in the rocker arms because the guide plates weren't clearanced for the additional lift of

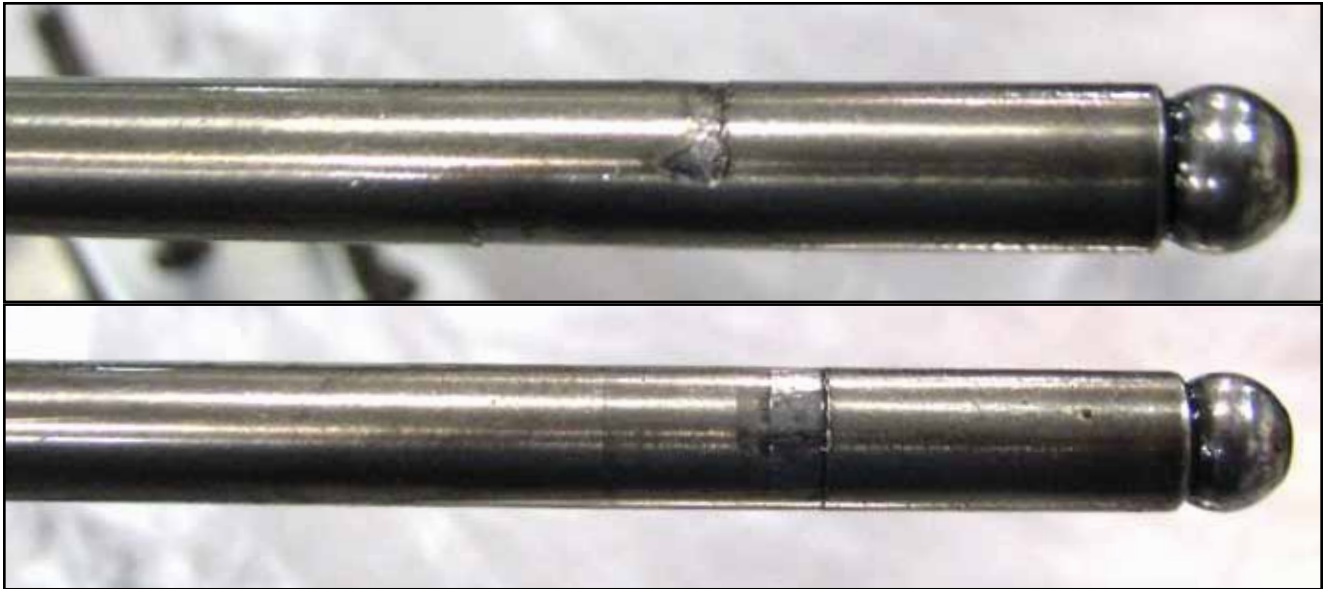
the new cam. I also found one lifter fully collapsed and stuck down. He said he had a hard time getting one to quiet down and he had to keep adjusting it. Sigh.

These were the worst, but virtually all of the pushrods were damaged and had to be replaced and the guide plates ground out for clearance. The pushrods move in and out as the rocker travels in an arc. More lift means more movement.

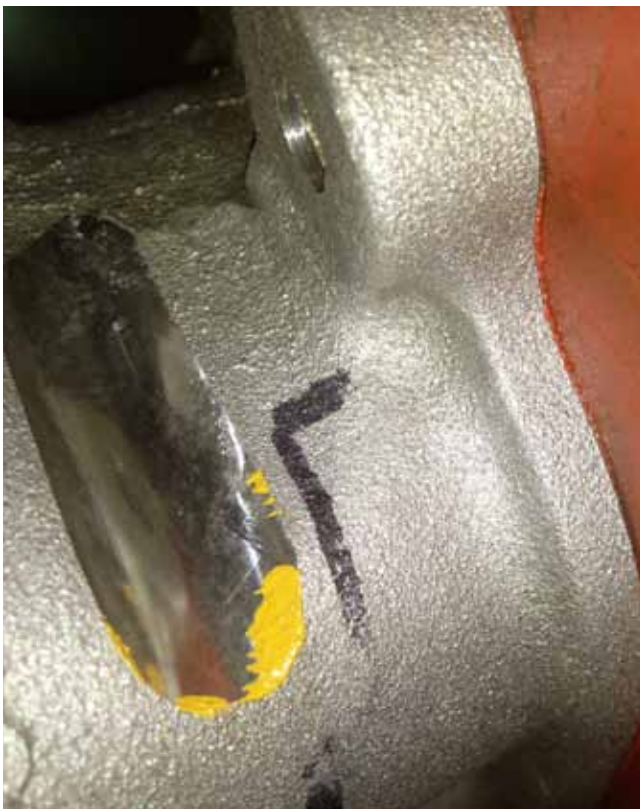
For those engines that don't use guide plates it doesn't mean you're out of the woods when it comes to pushrod contact with its neighbors. Here you can see gear marking compound that has transferred from the pushrod to the clearance notch in the intake runner.

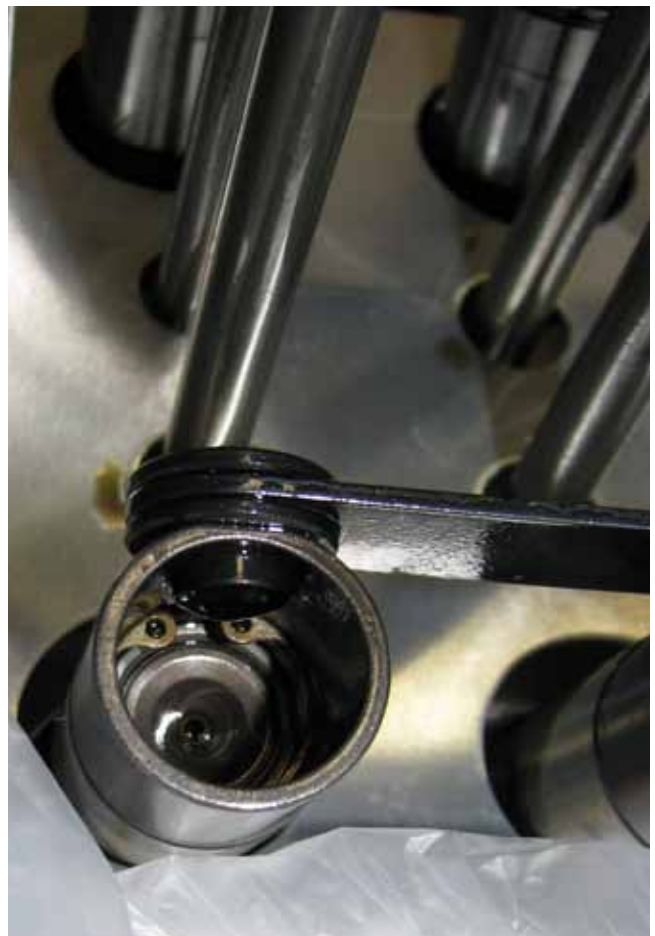
If you look closely you can see that the lifter is stuck down. I freed it up and tried to run it but it stuck again and had to be replaced.

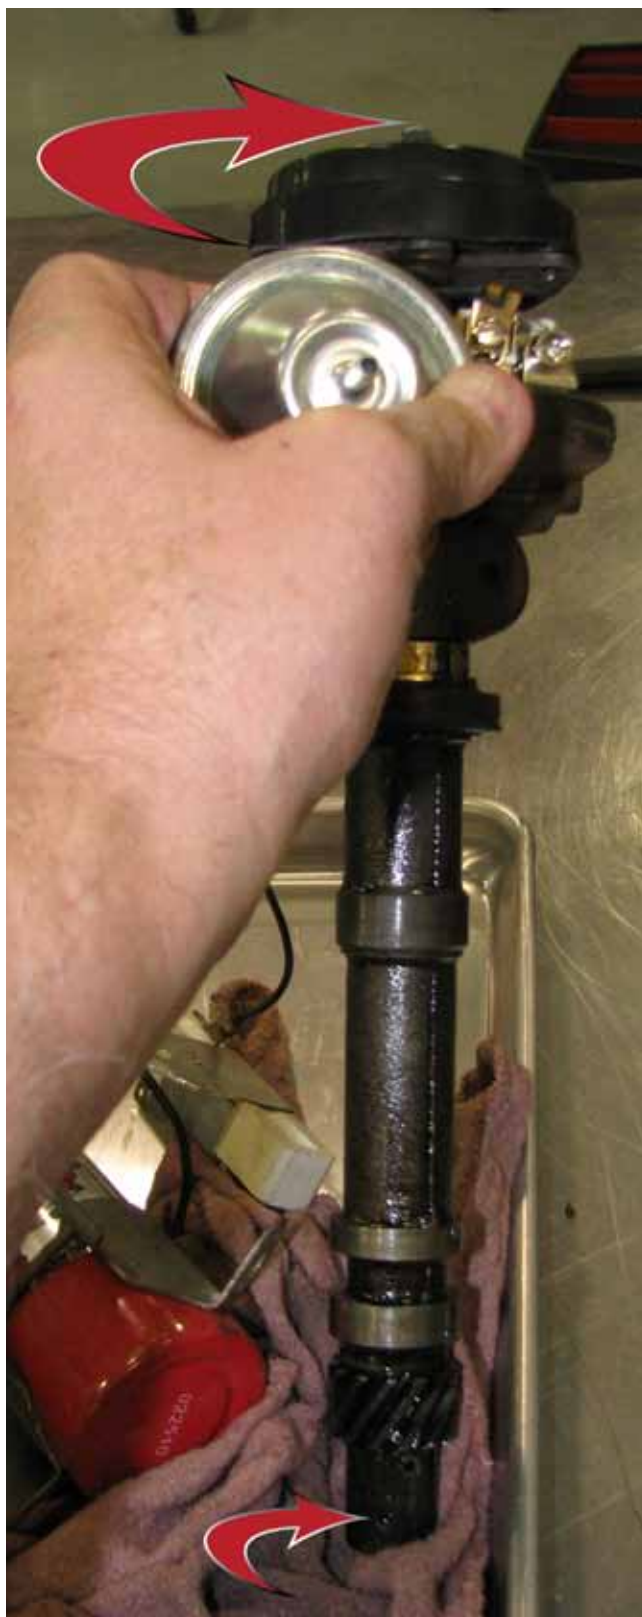
Another thing I found was that the customer had removed and rebuilt the distributor, and didn't get the gear on right. If you look at an old stock small-block Chevy, you'll see a drill mark on the gear (check the picture) that must align with the tang on the rotor. Not a big deal, but still... There are 13 teeth on that gear, and you'll throw your rotor register off if you mount the gear backwards.

The top tang is facing away from drill spot on the gear. This gear is on backwards. You can see the center tang sticking up but the rotor tang that directs spark to the cap insert is pointing away in this picture.

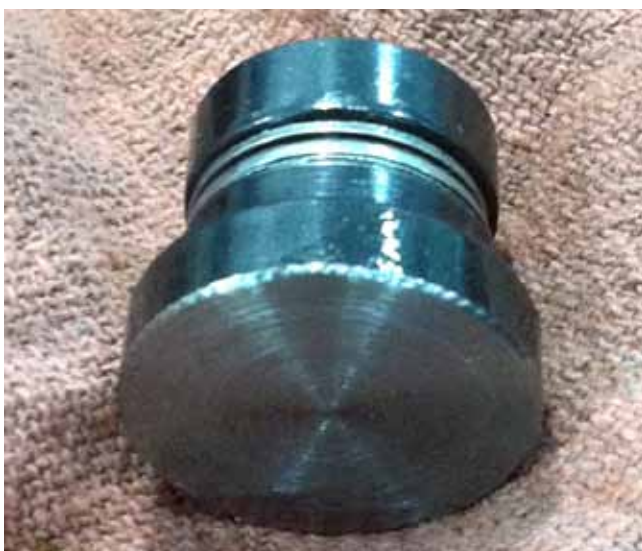
I also found that the owner picked the wrong intake gasket. It wasn't leaking that I could tell, but it looked to me like it was only one good cold morning backfire away from whistling. There was also a cam button installed to keep the cam from walking in and out of the block and it was jammed up against the front cover so hard it was trying to bore its way through. A little lathe work to shorten it up and I set the end play at about .006 in. and it was good to go.

If you use a roller cam you have to use something to keep the cam from walking in and out of the block. Just make sure you've got end play on the cam after installation.

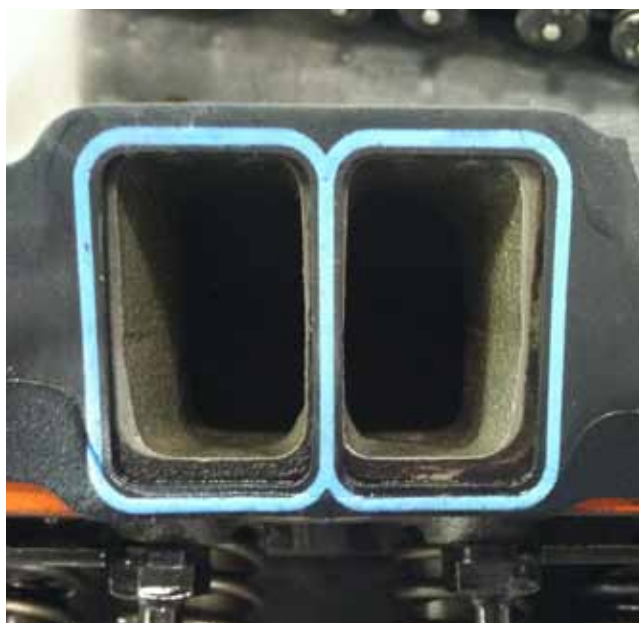
You can see the impression where the intake sealed on the gasket. Not much to hold on to!

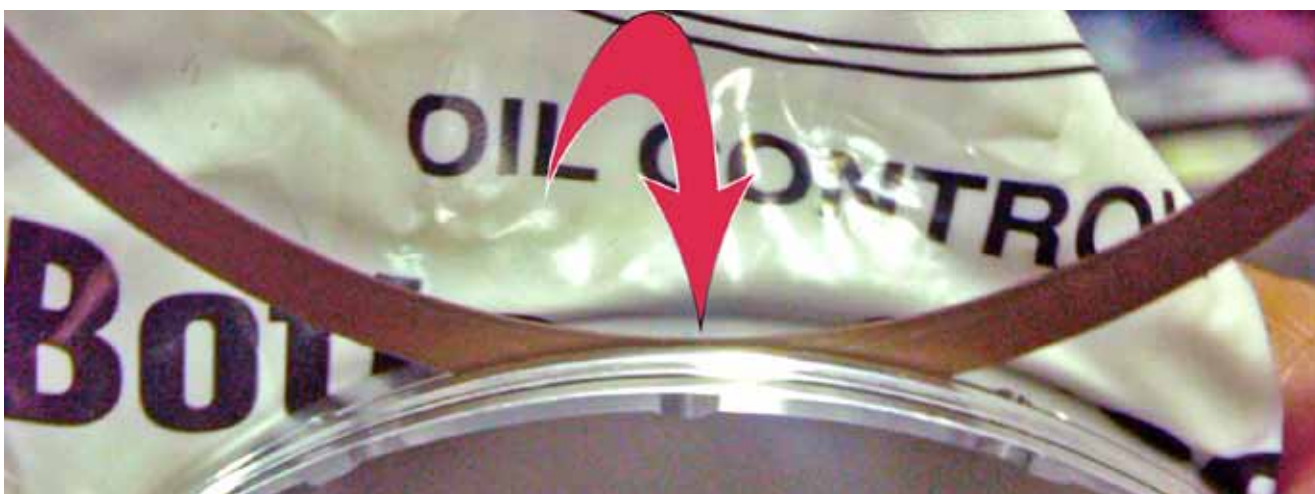
There are a hundred things to consider when doing this work, from parts that aren't made right, to cleaning, and learning good measurement techniques. If you need an example of parts that cost a lot of money, but aren't made quite right just look at the picture of the piston and ring. You can see that the ring stands proud of the ring groove... not enough back clearance. Oh, it'll fit into the bore, but if you miss a problem like

this on inspection, as soon as the engine starts and the ring heats up it'll grab the cylinder wall and stall the engine... and then restart, stall, restart, stall, restart, and stall over and over until you finally find it. Install bolts that are too long in the water pump of some engines and you'll shove the cylinder wall over into the piston. Fail to check your fasteners for proper minimum thread engagement and risk total failure. Or, fail to clean all threads on all fasteners and in

Look closely -- you can see the ring stands proud of the groove. Minimum safe back clearance is .005 in.
