Nissan Technical Service Bulletins to help make diagnosing and servicing Nissan vehicles a little easier.

Title: ABS Self Check Noise

TSB: NTB10-077a

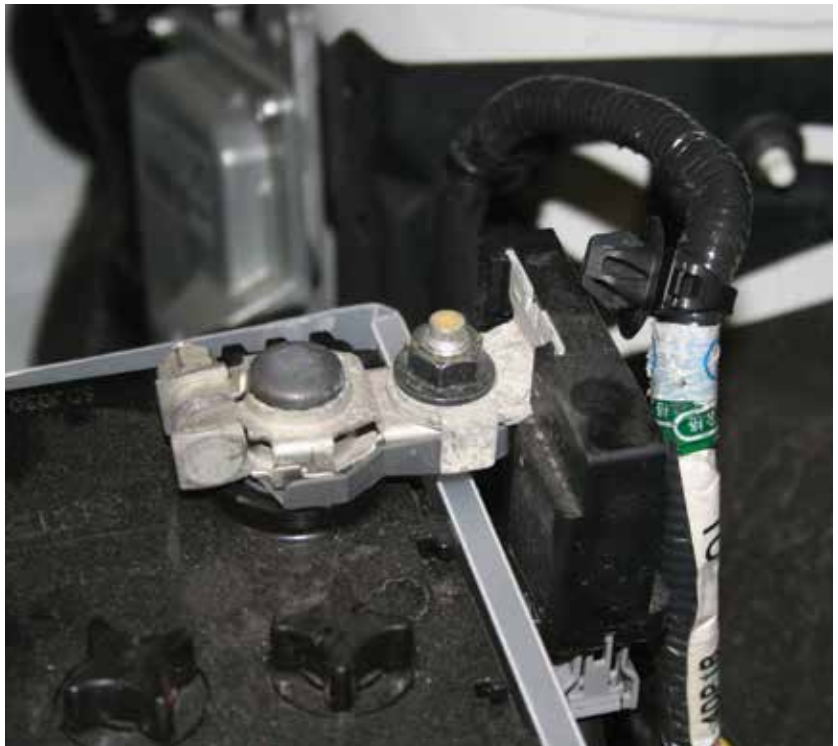
If you confirm a DTC P0300 is stored in the ECM and one or more of the ignition coils is blistered or melted, inspect the negative battery cable at the transmission end (at the battery terminal). Wiggle the end of the cable at the connector to make sure it is tight and not frayed.

Check the negative battery cable for damage.

1. If you find the cable broken or damaged, replace it with the appropriate Genuine Nissan part.
2. Inspect, test and replace each ignition coils as needed with the appropriate Genuine Nissan part.
3. Erase the DTC and test drive the vehicle to ensure that the engine runs smoothly and no further DTCs are set.

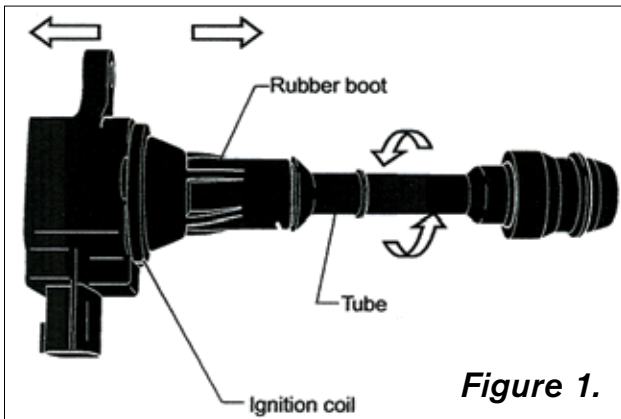
Figure 1.

The cause of this incident may be the ignition coils. A new resistor assembly (located inside the ignition coil tube) is available to repair the described symptoms, if they should occur.

1. Verify that the vehicle has one or more of the symptoms listed above.
2. Remove all four ignition coils. Refer to the appropriate 2002 Service Manual for the removal procedure of the ignition coils (page EM-26 for Altima, page EM-106 for Sentra).
3. Install the new resistor assembly in all four ignition coils as follows:
 - A. Pull the rubber boot away from the ignition coil. Then, twist and pull the ignition coil tube from the ignition coil to separate them (Fig. 1).
 - B. Remove the spring from the ignition coil and discard. Insert the new resistor assembly into the ignition coil tube exactly as shown (Fig. 2).
